CONCRETE DAMS - CONTROL AND TREATMENT OF CRACKS

Review and case histories

Bulletin 107

1997

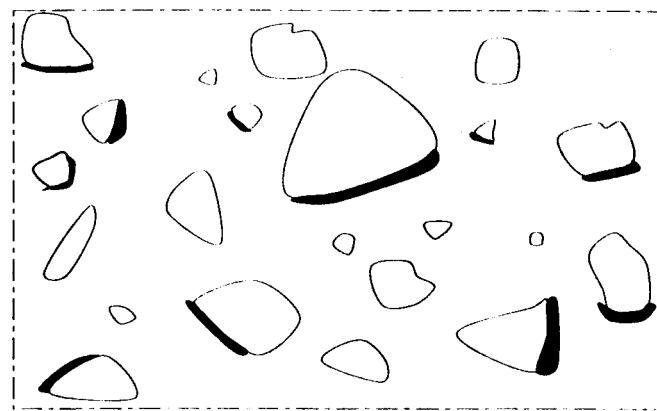
Fig. 5
Sketch of micro-cracking
Micro-fissuration

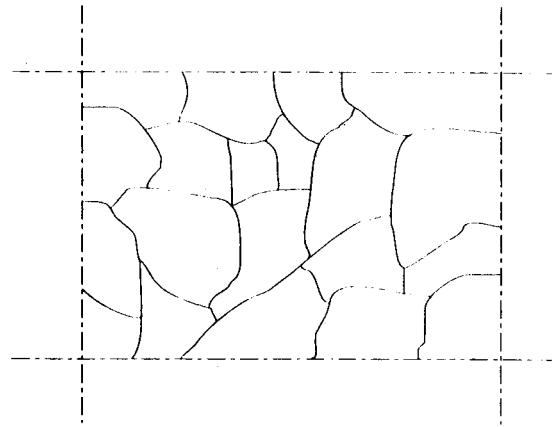
Fig. 6

Sketch of crazing
Craquelure (faïençage)

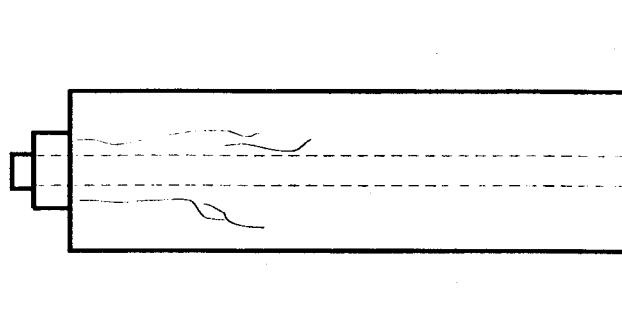
Fig. 8

Sketch of cracks caused by drying shrinkage

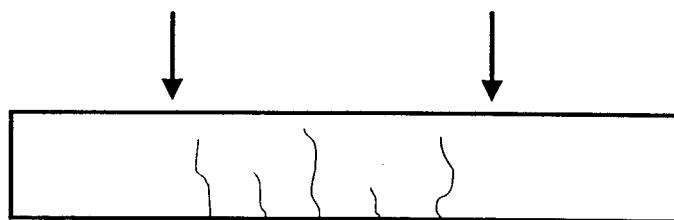
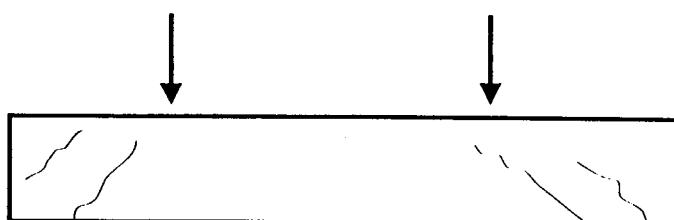
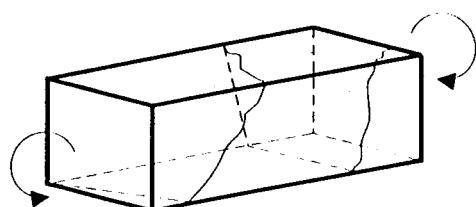
Fig. 10

Sketch of cracks caused by excess loading

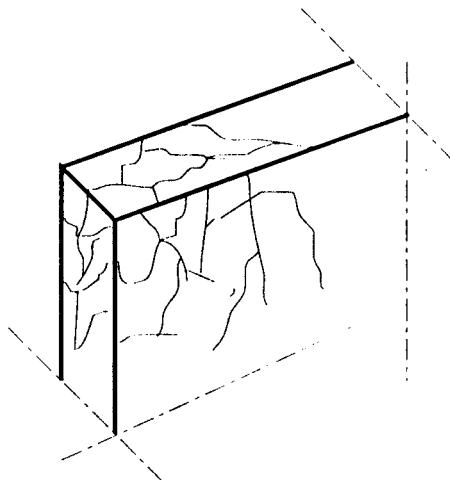
Fig. 12

Sketch of cracks caused by ground deformation
Fissures résultant de la déformation de la fondation

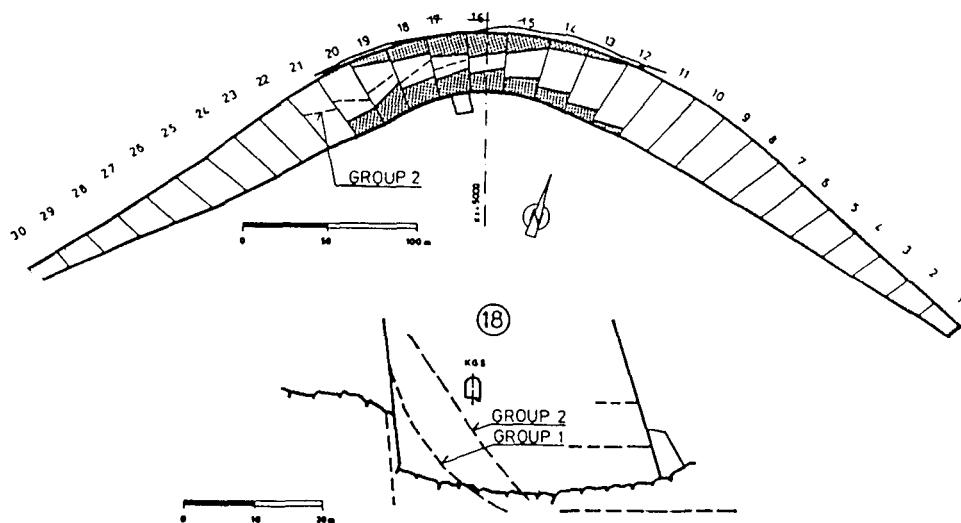
L'ouverture des fissures amont commence lorsque le niveau de retenue atteint la cote 1 820 m environ, l'ouverture atteignant 5 mm, alors que les fissures aval ont une ouverture maximale – 2 mm environ – à retenue vide.

After completion of the dam, problems arose during the first filling of the reservoir, which was stopped 12 m below top water level. In particular, cracks formed in the dam near its base and in the rock foundation, which led to high seepage and uplift [5.1.1].

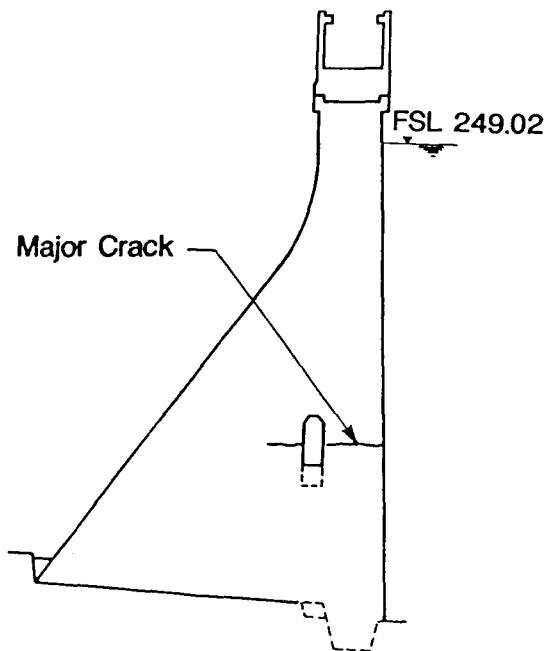
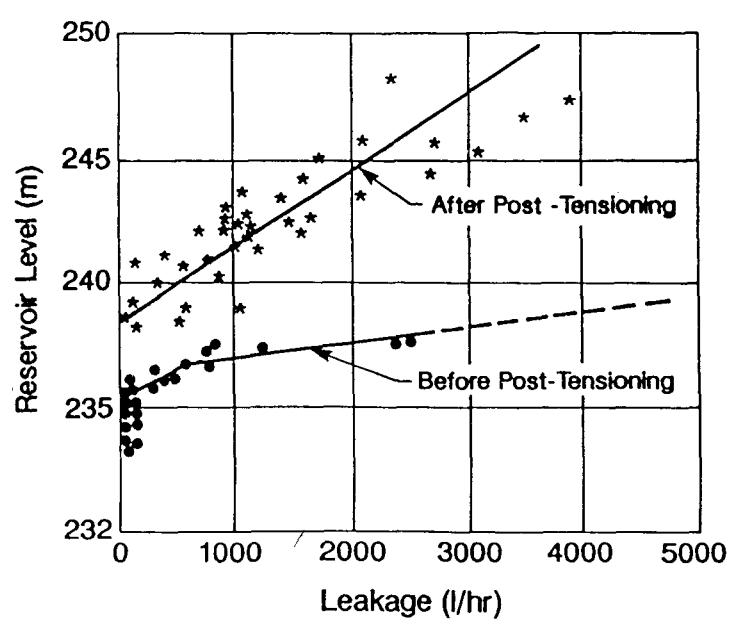
Fig. 32

The remedial measures at Mullardoch were successful in eliminating leakage into the central blocks of the dam (see Fig. 32) and in stabilising the cracks, the

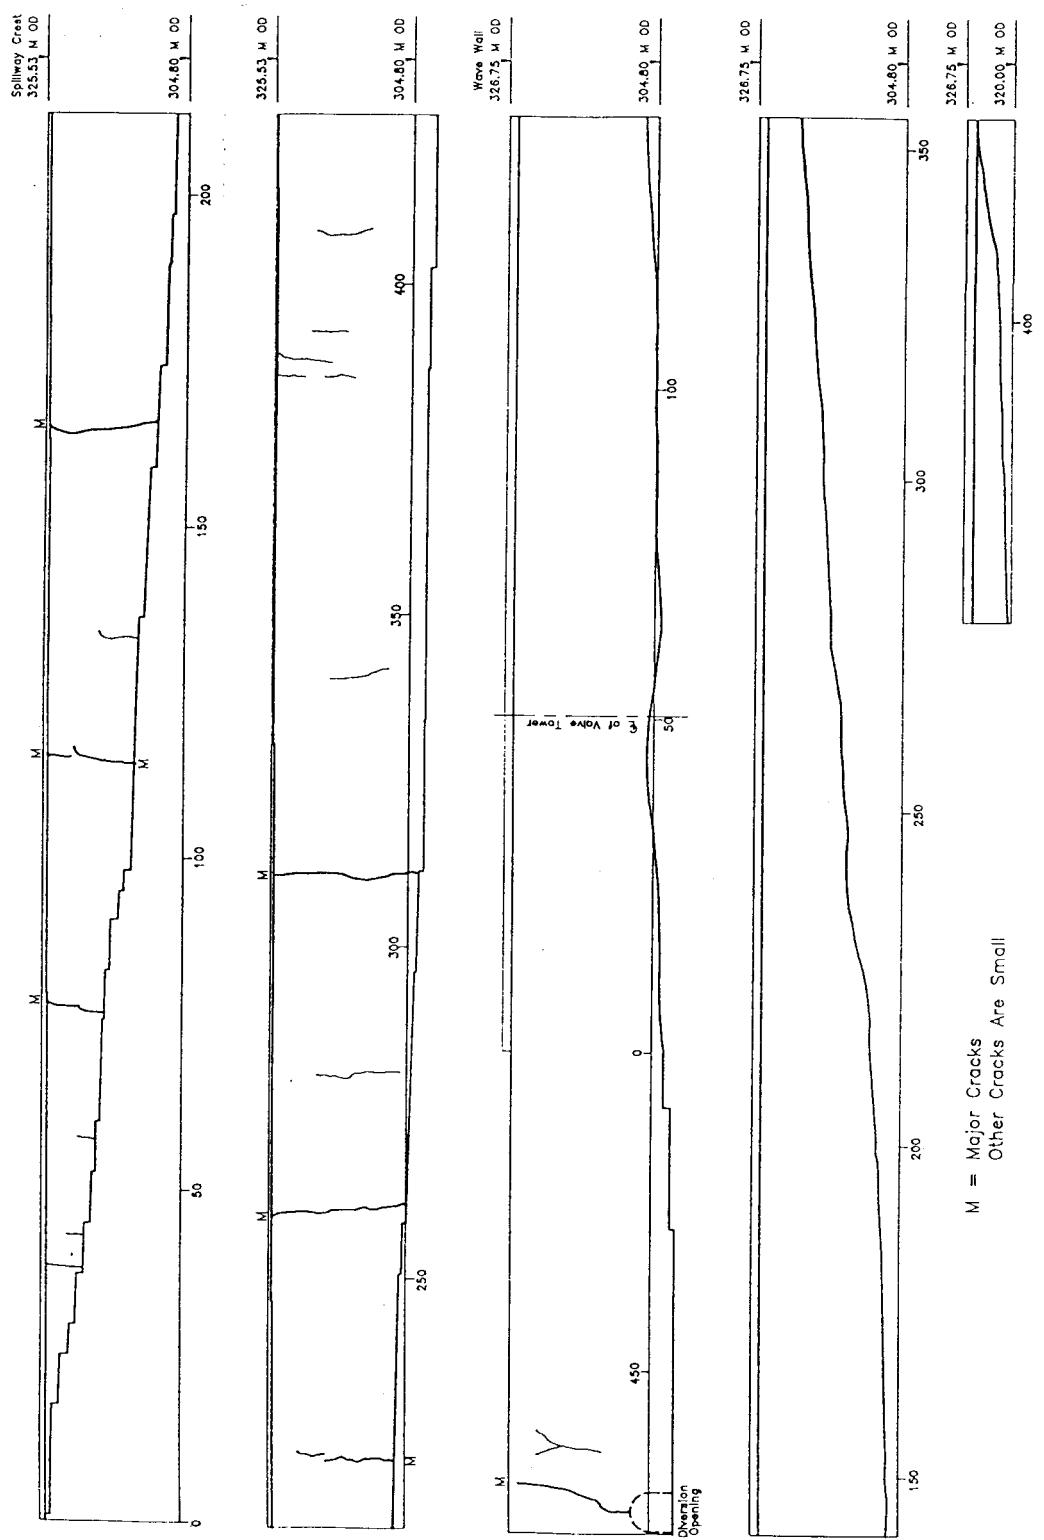
Practically no water was leaking through the dam by early 1910, the cracks apparently having self-sealed, either by sediment in the water or, more probably, by free lime leaching from the cement. The lime also built up as a hard white deposit where leaks surfaced on the face of the dam and is still visible today. Some modern leakage measuring points are still affected by a slow build up of calcium carbonate.

Fig. 34
 Downstream elevation of Blackwater Dam showing location of cracks
Élevation aval du barrage de Blackwater indiquant l'emplacement des fissures
 Spillway crest., 325.53 m
 Wave wall, 326.75 m
 Diversion opening
 Centreline of valve tower
 M = Major cracks
 Other cracks are small
 Crête du déversoir, cote 325.53 m
 Parapet anti-vagues, cote 326.75 m
 Pertuis de dérivation
 Axe de la tour des vannes
 M = Fissures principales
 Les autres fissures sont petites

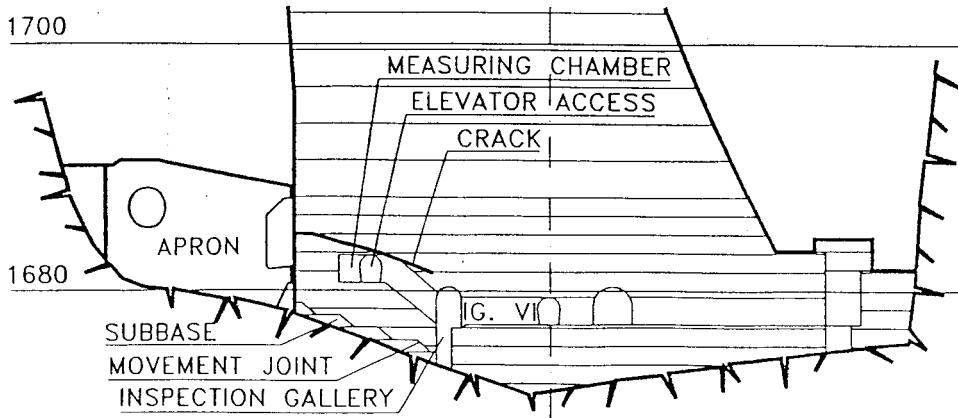
Exploratory borings showed that the overall stability of the dam was satisfactory, but that the crack was more extensive than first thought, with an area of

d'environ 350 m² et une ouverture de l'ordre de 1 mm sur le parement amont. Il fut nécessaire de vider la retenue et de traiter la fissure depuis le parement amont.

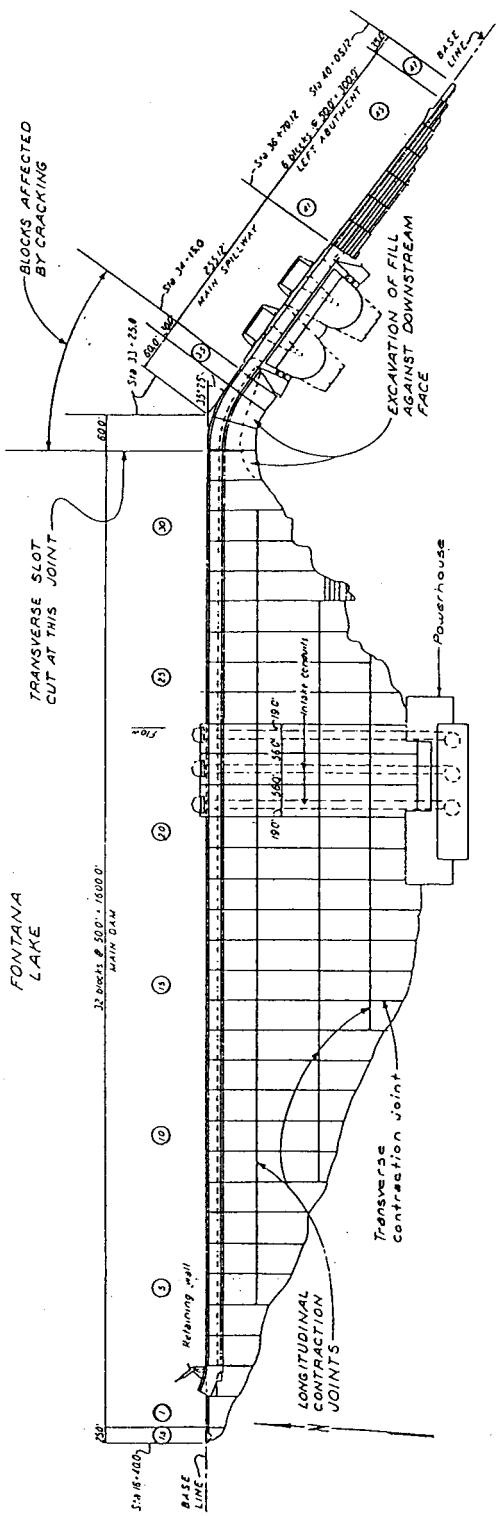
Fig. 45

A considerable programme of monitoring has been maintained before and since completing the slot. Cores from the dam have indicated that there is more reaction than was seen in the cores from the right side of the dam, indicating that

Since strengthening of the cracked blocks and spraying the dam during warm weather were deemed inadequate as a permanent solution, interrupting the longitudinal thrust by cutting one or more wide expansion slots across the upper portion of the dam was studied. For this study the structure was modelled and a computer analysis made using a finite-element methods. Seventeen analyses were made with various combinations of numbers and depths of slots. Comparison of results from these analyses indicated that reduction in stresses and closure of slots
