# REHABILITATION OF DAMS AND APPURTENANT WORKS

*State of the art and case histories*

**Bulletin 119**

**2000**

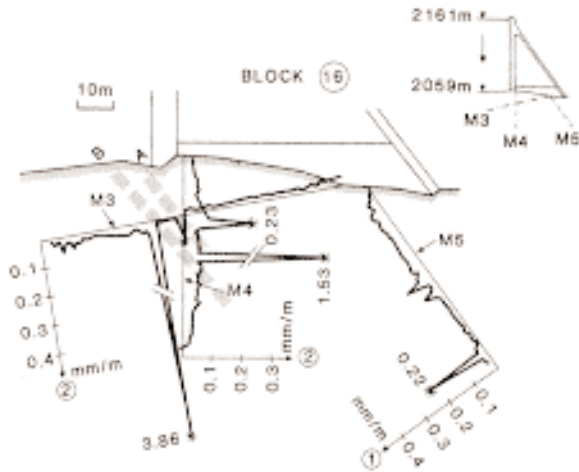
Fig. 3.2.1

To repair the dam it was necessary to reduce the water pressure in the fracture opening. Grouting would not have been effective since, as previously mentioned, the rock valley deforms at every change of the reservoir water level. Even grouted, the fracture would tend to re-open and the water would exert its pressure as before. To test its effectiveness in reducing the water pressure in the opened crack, a plastic foil of *hypalon* 2 mm thick and a few hundred mm wide was applied as a seal on the rock surface. The remainder of the seepage still percolating through the fracture was diverted to the lower gallery of the dam by drainage boreholes installed at the same time. These tests proved to be satisfactory. Therefore a watertight lining of neoprene 1.4 mm to 4.5 mm thick was applied and vulcanised to the lower part of

Albigna Dam. Strain development due to fall in water level (Kovari, 1985)

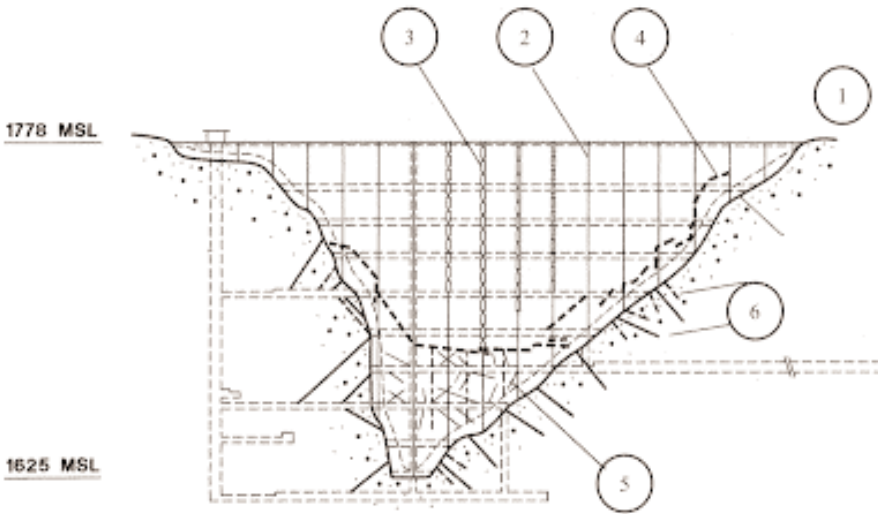
Fig. 3.2.2

A general ground movement was noticed, attributed to the drainage effect of an exploratory gallery constructed as part of the preliminary investigations for a highway tunnel. Although this gallery is located 400 m below the dam and 1400 m

Zeuzier Dam. Longitudinal section

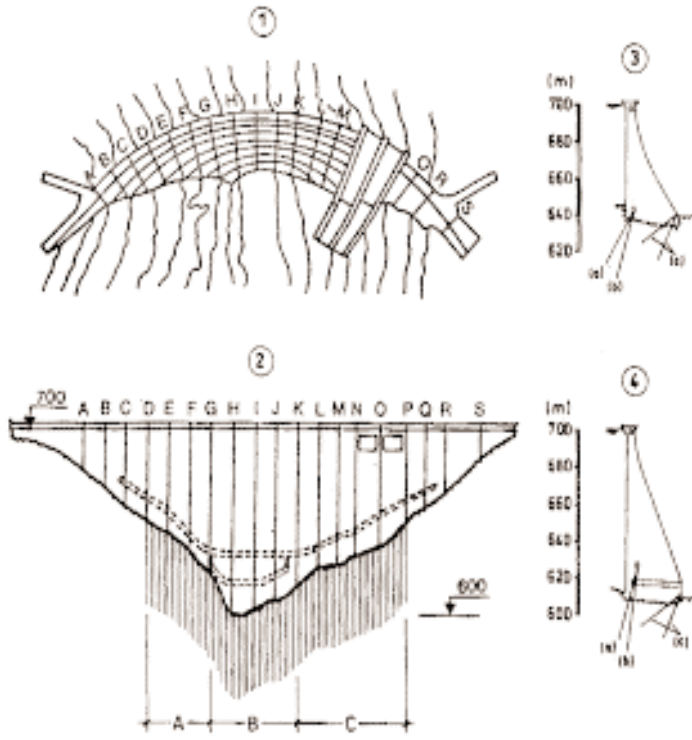
Fig. 3.2.4

The rehabilitation work was effective in reducing the seepage and the uplift in the foundation significantly. The maximum seepage was 1046 l/min before the repairs and only 12 l/min after. The maximum uplift pressure was reduced by factor 4 to 5.

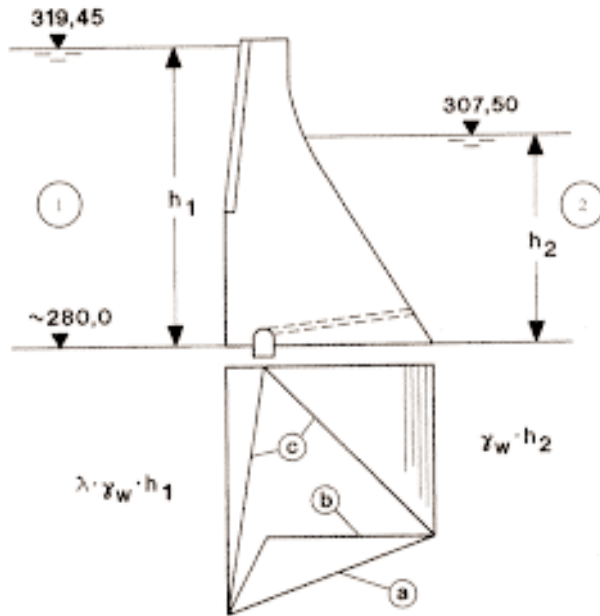
Fig.3.2.5

Drainage works have caused a high hydraulic gradient to the rock mass which has proved detrimental to the foundation. **Lister Dam** in Germany is a masonry dam 40 m high and 264 m long designed by Prof. Intze. In 1965 the dam was submerged up to  $2/3$  of its height  $h_1$  from the downstream side as part of the works for the Bigge Reservoir. To improve the stability of the dam, a drainage gallery was excavated at the bottom of the dam, to reduce the uplift pressure. With the gallery pumped empty the uplift pressure distribution was triangular on both sides, with a peak  $g_w h_1$  at the upstream side, and  $2/3 g_w h_1$  below the downstream face, and zero at the gallery. The hydraulic gradient at the upstream side exceeded 10. After some years it was observed that joint filling material was transported to the gallery, increasing the permeability of the rock below the dam. Additional calculations proved the dam to be stable with the gallery flooded from the downstream side (Bigge Reservoir) and since the end of the 1960s the gallery has been allowed to fill, preventing further erosion. Fig. 3.2.5 shows the uplift pressure distribution under different operating conditions (Rißler, 1998).

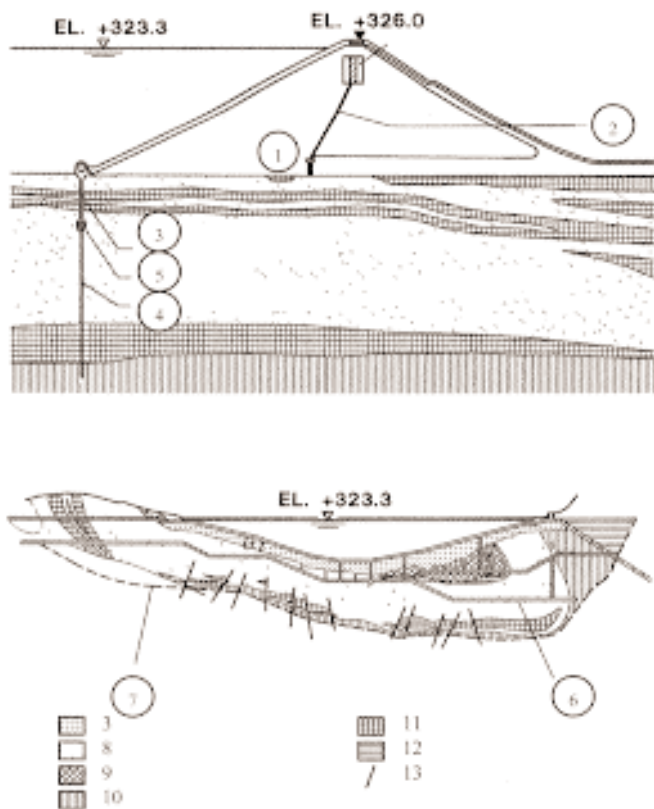
Fig. 3.2.6

**Henne Dam** is an example of a dam that has had to be abandoned (Heitfeld, 1961). This Intze masonry dam was constructed in Germany 1905 on soluble limestone formations to form a reservoir of 11 million m<sup>3</sup>. After 40 years of operation the dam foundation had become so pervious that remedial work was not economic. A new embankment dam with an internal asphaltic concrete core was built between 1949 and 1955 a few hundred meters upstream, on less soluble foundation rock. An extended gallery system, shown on Fig. 3.2.6, combined with intensive monitoring of seepage ensures the safety of the structure and would enable the owner to start remedial measures rapidly.

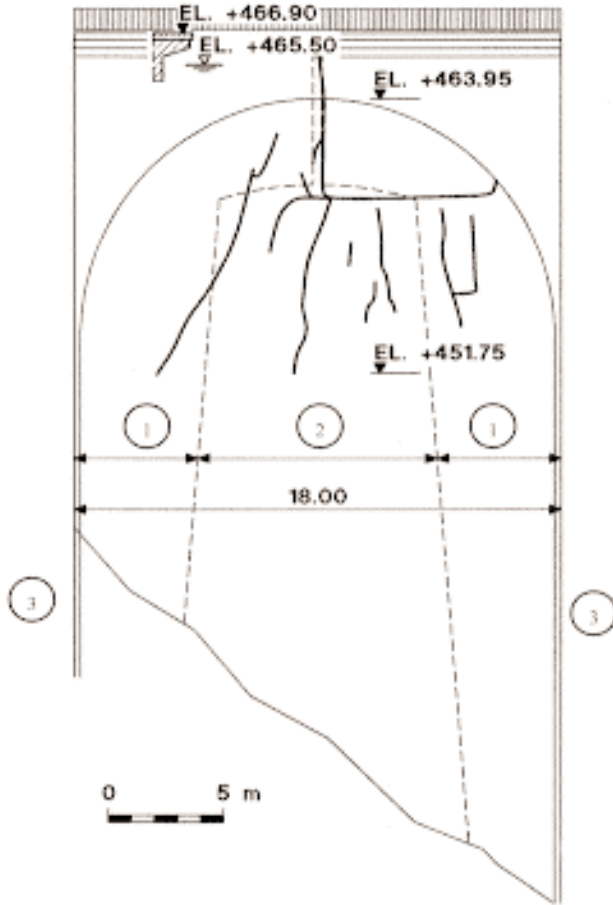
Fig. 3.3.6

After 10 years of operation of the reservoir, hair cracks were discovered in the upstream face of the dam. Measurement confirmed that the cracks were nearly closed in winter and up to 0.5 mm wide in summer. Typical cracks are shown on Fig.3.3.6. The cracks were concentrated in the area of the face subject to fluctuating water level. On average the cracks were 200 mm to 250 mm deep, but one was measured to be 800 mm deep.

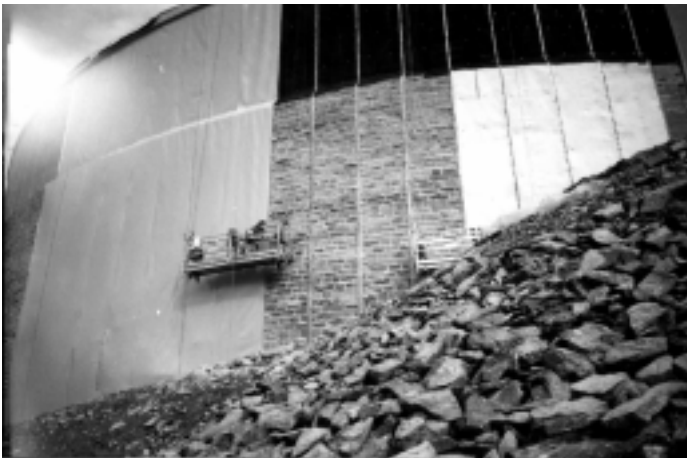
Fig. 3.3.12 shows work underway on the **Illsee Dam** in Switzerland. This is a 36 m high arch-gravity dam built in 1924 (Regamey et al 1995). Displacements were

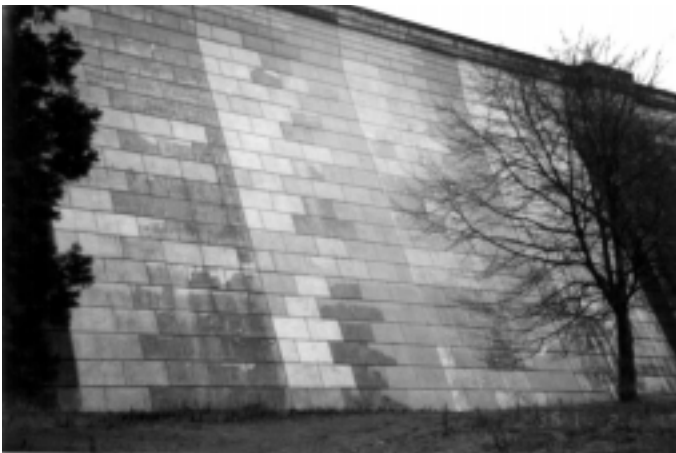
Fig. 3.3.15

It appears that the repairs have been successful in the main. After ten years there is some cracking of the repair mortar. Seventeen 2 m long cores were drilled horizontally into the downstream face. Of these ten were in the original concrete and seven were through areas that had been repaired. In three of the cores the bonding to the original concrete was breaking down.

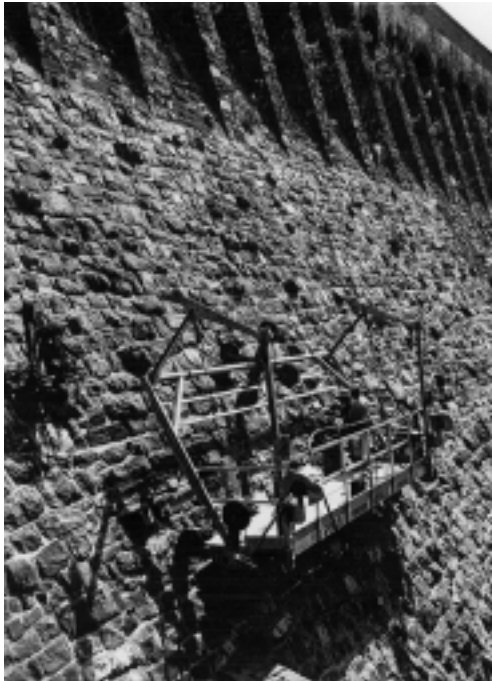
The **Möhne Dam** in Germany is shown on Fig. 3.3.16 and 3.3.17 and 5.4.1. The masonry gravity dam is 40 m high and 650 m long and was completed in 1913. The dam was damaged by bombing in 1943 and repaired rapidly in the same year. The downstream face of the dam had not been investigated since the reconstruction in 1943. At the beginning of the nineties, a detailed inspection was made of the 25 000 m<sup>2</sup> of the downstream face using specialised access platforms. It revealed that extended rehabilitation work was necessary. The masonry was repaired by replacing stones of the face and by renewing the mortar in joints. Afterwards the faces of the two towers of the dam were rehabilitated in the same way and this was followed by rehabilitation of the 105 pillars between the flood escape openings at the crest. Altogether 1500 m<sup>2</sup> of stones were replaced and 15 000 linear m of joints treated.

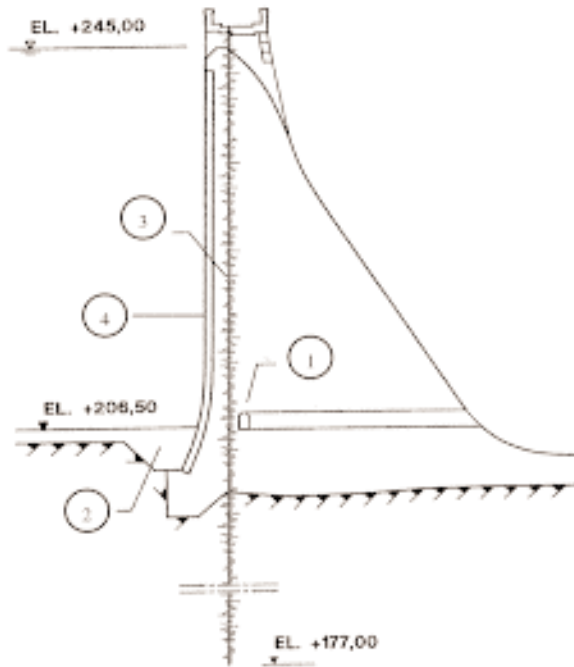
**Eder Dam** (WSB, 1994) is one of several examples of the stability being improved by adding prestressed anchors. Important considerations for such a solution include the need to ensure that the anchors maintain their load throughout the life of the dam. Thus corrosion protection and regular monitoring are essential. Eder Dam, a masonry gravity structure, was built between 1909 and 1914 in Hessia, Germany. It is 48 m high and 399 m long. It was damaged in 1943 during World War II, but was rebuilt in the same year. A drainage gallery was installed during the repairs at the base of the dam. Drainage and grouting work was undertaken at the upstream face and around the gap made by the bombs. The dam and the rock abutment were grouted in 1962 and 1963. Fig. 3.4.1 shows the cross section as it was at the end of 1963.

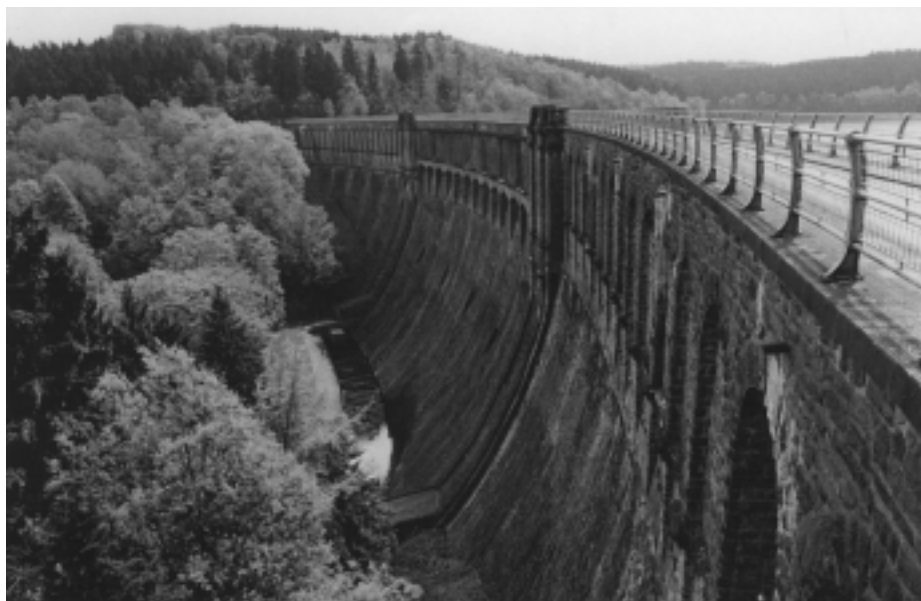
**Ennepe Dam** is a second example of a dam where the stability is improved by additional drainage. As shown on Fig. 3.4.10 it is a 50 m high and 320 m long masonry gravity dam in the Ruhr River catchment, built between 1902 and 1904. Between 1909 and 1912 the dam was raised by adding a 10 m high masonry block on the crest to increase the storage capacity by 2.3 million m<sup>3</sup> to 12.6 million m<sup>3</sup>. The reservoir is used for the water supply of about 170 000 people and to empty the reservoir to undertake remedial measures would have been an unacceptable cost. Therefore all remedial measures described below have had to be done during normal reservoir operation.

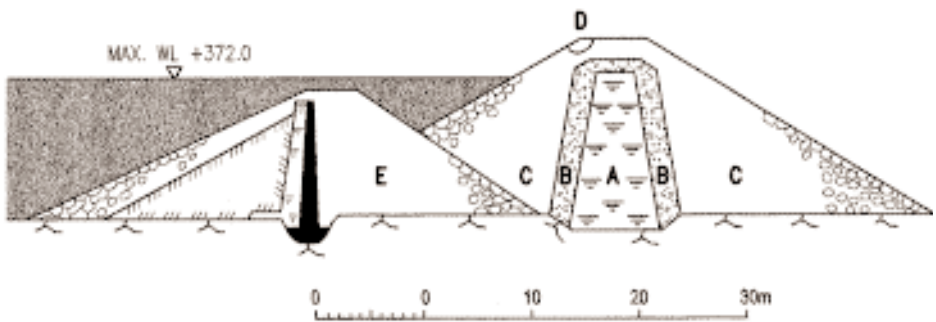
Fig. 4.4.2

**Porjus Dam** in Sweden is a rockfill dam with a central vertical core of moraine, approximately 22 m high (Johansson et al, 1996 and Johansson, 1994). In 1993 an almost cylindrical sinkhole, with a diameter of some 4 m and approximately 3 m deep, was found at the upstream side of the crest, on the line of the upstream filter of the dam, as shown on Fig. 4.4.2.

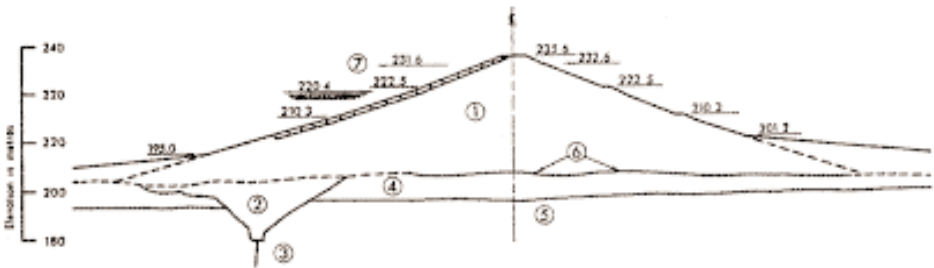
Fig. 4.4.6

**Wolf Creek Dam, USA**, is a combination concrete gravity and earthfill embankment structure with a maximum height of 61 m (Fetzer, 1979). The dam was completed in 1951. The homogeneous sandy clay embankment was founded directly on the overburden of sandy clay and sandy silt about 16 m thick. The overburden is underlain by highly solutioned limestone. The embankment design included a cut-off trench near the upstream toe that extended to top of bedrock as shown on Fig. 4.4.6.

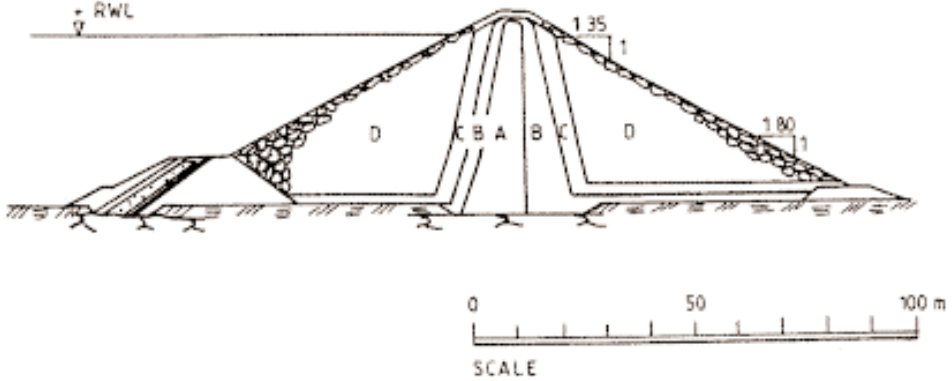
Fig. 4.4.11

**Ajaure Dam** in Sweden is a 46 m high rockfill dam with a central impervious core of glacial till supported by filter zones on the upstream and downstream side. The shells are made of rock from the excavation for the appurtenant structures and the powerhouse. The central high part of the dam is founded on rock, while the abutments are founded on glacial till. The crest has been subsequently raised by 1 m leading to slopes of 1V :1.35H to 1.40H in the upper 12 m of the dam. Below this level the downstream slope is inclined at 1V :1.8H. The dam, shown on Fig. 4.4.11, was completed in 1966 (Nilsson et al, 1991).
