TAILINGS DAMS RISK OF DANGEROUS OCCURRENCES

Lessons learnt from practical experiences

Bulletin 121

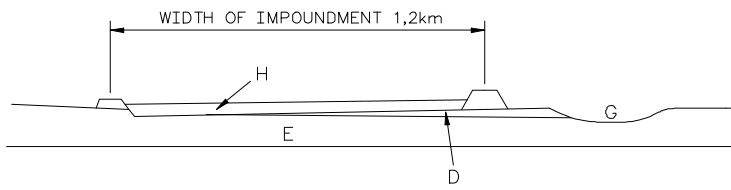
Figure 13. Section of Aznalcóllar Tailings Dam.

- A WASTE ROCKFILL.
- B EARTHFILL.
- C SLURRY TRENCH CUT-OFF.
- D ALLUVIAL SAND AND GRAVEL ABOUT 4m THICK.
- E BLUE MARL 60m THICK. $k = 10^{-11}$ to 10^{-12} m/s.
- F SLIP SURFACE. $c' = 0$, $\phi' = 16^\circ$
- G RIVER
- H TAILINGS. $\gamma = 28 \text{ kN/m}^3$

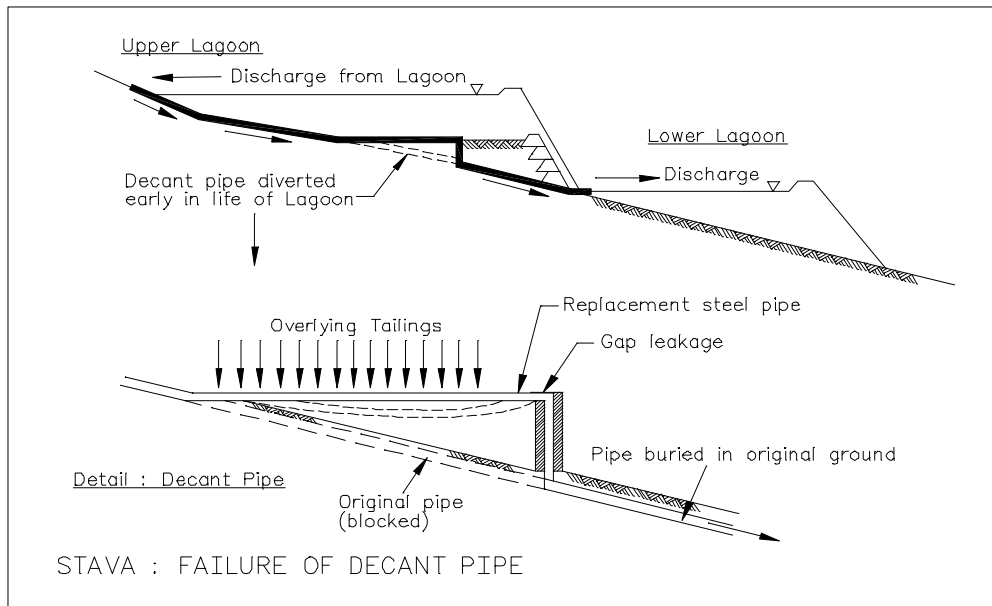
Figure 16. Failure of the decant pipe at Stava.
