DAM SURVEILLANCE

LESSONS LEARNT FROM CASE HISTORIES

COMMITTEE ON DAM SURVEILLANCE

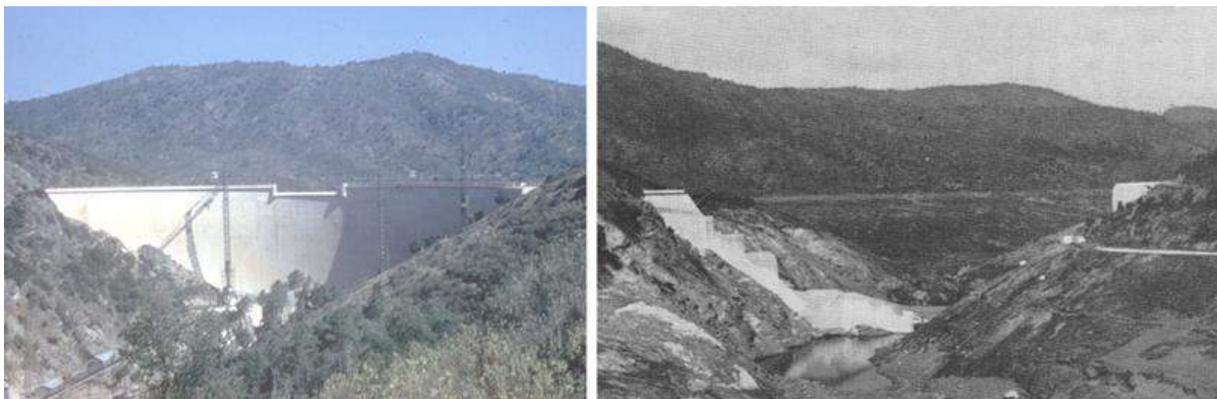
Figure 1. Malpasset Dam at the end of construction, mid 1954 (left) and soon after failure in December 1959 (right)

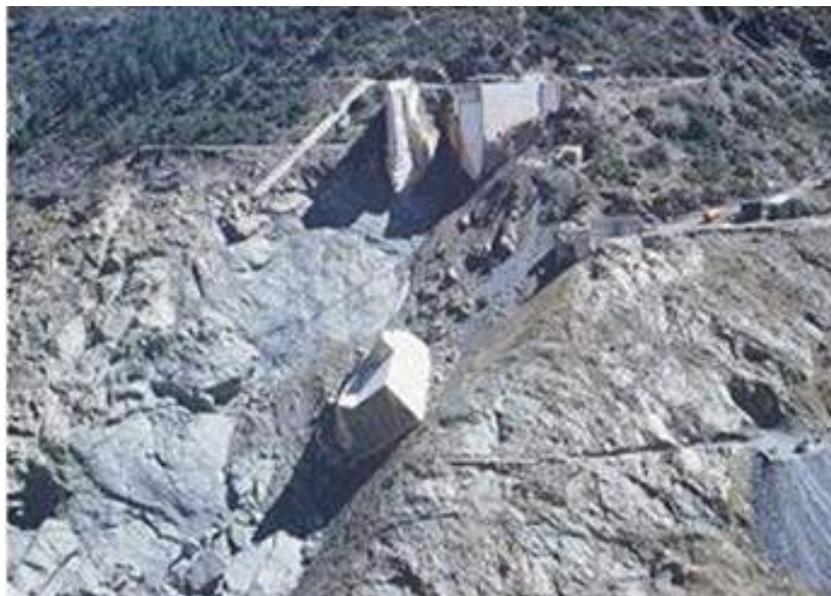
The dam failed the same evening around 21:11 after a sudden failure of the left bank. A large wedge of rock dislodged, below the left half of the arch dam, leaving an excavation in a dihedral form as shown in Figure 5. Only the bases of the right bank and central concrete blocks were still there, as shown in Figure 6. All other parts of the arch washed away; some blocks of concrete were swept away for more than 1.5 km.

Figure 5. The left bank after failure. "Dihedral" excavation with half of the upper thrust block fallen after the failure (the exploratory adit on the lower right was excavated after the failure to perform in situ jack tests).

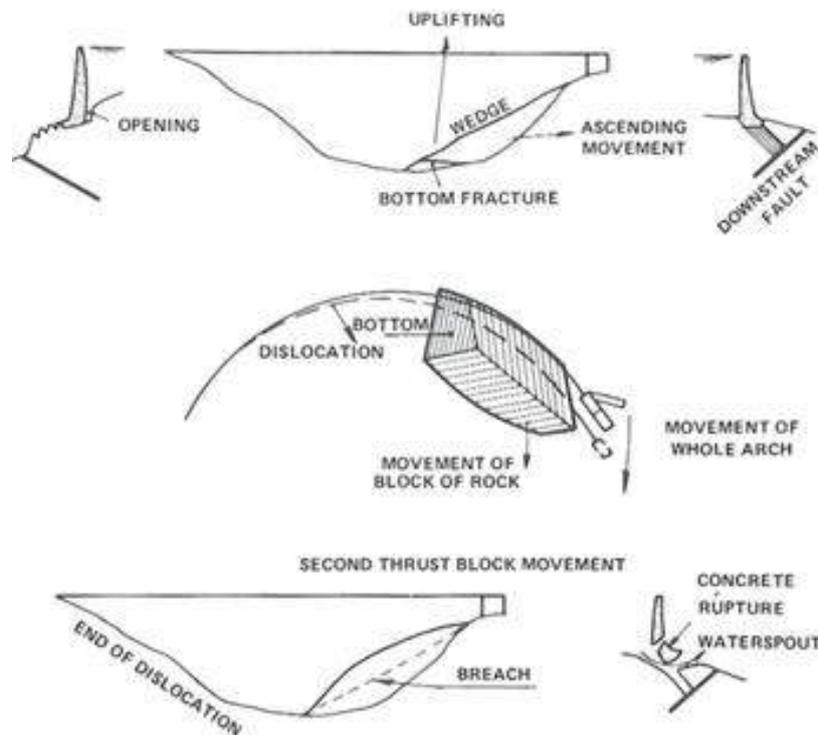
- stress in discontinuous media can penetrate quite long distance following discontinuities, particularly in the direction of the rock foliation, therefore forming a watertight barrier at depth under the dam toe,
- upstream crack developing in the arch dam foundation provided a preferential path for the development of full hydrostatic pressure, which could penetrate deeply when combined with the above mentioned watertight barrier,
- deformability of the foundation was relatively high, with very low modulus of elasticity in the left bank (as demonstrated by finite element back analyses performed during the eighties).

Figure 8. Schematic representation of the “explosive” failure phase

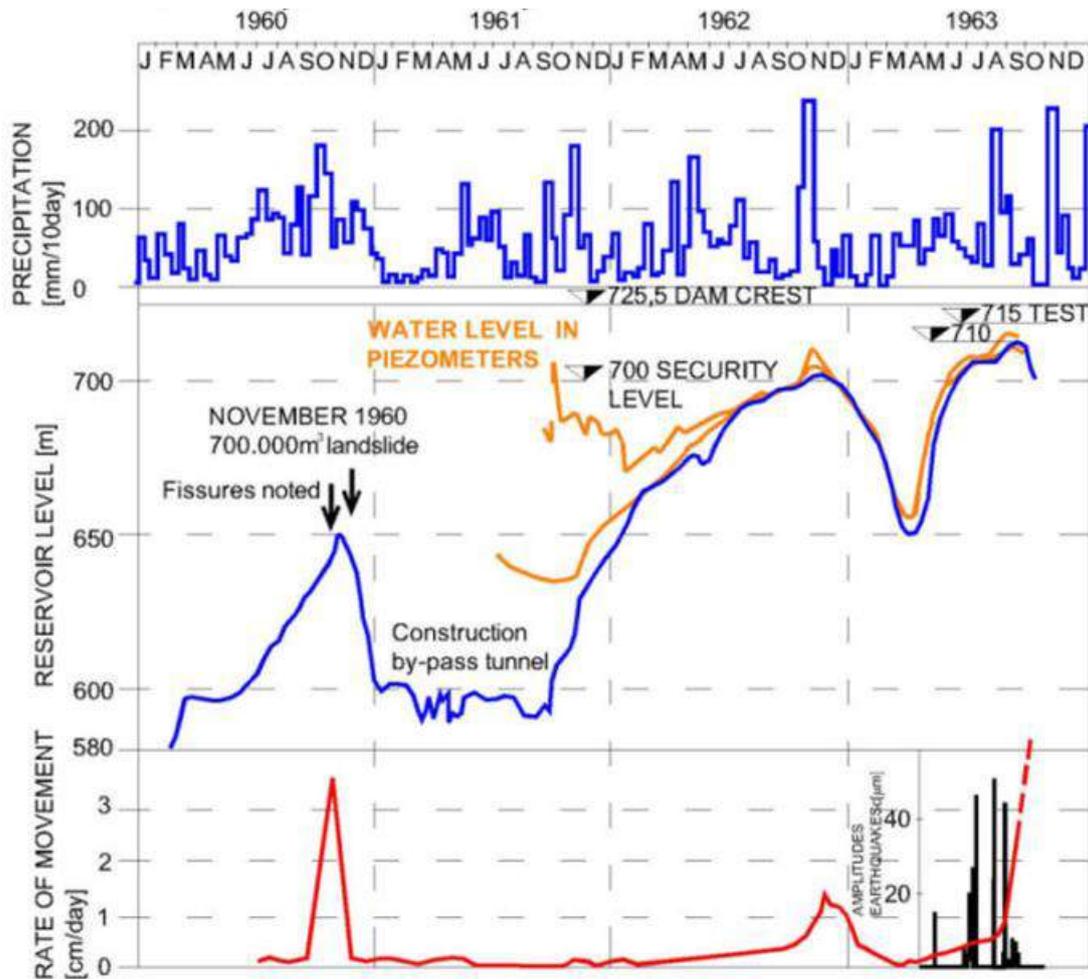
On November 4, 1960, when the reservoir level reached 180 m, a 700,000 m³ lump fell off the front of this larger landslide over a period of about 10 minutes. The speed of the slope displacement at this time was 3-4 cm/day (Oct 1960) with a maximum displacement of 100 cm.

Figure 11. Summary of monitoring data recorded at Vajont Dam: precipitation, water levels in the reservoir and groundwater levels (measured with piezometers) and rate of movements (Belloni et al: 1987)

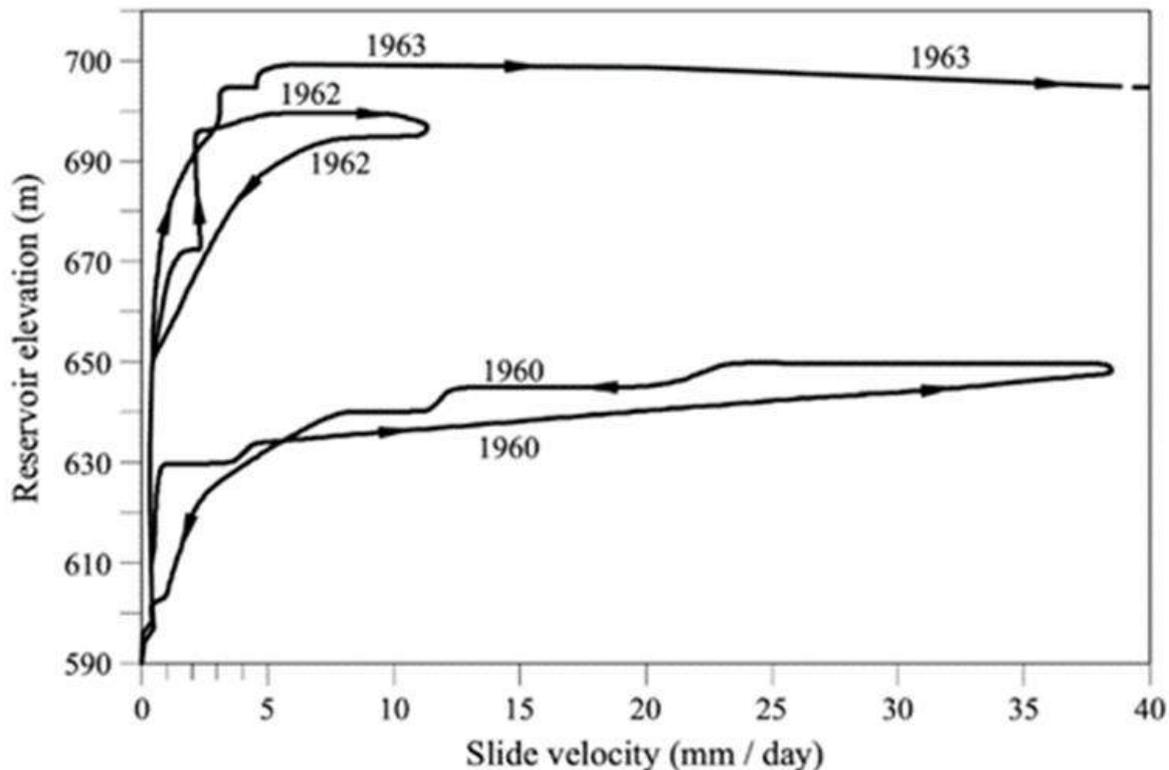
The dam engineers believed that by carefully elevating the level, movement of the large landslide mass could be started and then controlled by altering the level of the reservoir. It was calculated that, should a sudden movement occur, providing it did not lead to a filling of the reservoir in under 10 minutes, it would not cause over-topping of the dam.

Figure 12. Relationship between water level in the reservoir and sliding velocity (Alonso et al: 2010)

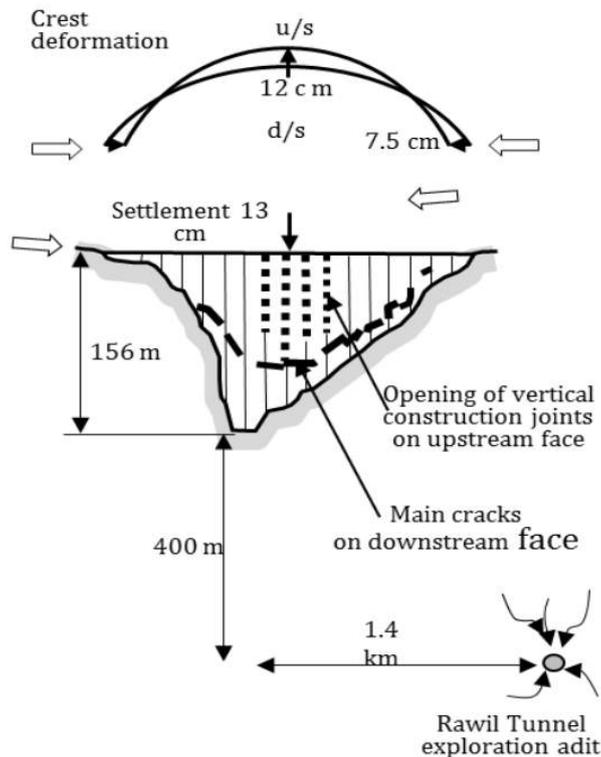
Due to unfavourable weather conditions (heavy snow), the geodesic survey could only be carried out in spring 1979. The results indicated a settlement (almost 10 cm) and a movement towards the upstream (almost 9 cm) at the level of the crest as well as a narrowing of the abutment. Actually, the valley itself was narrowing (almost 7 cm). Further to these movements, opening of vertical joints in the top of the upstream facing and the development of cracks in the downstream facing has been noticed (Figure 5).

Figure 5. Maximum dam deformations and crack pattern observed on both faces. Width of main cracks (December 1980): 1 to 15 mm

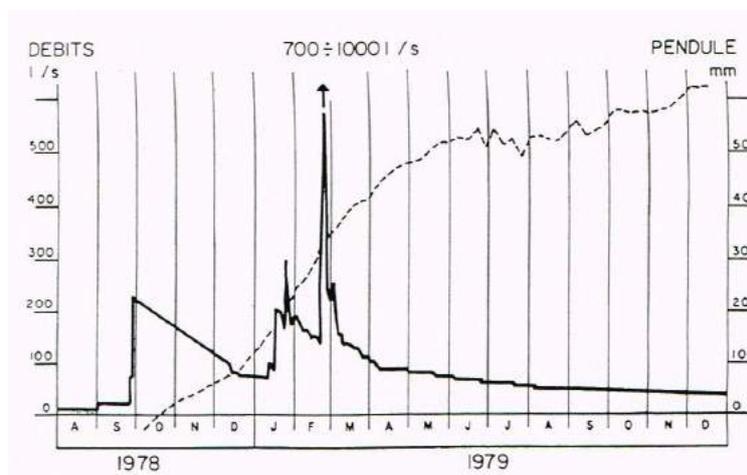
The analysis of diverse hypotheses (mainly tectonic and hydrogeologic) pointed out that these unusual deformations followed a general bowl-shaped settlement of the ground extending on 2 to 3 km. The hypothesis of the influence of the drilling of a tunnel exploration adit for the construction of the Rawil road tunnel was immediately considered as the tunnel was drilled only 1.4 km away from the Zeuzier dam. This hypothesis was supported by a striking connection between the curve of the exceeding deformations of the dam and that of the cumulative water flows drained by the above-mentioned gallery (Figure 6). The establishment of a mathematical model representing the behaviour of a cracked elastic saturated rock massif scientifically confirmed that the drilling of the adit was at the origin of the settlement of the ground, (Lombardi. 1992, 2004). Consequently, the tunnelling works were interrupted in March 1979.

Figure 6. Flow in the Rawil tunnel exploration adit (full line) and deformations shown by the pendulum (dotted line)

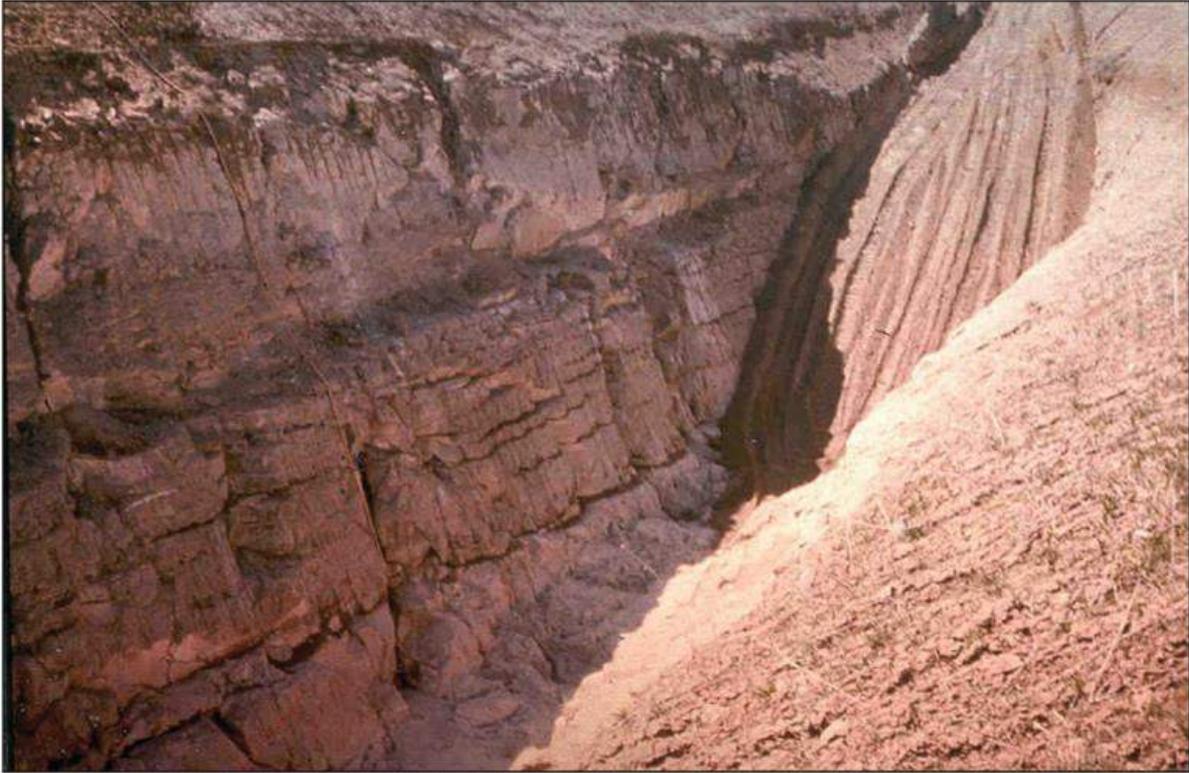
Continuous high-angle joints in the right abutment have been traced for lengths of as much as 60 m, but most are between 6 m and 30 m long. The aperture of most high-angle joints is less than 4 cm, but many joints are as much as several decimetres or even bigger. Examples of the jointing can be seen in Figure 17.

Figure 17. Right abutment key trench showing the jointed nature of the foundation

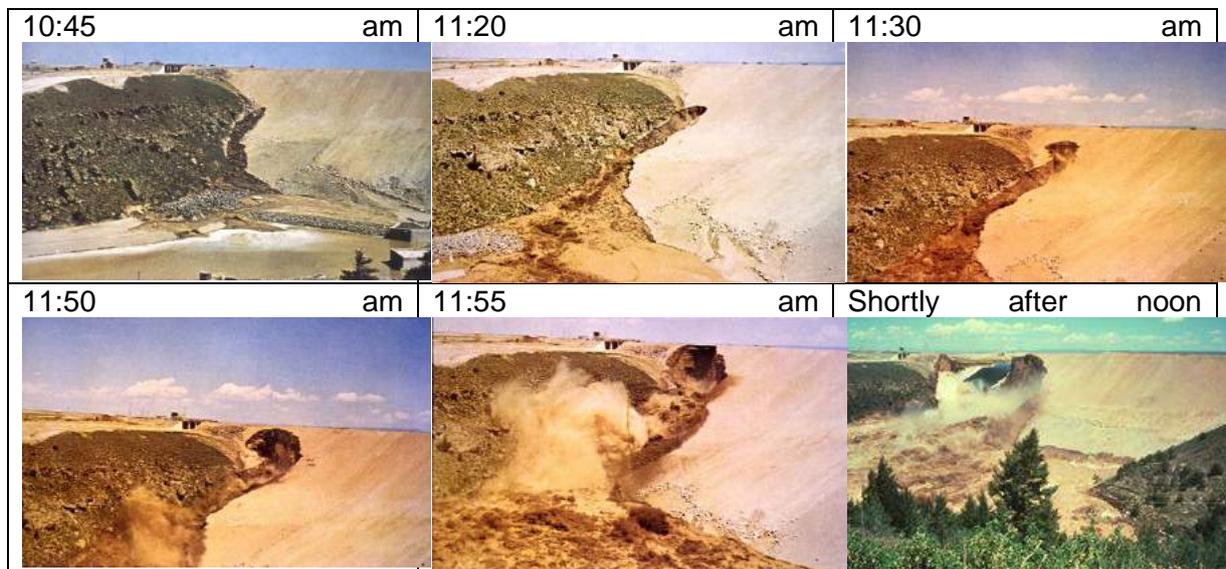
embankment causing a catastrophic failure and release of the entire pool. The uniqueness of the failure was the very rapid progression from discovery of a rather minor seep at the abutment to the total collapse of the dam. The speed of the progression to failure highlights the gross inadequacy of design and treatment to control seepage through the foundation

Figure 21. Photo sequence showing Teton Dam breach in roughly 90 minutes on June 5th, 1976

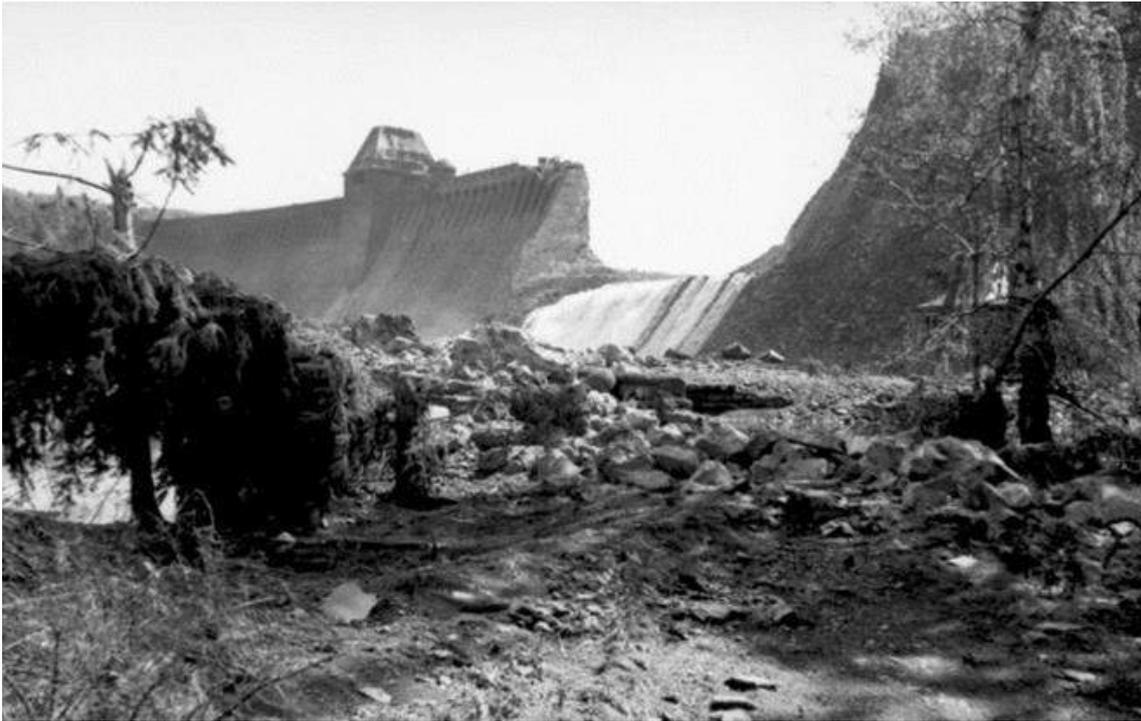
Figure 22. Breached Möhne Dam (Source: Bundesarchiv Bild 101I-637-4192-20, Zerstörte Möhnetalsperre)

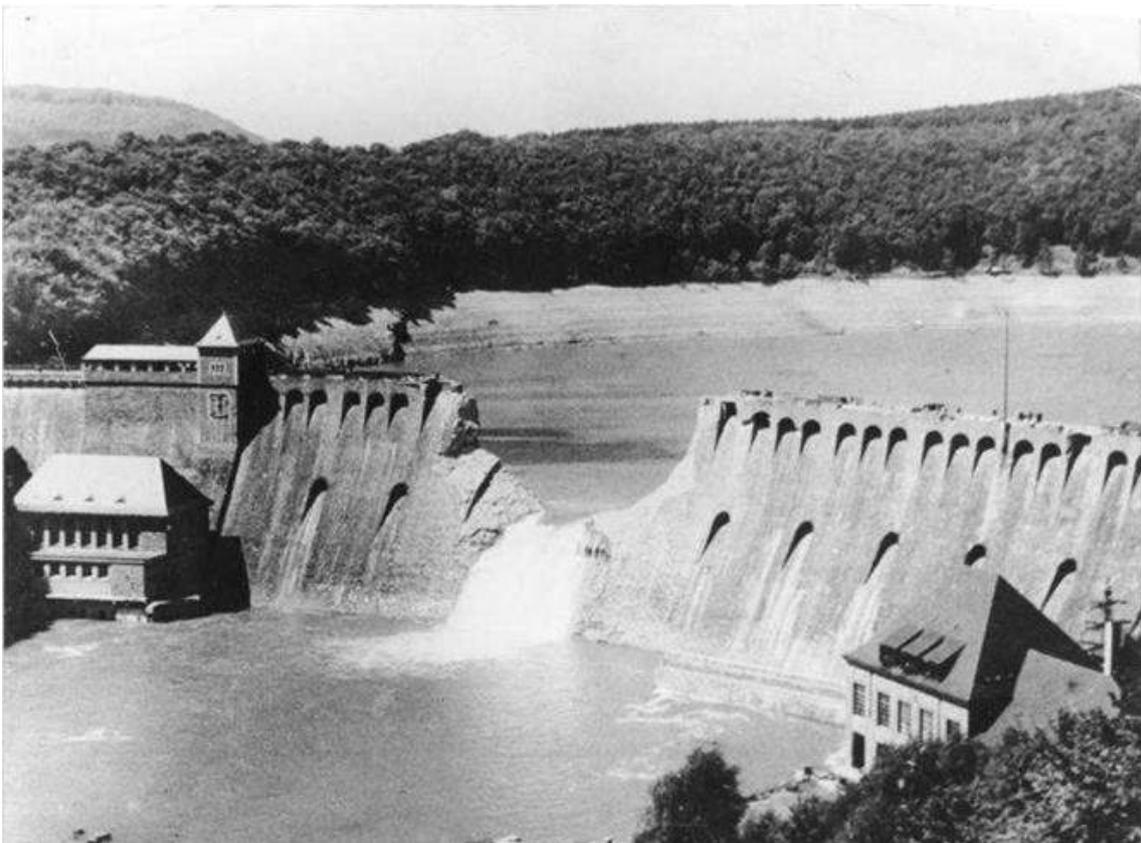
Figure 23. Breached Eder Dam (Source: Bundesarchiv Bild 183-C0212-0043-012, Edertalsperre, Zerstörung)

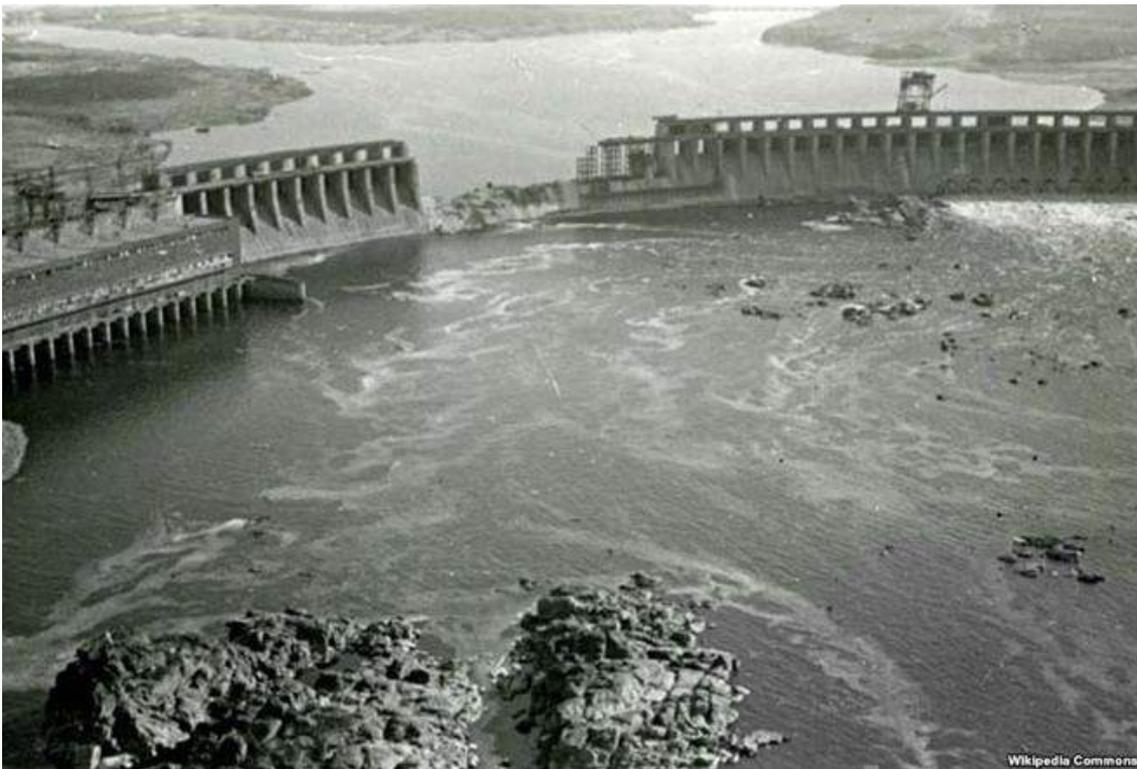
In September 1941, retreating Soviet troops reportedly detonated 90 tons of dynamite in a gallery of the dam. The upper part of the dam, about 200 m long was breached (Figure 3) and the resultant outflow of water caused casualties of between 20 000 and 100 000 people. The exact number is still discussed by historians, as little information is publicly available on the true sequence of events and its consequences. Some of the available online references are listed below. More references in Russian language can be found online. The pressure of the blast caused also heavy damages in the powerhouse. Additionally, retreating German troops dynamited the dam in 1943.

Figure 24. Breached Dnieprostroi Dam (Moroz & Bigg: 2013)

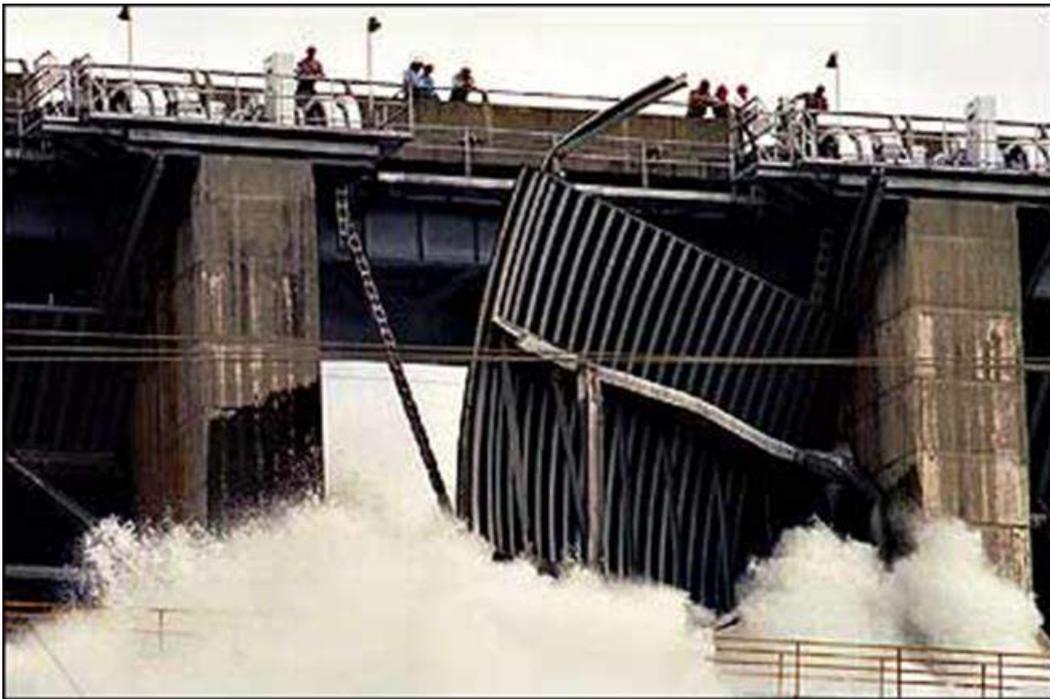
Nearly 40 percent of Folsom Lake drained out past the broken gate before it could be repaired. Luckily, no major flooding occurred as a result of the failure, and the Folsom Dam was fully repaired.

Figure 26. Failed Tainter gate No. 3 at Folsom Dam (Source: <http://www.pbs.org/wgbh/buildingbig/wonder/structure/folsom.html>)

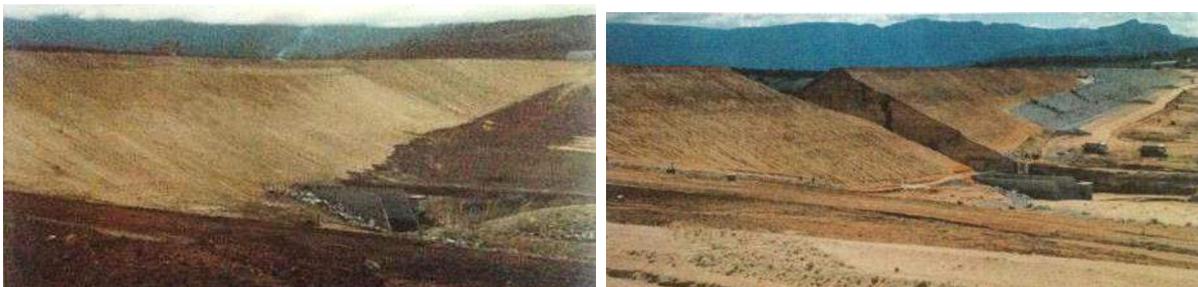
The embankment material comprised of leached granite from the basin area. Dispersive tests done prior to and during construction tested non-dispersive. Apparently tests were always done on the upper leached layers and not on the deeper lying material. The deeper layers of the borrowed material was, however, highly dispersive. ASHTO specifications for optimum moisture content (OMC) were used and not Proctor values. The dam was therefore constructed with highly dispersive material compacted at dry of optimum moisture content (a fatal combination).

Figure 32. Zoeknog Dam started impounding December 1992 and failed in January 1993

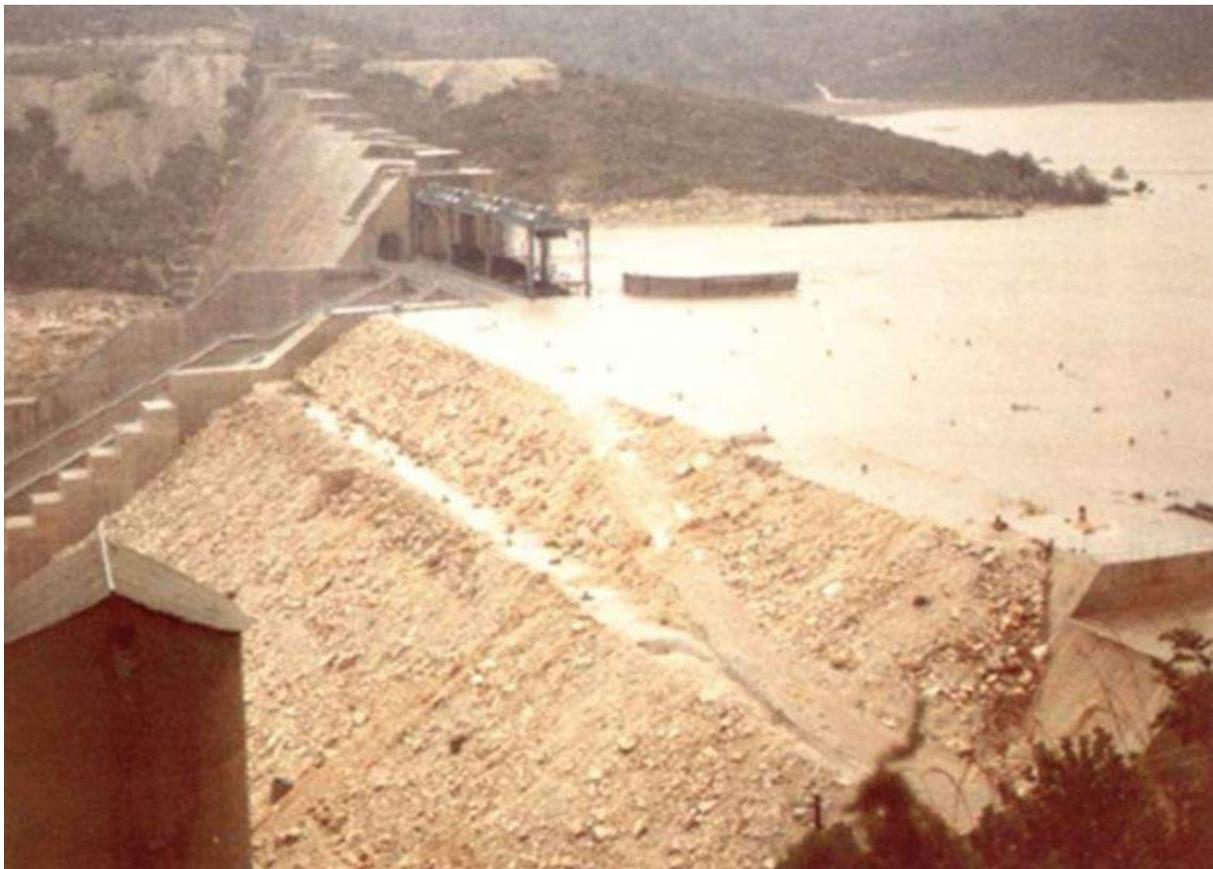
The overtopping started at 16:50 h (see Figure 37); the maximum water level reached about 1.10 m above the crest at 19:15 h.

Figure 37. Beginning of overtopping of Tous Dam

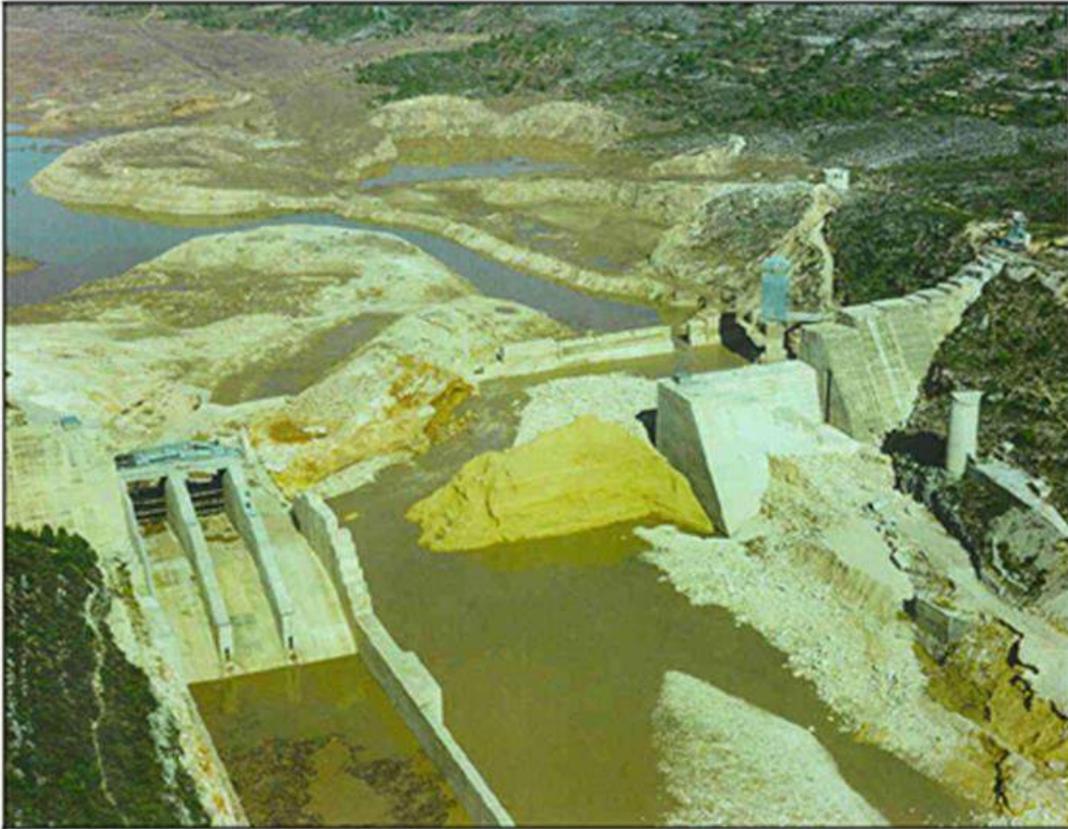
Figure 38. The remains of Tous Dam after the failure

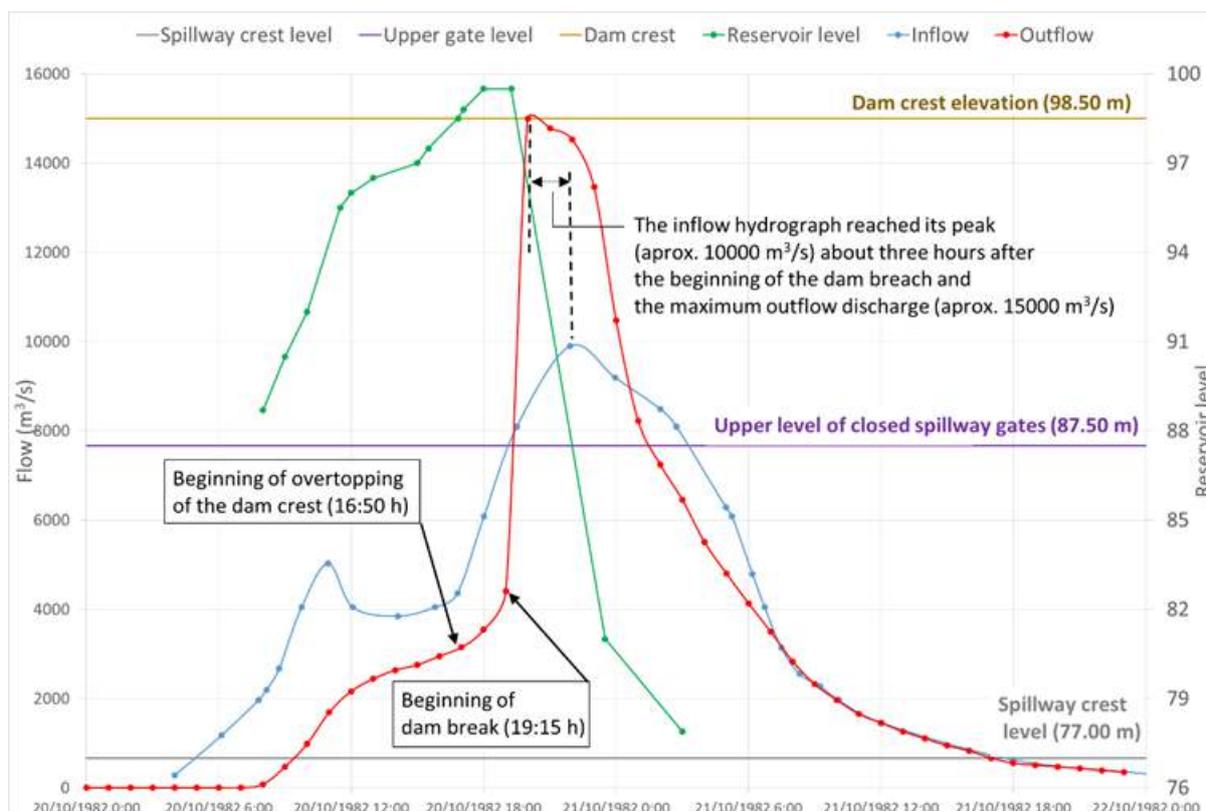
could not have been avoided. The load scenario of a 1 000-year flood was beyond the design assumptions.

Figure 39. Inflow and outflow hydrographs and reservoir level evolution during October 20 and 21 at Tous Dam (Source: Téméz et al. and Arenillas et al.)

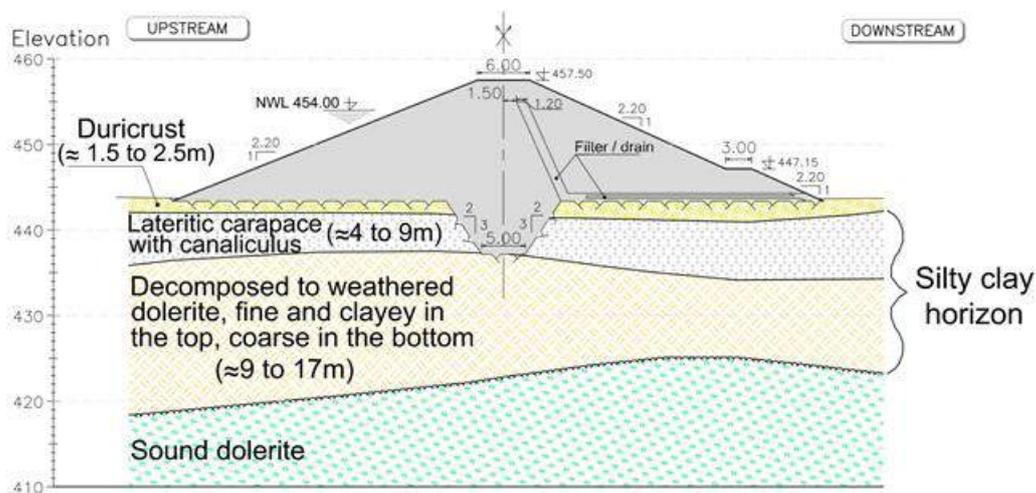
Figure 47. Cross section of dam (seepage concentrated in the silty clay horizon)

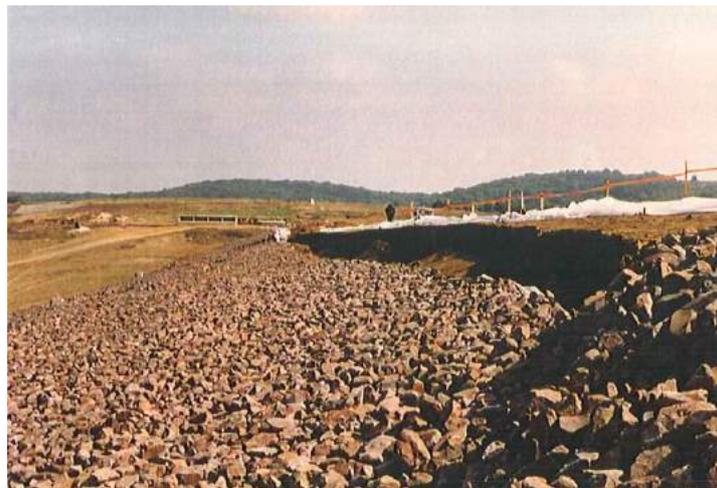
Fig. 1. Slide of the upstream embankment, 1982.

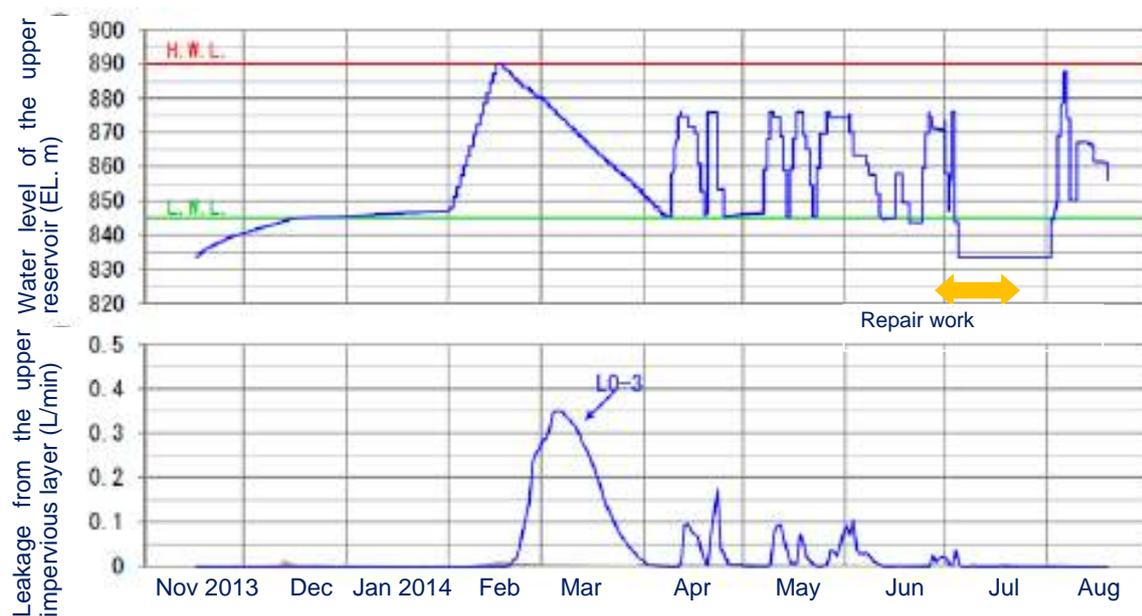
Figure 1 Leakage during the initial impoundment and repair work

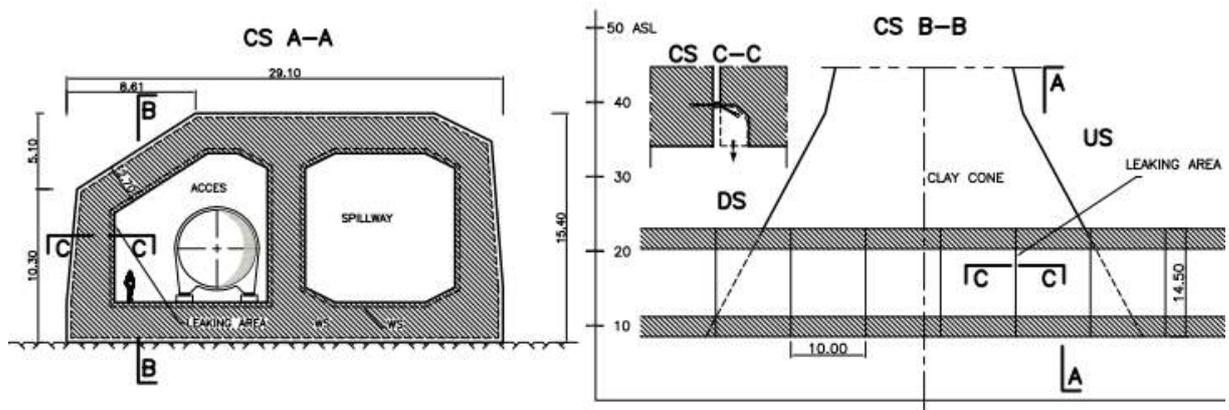
Fig. 1. Culvert definition, cross section CC corresponds to the area where the leakage occurs. Almost 30 m³ of core material were washed away.

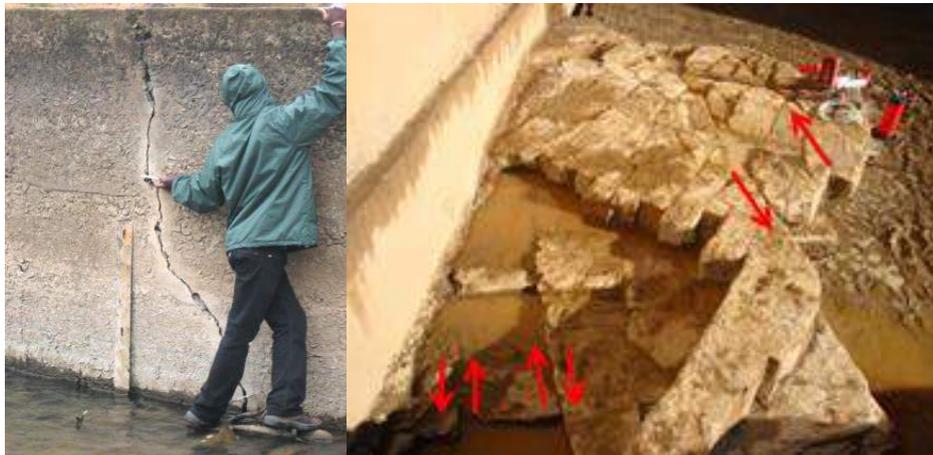
Fig. 1. Crack in arch spillway and relative movements of the rock in the foundation of the apron next to the right abutment

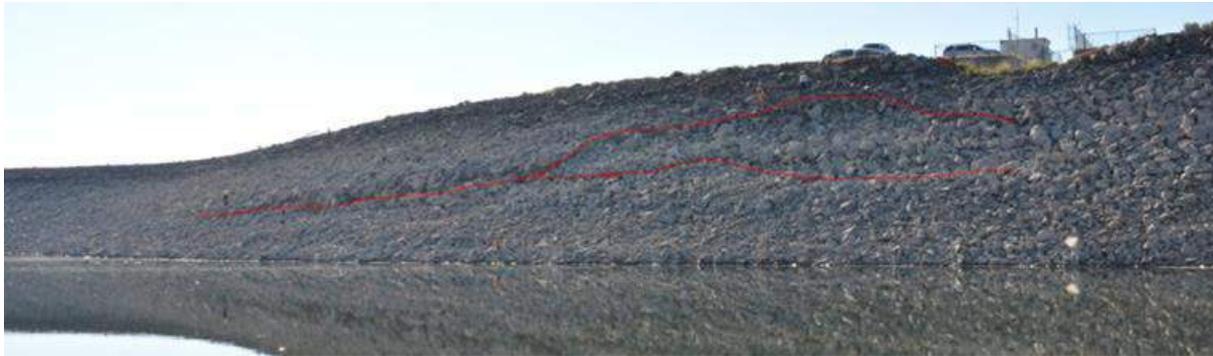
Figure 60. Upstream slope at right abutment (slide scarps highlighted in red)

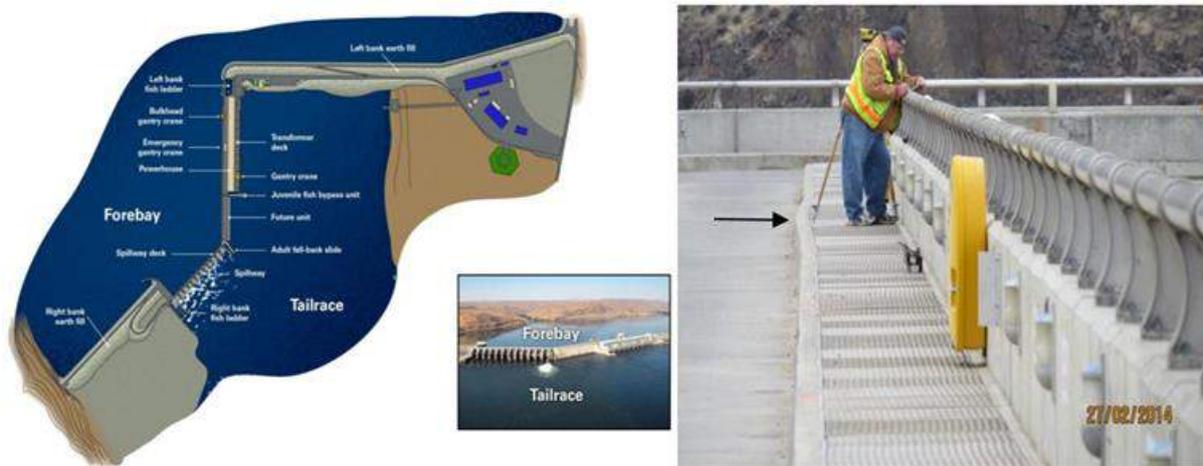
Figure 61. Plan of Wanapum Dam and offset at upstream curb of Pier 4
