## SAFETY PERFORMANCE OF DAMS IN CHILE HIGHLY SEISMIC ENVIRONMENT

### ABSTRACT

The paper presents a summary of the performance of large dams in Chile (heights  $\geq 15$  m) from the end of XIX century to the present, including moderate high dams for irrigation and water supply built since 1850 up to 1930 and larger dams for the same purposes as well as for energy generation from 1930 to the present days. Being Chile an important mining country there are numerous tailings dams of different types which seismic performance is also discussed. The variety of dam's types for different purposes and different construction materials constitutes an interesting scenery to the analysis of dam behaviour under high seismic loading. Although the number of concrete dams in Chile is rather limited, comments on the seismic behaviour of two arch dam and a few rolled concrete dams of medium height are also presented, as well as the case of the only rockfill dam with asphalt core existing in Chile.

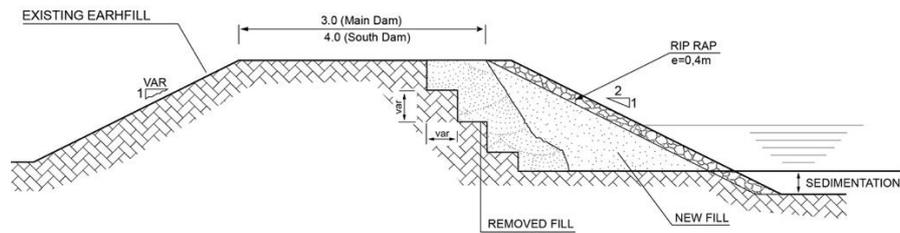
Catapilco dam is an earth dam with central impervious core, originally 13 m high and raised to 15 m in the decade of 70's, crest length 1,800 m and 8,0 million  $m^3$  original reservoir capacity [11]. The construction of this dam started in 1853 and completed in the period 1856-1859. This 171 year-old dam, the oldest one registered in the country, was still in operation by a local irrigation association up to some years ago when the operation of this reservoir was interrupted due extreme sedimentation of the reservoir. Removal of 250.000  $m^3$  of sediments allowed to recover part of the original reservoir capacity. Works started in October 2017 and completed in June 2018 and included some repair work in the upstream slope and placement of rip rap in the dam slopes. The strong EQs of March 1965 ( $M = 7.4$ ) and July 1971 ( $M=7.8$ ) could have produced some minor damage, probably the reason for the repair work done in 2017.

**Fig. 12 - Catapilco dam, upstream slope repair. [11]**

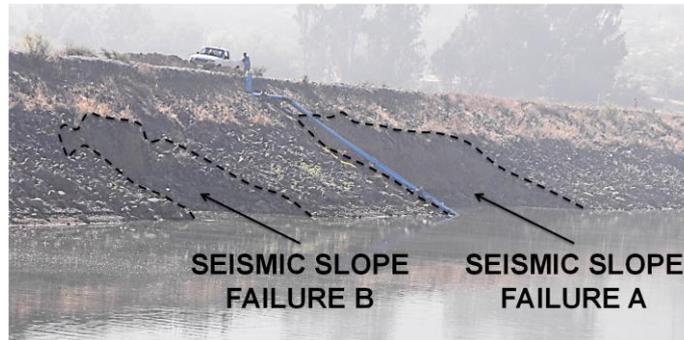
As already mentioned, Lliu Lliu earth dam was significantly damaged during the EQs of March 1965, July 1971 and March 1985 [9][12][13]. A visit to Lliu-Lliu dam after the 2010 Maule EQ ( $M=8.8$ ) [14] identified two localized seismic slope failures in the u/s slope of the dam as shown in Fig. 13. The length along the crest of these failures were 36 m and 21 m. Additionally, a series of longitudinal cracks along the crest with a maximum lateral opening of 10 cm were observed.

**Fig. 13 - Local slopes failures u/s slope Lliu – Lliu dam after 2010 EQ [14]**

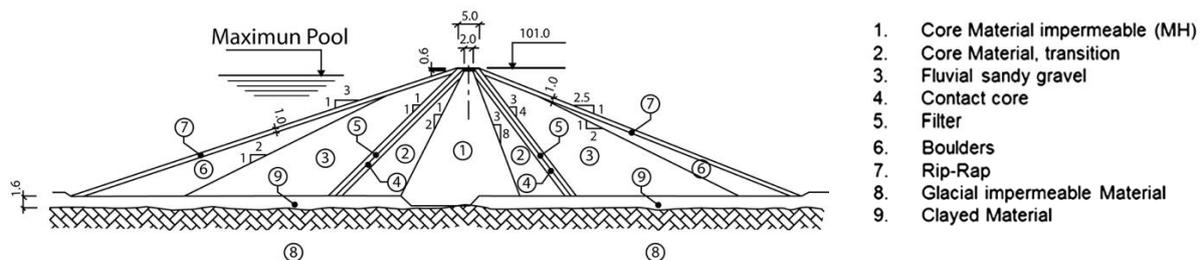
The Coihueco dam experienced significant seismic deformations during the Maule EQ of 2010 (M=8.8). The dam, which was built in 1971, is located approximately 28 km east of Chillán. It is a zoned earthfill dam that has a crest length of 1,040 m and a maximum height of 29 m (31m\*) as shown in Fig. 16. Following the EQ, a portion of the u/s slope experienced a failure that generated significant deformations and cracks as indicated in Fig. 17 and 18. Maximum vertical displacements of the u/s slope were observed towards the left abutment, reaching values close to 4 m. Uniform clean sand (SP) ejecta was present at the toe of the u/s earth slump.

**Fig. 16 - Coihueco dam design cross section, significant damage during Maule EQ 2010 [14]**

According to the analyses done after the EQ [14], the foundation consisted of layers of sandy gravels with low to medium non-plastic fines content, clayey silts of medium to high plasticity (MH) and silts of low to medium plasticity. A pseudo static slope stability analysis applied to non-circular surfaces was performed with both horizontal (Kh) and vertical (Kv) seismic coefficients, and  $Kv \leq 0.5Kh$ .

The results showed that failure ( $FoS \leq 1$ ) occurs for seismic coefficients:  $Kh \geq 0.22$  and  $Kv \geq 0.11$ . The authors concluded that “These values are consistent with the level of shaking experienced at this site and match well with values adopted in engineering practice for evaluating the impact of large EQs (i.e., MCE) on earthen structures”.

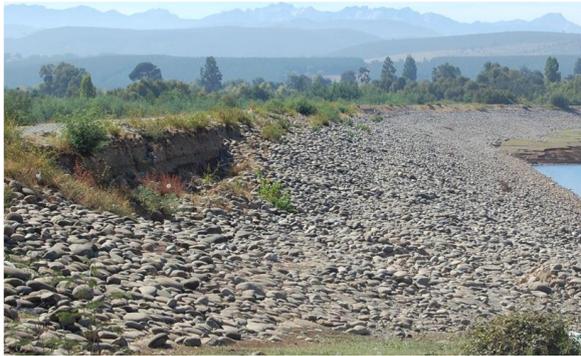
**Fig. 17 - U/S slope Coihueco. Maule EQ 2010.**

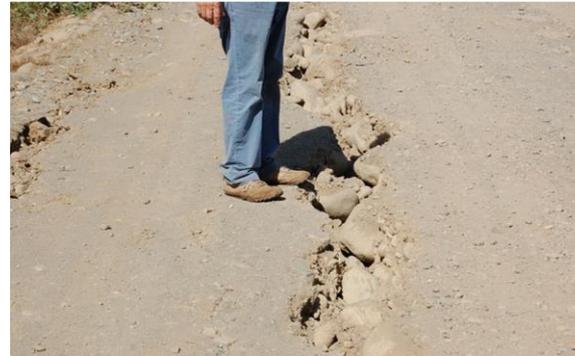
**Fig. 18 – Crest Coihueco dam.**

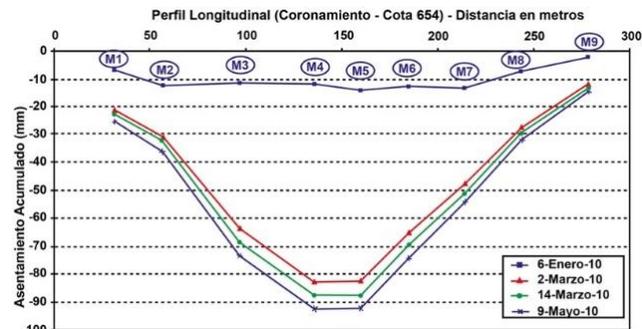
Visual inspection indicated a longitudinal crack along the crest, 10 to 20 mm width and 100 cm long. Also, a transversal crack near the left abutment and another one in the contact with the spillway. None of the cracks were too deep. No variation on Casagrande piezometers were detected as well as no changes in infiltration flows.

Surface monitors indicated a settlement of 7,1 cm at the centre of the dam diminishing to a 20% of that value near the abutments.

Fig. 23 – Melado dam crest settlements, Maule EQ 2010 [23]

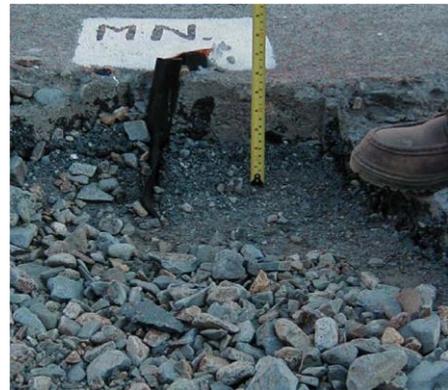
**Fig. 29- Settlement asphaltic core**

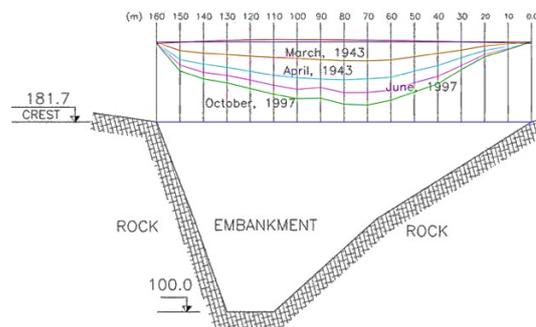
**Fig. 31 - History of settlements measured in Cogotí Dam [17]**

Several EQs have hit Cogotí dam, causing damages in the concrete face due to the settlements experienced by the poorly compacted rock fill. The registered settlements are shown in Fig. 31. It is interesting to mention that the maximum vertical settlement does not take place in the section associated with the maximum high of the rockfill. Indeed, the maximum vertical settlement occurs above the point where the bedrock presents a change in slope. The maximum settlement corresponds to control point M7. At the end of 2001, the total maximum settlement reached 138.7 cm, resulting in 1.7% of the high of the dam after 63 years of its construction [17].

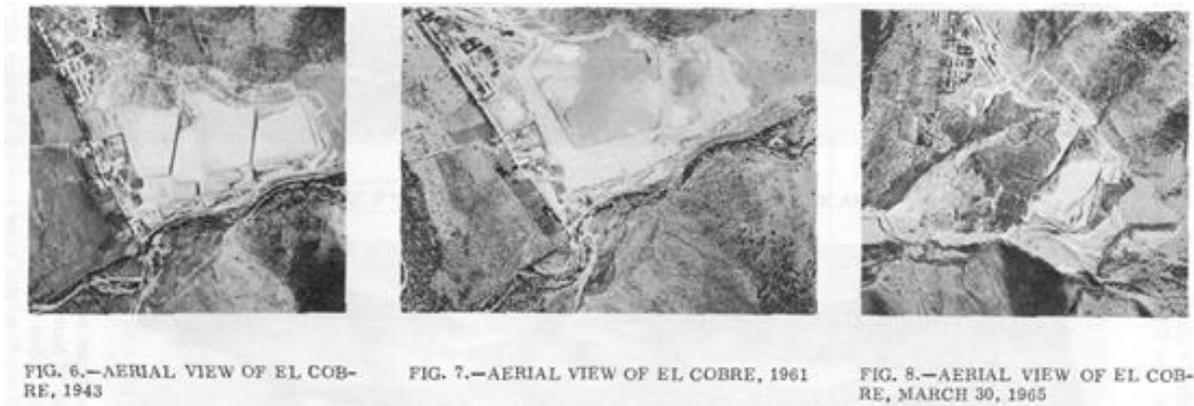
**Fig. 38 - El Cobre tailing dams, before and after March 28, 1965 [37]**

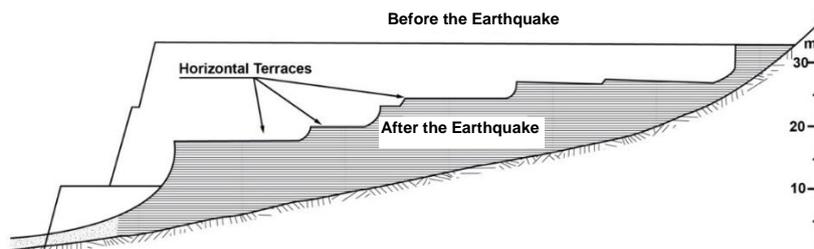
**Fig. 39 - Failure of El Cobre tailings dam (deformed scale) [37]**

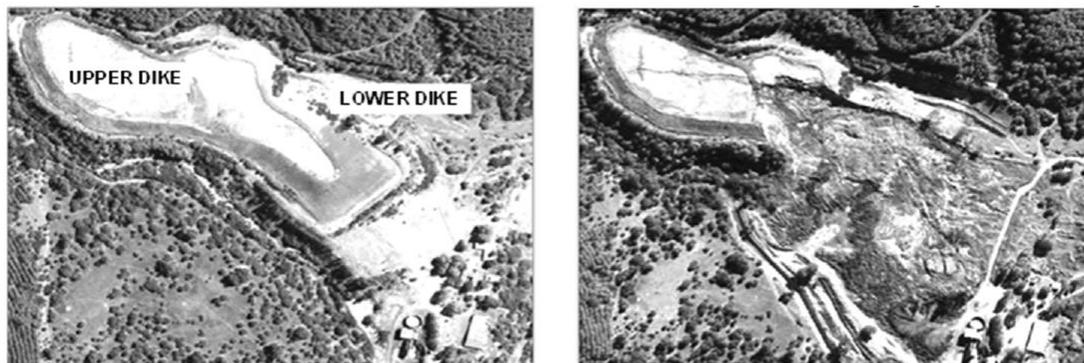
During the Maule EQ of 2010 ( $M=8.8$ ), the tailings deposit retained by the lower dam of Las Palmas liquefied, the eastern portion of the tailings impoundment nearest the mine facilities was breached, and a tailings volume in excess of 100,000 m<sup>3</sup> flowed a distance of about 0.5 km, killing 4 people in a house that was buried under four meters of tailings (Fig. 40).

**Fig. 40 - Failure of Las Palmas tailings dam during the Maule EQ of 2010. [14]**
