CONCRETE DAMS - CONTROL AND TREATMENT OF CRACKS

Review and case histories

Bulletin 107

1997

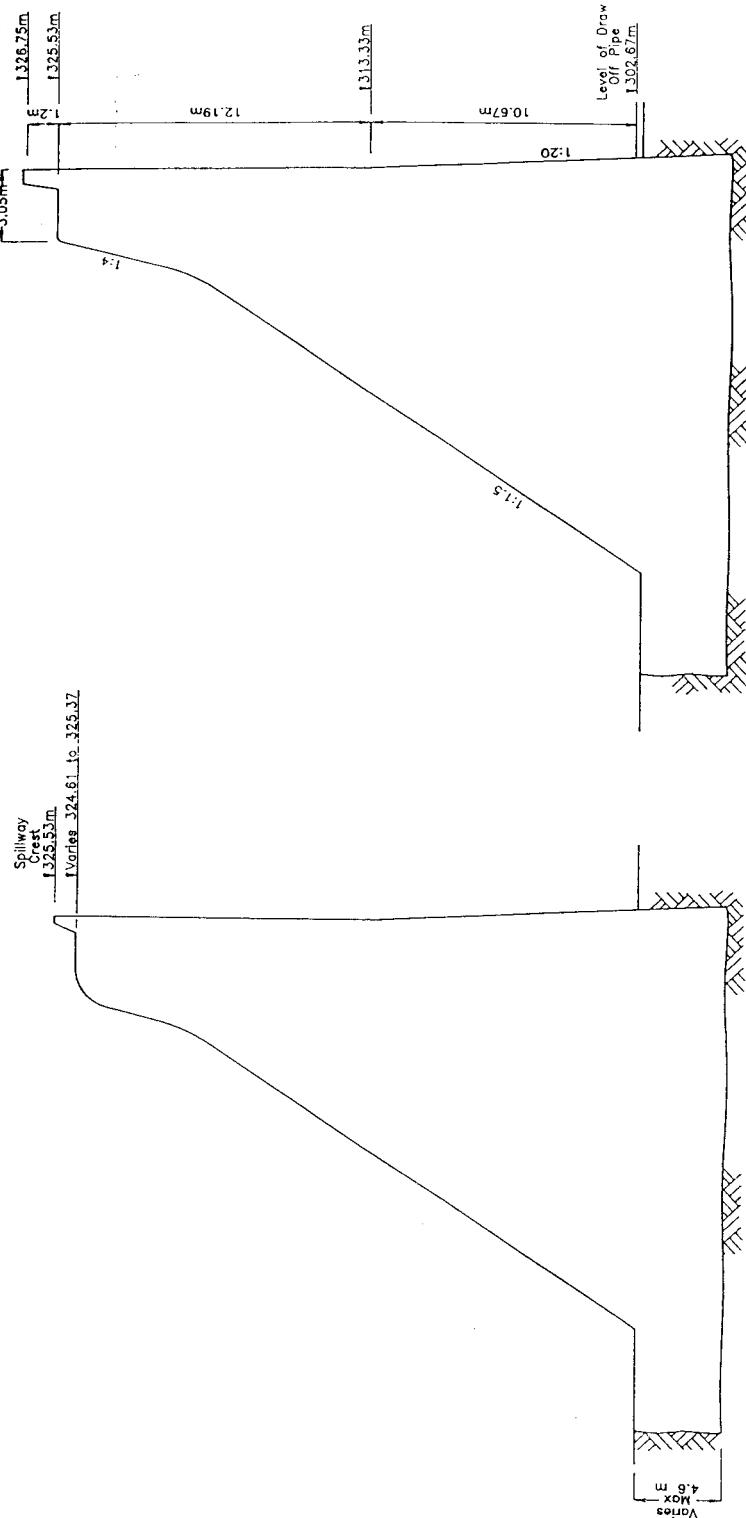
Fig. 33

Cross-sections of Blackwater Dam
Coupes transversales du barrage de Blackwater

Several vertical contraction cracks appeared at the time of construction and before the reservoir was first filled. Water leaked through these cracks for a short period although they eventually sealed. The early history of this cracking is given in Reference 5.4.2.

These cracks were widest at the top, but scarcely perceptible at the bottom, some of them not extending as far down as the base. The largest crack was 2.4 mm wide, but the average width was about 0.8 mm. There were seven main cracks, all to the north of the valve tower (see Fig. 34). This part of the dam was built rapidly during the summer of 1908, whereas the part south of the valve tower was built more slowly during the early months of 1909. In this southern part, some cracks appeared during the winter of 1909/10, but they were less pronounced.

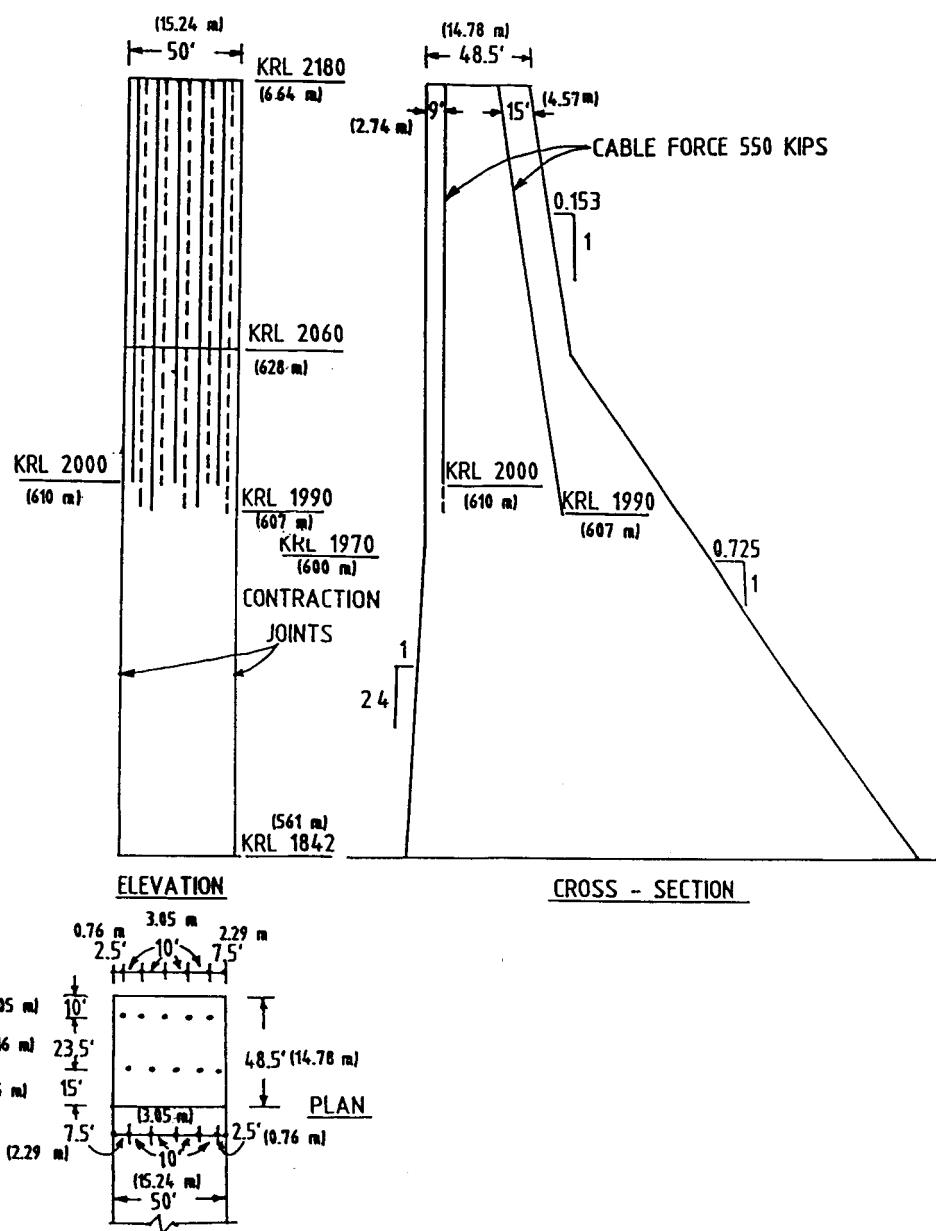
Fig. 35

1. It was not necessary to strengthen the overflow sections, which showed little distress.
2. In the non-overflow sections the greatest distress was at the level of the change of slope, where analysis showed high dynamic stresses and the shear friction factor of safety to be the minimum, the cracks would be sealed by epoxy resin grouting, and the top portion of the blocks prestressed with cables as shown in Fig. 35.

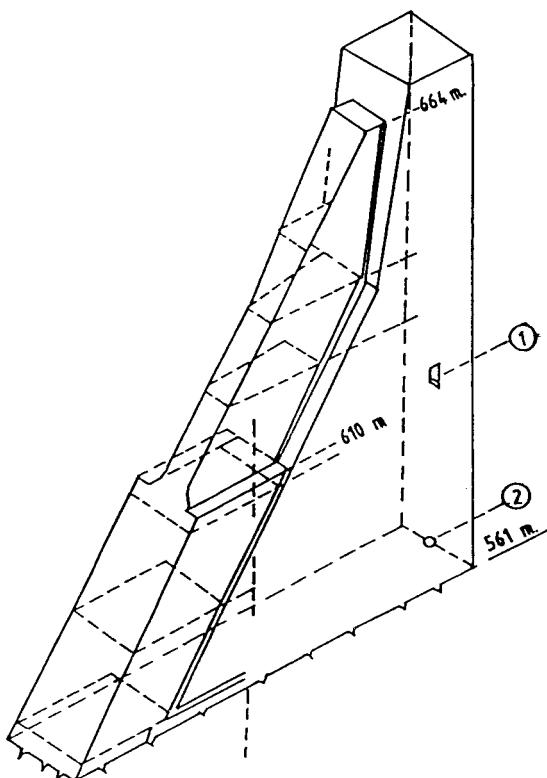
Fig. 36

The redesigned section of the dam is shown in Fig. 36.

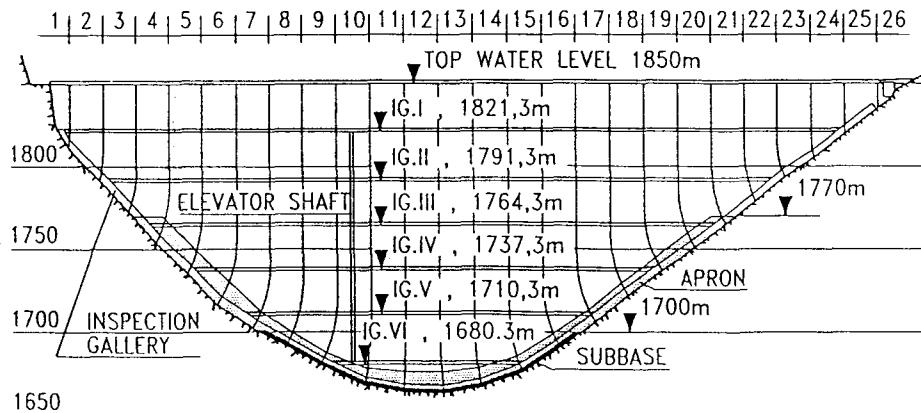
Fig. 41

In the mid-valley area there is another movement joint between the upstream face and the inspection gallery (see Fig. 41). This runs below the main membrane and its purpose is to prevent potential tensile stresses and cracks at the heel of the dam.

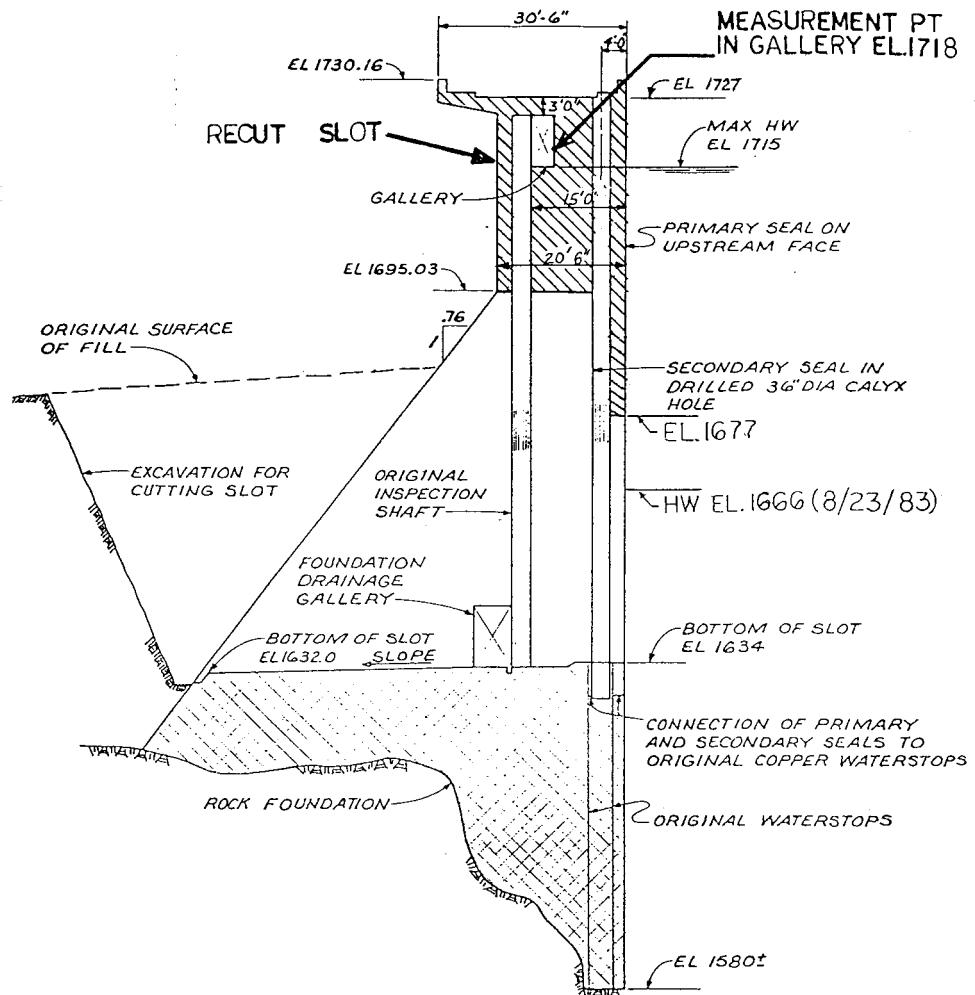
Fig. 46

By the summer of 1983, the upper-most portion of the slot had completely closed and was re-cut to a depth of approximately 15 m in late 1983 (see Fig. 46). Total permanent closure of the slot has been over 100 mm since the slot was initially cut in 1976, as shown in Fig. 47.
