# REHABILITATION OF DAMS AND APPURTENANT WORKS

*State of the art and case histories*

**Bulletin 119**

**2000**

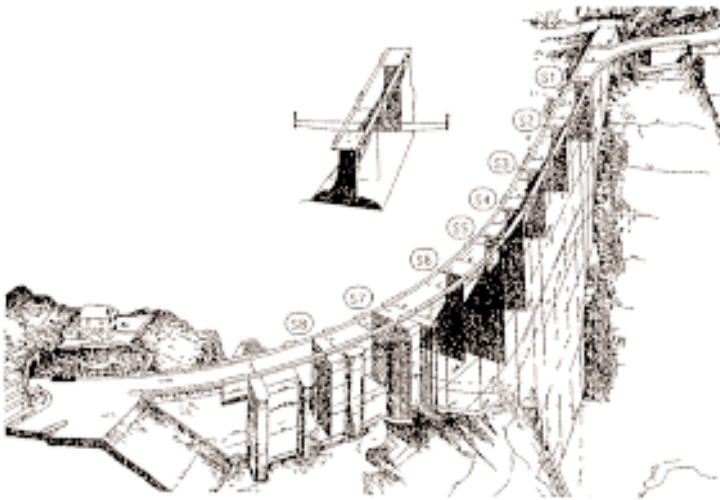
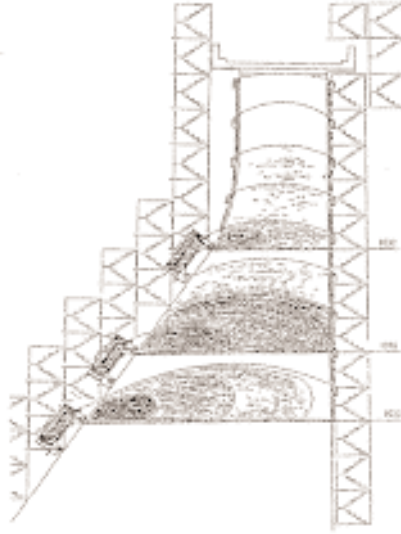
Fig. 3.3.1

In 1995 the influence of the saw cuts was detectable at about 60 m or 70 m on each side of the slot. There was a displacement of about 10 mm downstream and the slot, initially 11 mm wide, rapidly closed to about 8 mm and closed completely in a few weeks. During the campaign of 1996 the influence of the slot was detected at about 40 m or 50 m and the downstream displacement was 6 mm to 8 mm. In 1997 the influence of the slot was detected at about 30 m and downstream displacements were 2 mm or 3 mm. Several of the joints or slots are still open showing that decompression of the top of the dam has been achieved.

Chambon Dam. Slotcuts

Chambon Dam. Slotcut system

The works were effective in relieving the dam of the effects of the expansion caused by ASR. The owner anticipates that in 5 or 10 years it will be necessary to re-saw the structure. He considers that it will be possible to re-saw the original slots.

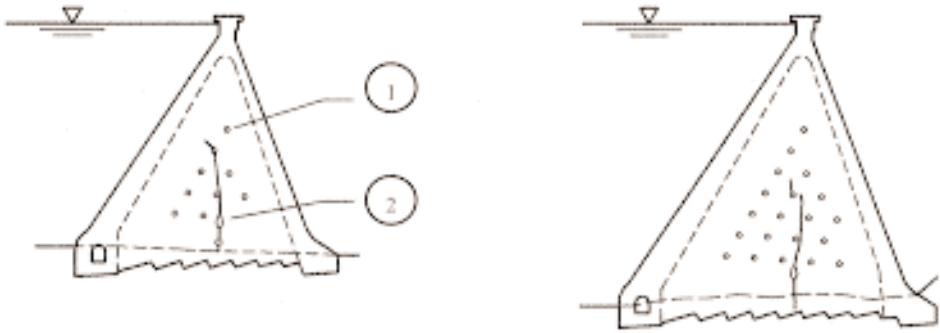
Fig. 3.3.4

**Olef Dam** is an example (Mehmel, 1964, Hoffmann, 1985, Baecker et al, 1985) where it was found necessary to strengthen the dam because of the combined influences of creep, shrinkage and thermal cycling. Olef Dam is a buttress dam in Germany, built in 1955 of un-reinforced concrete. During construction shrinkage cracks appeared in the buttresses. The dam and the cracks are shown on Fig. 3.3.3 and 3.3.4. Additional reinforced concrete support was provided on the inner side of each buttress. This is 400 mm thick at higher levels and 600 mm below (Fig. 3.3.5). A concrete thermal protection wall was installed at the downstream face of the dam between the buttresses in order to reduce the magnitude of the temperature variations associated with climate and season.

Olef Dam. Typical crack pattern in the buttresses

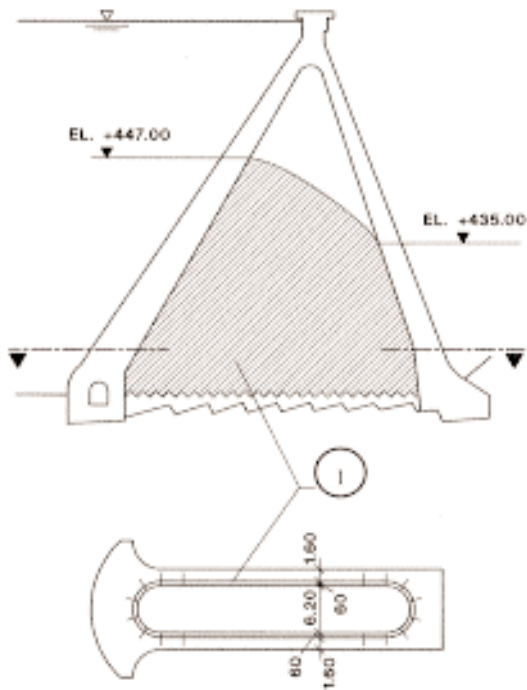
Fig. 3.3.5

Olef Dam. Strengthening of the buttresses

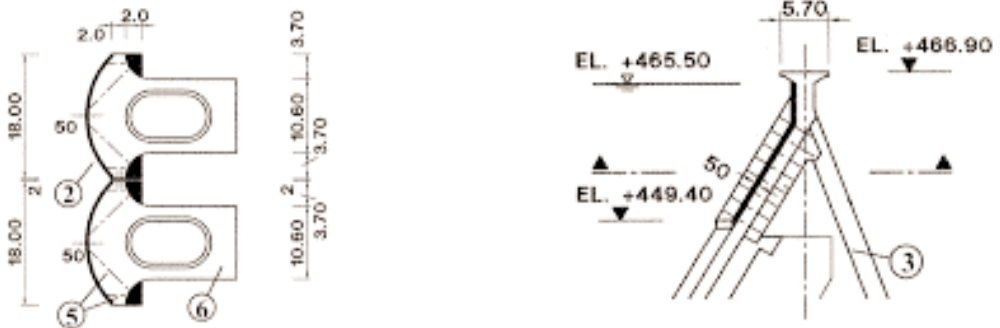
Fig. 3.3.7

subject to tensile stress, especially remote from the supporting pillar walls, the tensile strength of the concrete would be exceeded if the crack development were not stopped. Therefore as a first measure the reservoir level was lowered by 10 m.

Olef Dam. Rehabilitation of the upper part

A 500 mm thick reinforced concrete shell was placed over the upper 17.5 m of the upstream face. Prestressed anchors were used to compress the cantilevers to eliminate the tensile stresses. (Fig. 3.3.7). The cantilevers are supported from the downstream side by a reinforced concrete construction supported on the strengthened buttresses. (Fig. 3.3.8).

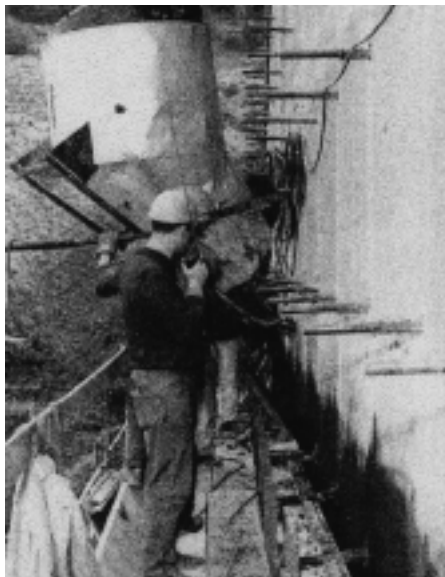
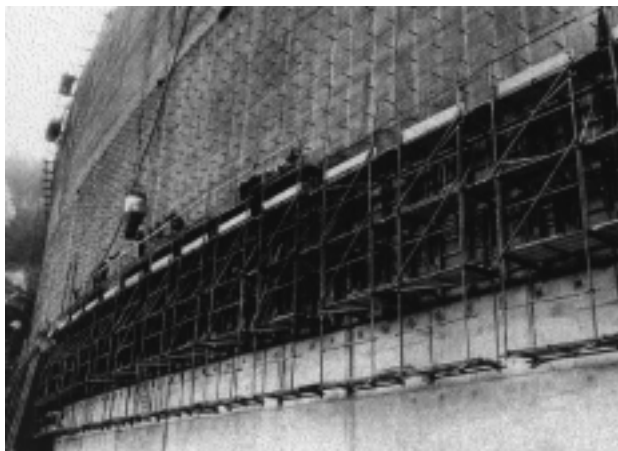
Fig. 3.3.10

**Agger Dam** in Germany is a concrete gravity dam, 45 m high, completed in 1928, and modified in 1967. The upstream face of the dam was attacked severely by the water for a period of 40 years and considerable water losses due to seepage and other phenomena finally required rehabilitation measures. This consisted of a complete renewal of the crest and sealing of the upstream face. The latter comprise

Agger Dam. Protection wall and anchors

Agger Dam. Casting the vertical asphaltic concrete seal

a 120 mm asphaltic concrete seal behind a 280 mm reinforced, nearly vertical concrete protection wall fixed by anchors to the dam body. (Feiner et al, 1967). Although this had been done 30 years ago the owner remains satisfied with this solution (Fig. 3.3.10 and 3.3.11).

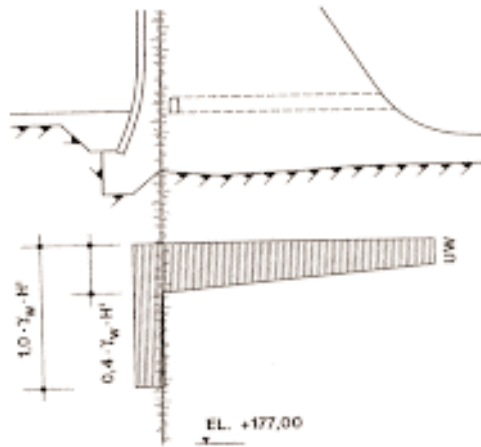
The uplift distribution shown in Fig. 3.4.2 was used for the stability calculation. It was found that the dam stability was not sufficient to meet the required standards. As an immediate step the reservoir water level was lowered by 1.5 m while feasibility studies were put in hand permanently to improve the stability of the dam. The six options considered are shown on Fig. 3.4.3.

Eder Dam. Uplift distribution

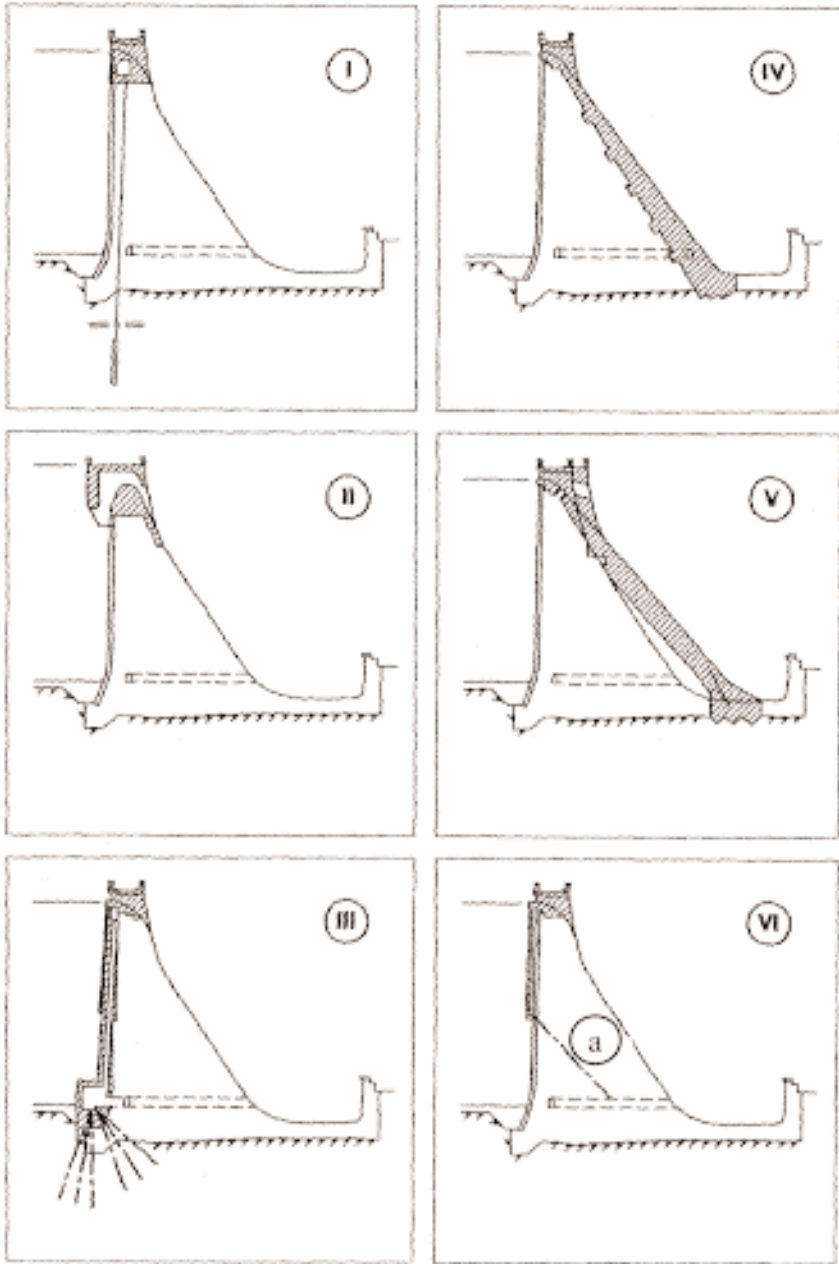
Fig. 3.4.3

The owner rejected alternative 2 because the German standards require the assumption of a water level at the crest level for an extraordinary loading case. He rejected alternatives 4 and 5 because of the complexity of the design problems and the high cost. Alternative 3 was rejected because it required the Eder lake to be emptied for several years.

Eder Dam. Six alternatives for rehabilitation

Alternatives 1 and 6 were evaluated and alternative 1 was chosen because of its smaller influence on the lake level, because of its smaller alteration of the outer profile of the existing dam and because of lower risks during construction. The configuration finally adopted is shown on Fig. 3.4.4.

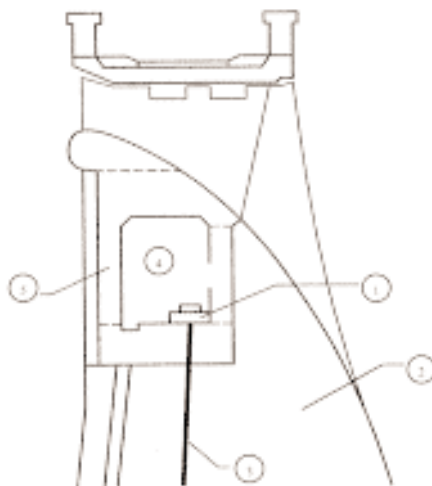
Fig. 3.4.4

Eder Dam. Final crest configuration

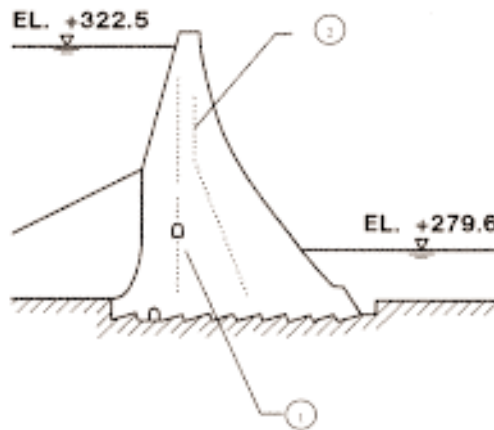
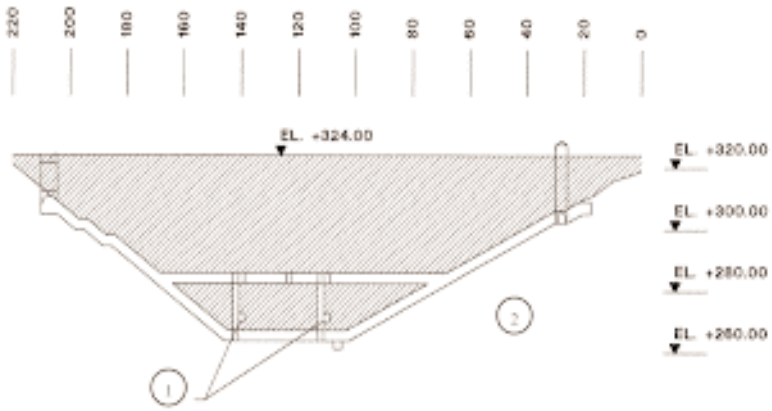
Water pressure tests showed that the permeability of the masonry was  $10^{-6}$  m/s to  $10^{-7}$  m/s with higher values in the foundation. The elastic modulus of the masonry was between  $3000 \text{ MN/m}^2$  and  $6000 \text{ MN/m}^2$ . The siltstone in the foundation was slightly weathered. The jointing was more developed in the siltstones than in the sandstones. The water pressure tests showed that permeability decreased with depth. Dilatometer tests showed Young's modulus of  $4000 \text{ MN/m}^2$  to  $8000 \text{ MN/m}^2$ .

Urft Dam. Cross section

Urft Dam. Longitudinal section

Preliminary three dimensional finite element analyses confirmed adequate stability (Wittke et al, 1995). But further work was needed for the dam to meet current German standards. For this, two control galleries were excavated as shown on Fig. 3.4.5 and 3.4.6. The first at the contact between dam and foundation rock. The second one at about one third of the height of the dam on the line of the vertical drainage holes. By this means it became possible to monitor these devices and if necessary to rehabilitate them. Instruments were installed in the dam as shown on Fig. 3.4.7 to 3.4.9 to measure displacements, piezometric heads and temperatures. Displacements are monitored by extensometers, by inclinometers and by plumb lines and inverse pendulums. The alignment and level of the crest were measured. In both galleries large flat jack tests were done to evaluate more precisely the Young's modulus. The finite element analyses were refined with the measured data.

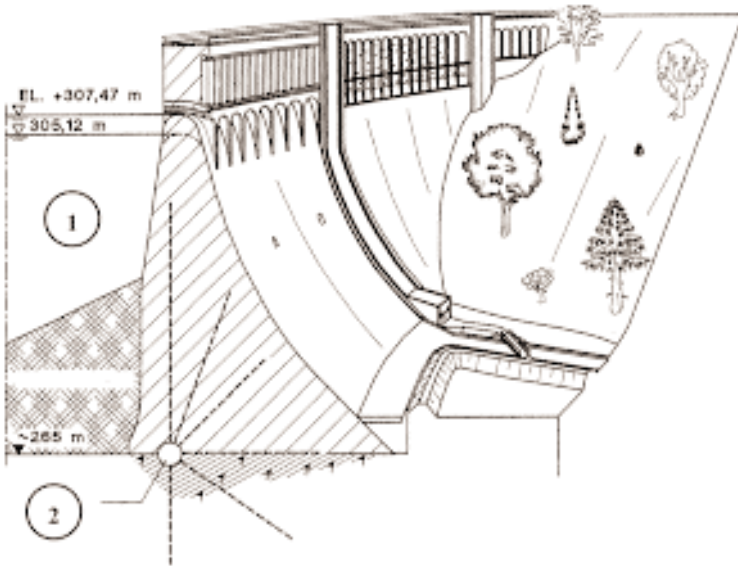
Fig. 3.4.11

Uplift pressure was not considered in the original design in 1902 and the dam therefore did not meet German Standards. As a preliminary measure the storage level was lowered by 2.3 m and the spillway crests lowered. The state authorities required intensive investigations and rehabilitation. Work was delayed by shortage of money. In 1995/96 a concept was developed to meet the financial and technical requirements and to guarantee for the future, an impoundment up to the original storage level. A drainage gallery was to be excavated at the base of the dam only 3.5 m from the upstream face. Fans of drainage holes are to be drilled from the new gallery, three in the dam and three in the abutment rock (Fig. 3.4.11). The spacing of the fans is to be decided after intensive investigation of the pore pressure distribution when the drainage gallery has been excavated. The gallery shall remain unlined as far as possible in order to improve the drainage of the surrounding rock and masonry.

Ennepe Dam. Drainage gallery and drainage holes

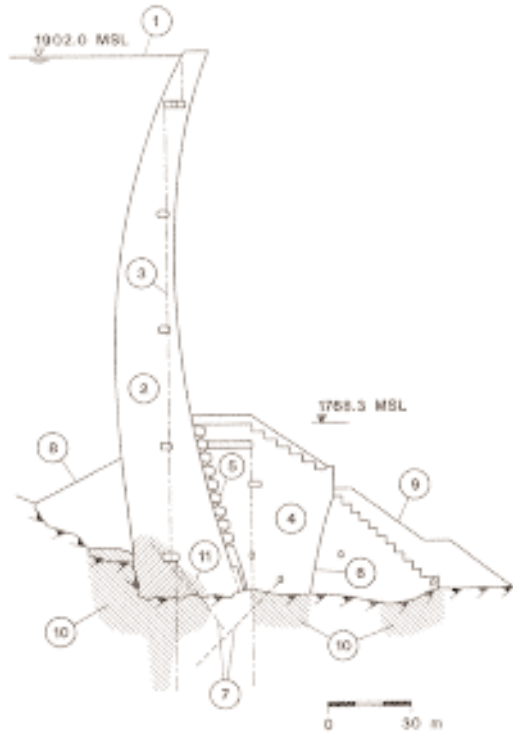
Fig. 3.4.14

On first filling in 1978, when the reservoir level reached 1890 m, 42 m below the normal full storage level, the seepage into the drains just above the base of the dam increased suddenly. As the reservoir level increased to 1891 m, the seepage increased to 200 l/s. The uplift below the upstream foot of the dam was 100 % of the hydrostatic pressure in the reservoir. The cause was considered to be a new set of inclined cracks in the foundation rock running from about elevation 1750 m downstream at a slope less than  $45^\circ$  between the control gallery and base of the dam. The cracks were assumed to be a consequence of high shear stresses in the base of the slender dam. Ad hoc measures were carried out to reduce the high pressure and the seepage :

Kölnbrein Dam. Cross section after rehabilitation

- grouting with epoxy resin
- a freezing zone had been installed as a temporary measure in the cracked zone at the base of the dam

The rehabilitation work began in 1989 and was finished successfully in 1994. The adopted solution was to install a 70 m high supporting block of concrete downstream of the dam. Its function is to support the lower third of the dam, but only when the water in the reservoir exceeds a certain level. It was therefore necessary to bring the two elements together only after a certain water load had been applied. The problem was solved by installing 613 flat, 1.2 m square, reinforced neoprene cushions at nine levels at concrete consoles as shown on Fig. 3.4.15. Each cushion is connected to a double steel wedge construction, shown on Fig. 3.4.16, that can be calibrated in height from adits below and above their horizon. In this way it was and remains possible to alter the support provided by each of the wedges. Numerical calculations determine the support to be provided as a function of the reservoir water level. The advantage can also be seen from the arch dam's deformations and seepage. In Fig. 3.4.16 these parameters are shown for the situation before and after rehabilitation (after Heigerth et al, 1994, oral presentation).

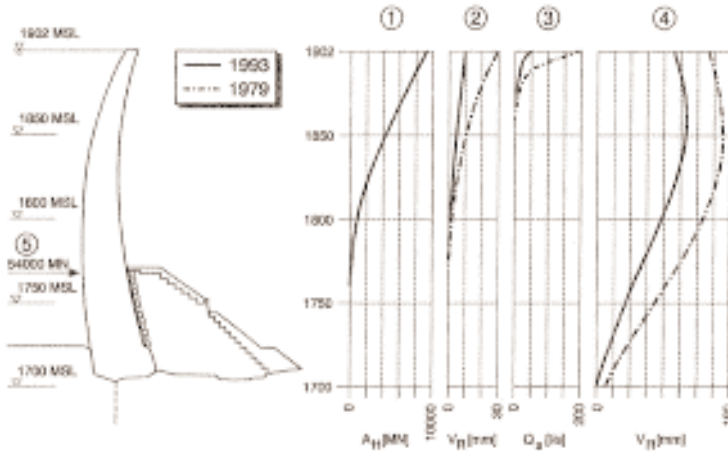
Fig. 3.4.16

Kölnbrein Dam. Deformation and seepage before and after rehabilitation

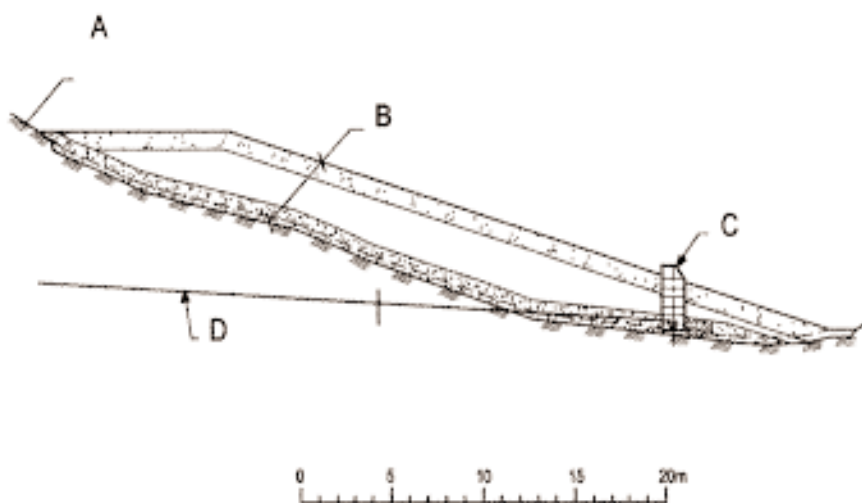
Fig. 4.3.1

Standpipe readings after the rehabilitation indicate a considerable lowering of groundwater level in the area and it has since been necessary to install new standpipes because several of the pipes became dry. It can be concluded that the rehabilitation has given even better result than anticipated but it is important to follow up the effect by means of continuous measurements and evaluation (Nilsson et al, 1996).

Långbjörn Dam. Cross section, horizontal drains and stabilising berm

To lower the ground water level permanently, the decision was made to install almost horizontal drains into the abutment from the toe of the slope in the old riverbed. The rehabilitation was carried out in 1995 and 20 drains with a diameter of 100 mm and a length of 25 m were drilled. To further increase the stability of the slope of the abutment a stabilising berm of permeable material was laid out along the toe. The rehabilitation measures are summarised in Fig. 4.3.1.

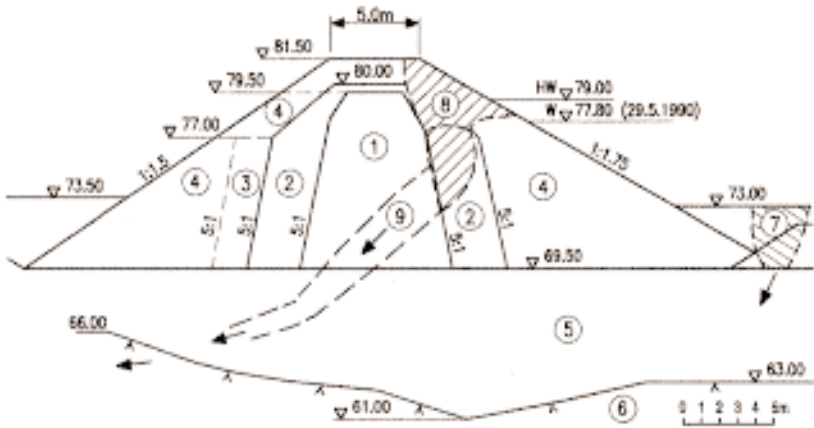
Fig. 4.3.2

Geological investigation showed that massive erosion of the foundation and the dam body had occurred at the junction of two water bearing fractured zones in the bed rock. The seismic velocity in the junction area is 3 km/s to 4 km/s and the rock was found by diamond drill coring to be heavily fractured with much core loss. The soil is an extremely erodible silty glacial till. The first muddy seepage was probably material moving from the embankment along a path near the original soil surface. The first exploratory boreholes used air flushing equipment and are thought to have disturbed the foundation when it intersected one of the internal erosion channels. The erosion progressed rapidly upstream causing a sudden and extensive sinkhole. The cross section showing the hypothetical failure mechanism is shown on Fig. 4.3.2. The erosion damage was limited to a 60 m length of the dam, and this was replaced in the dry behind a coffer dam. As the damaged portion of the dam was removed the existence of the erosion channel was confirmed as a tube about 3 m in diameter, sloping down through the core and into the foundation, as shown on Fig. 4.3.2. During the collapse of the dam this tube had filled with some 50 m<sup>3</sup> to 100 m<sup>3</sup> of gravel from the upstream filter. As the rehabilitation work proceeded the gravel was removed carefully as far as possible and the area was sealed by grouting.

Uljua Dam. Cross section of damaged dam

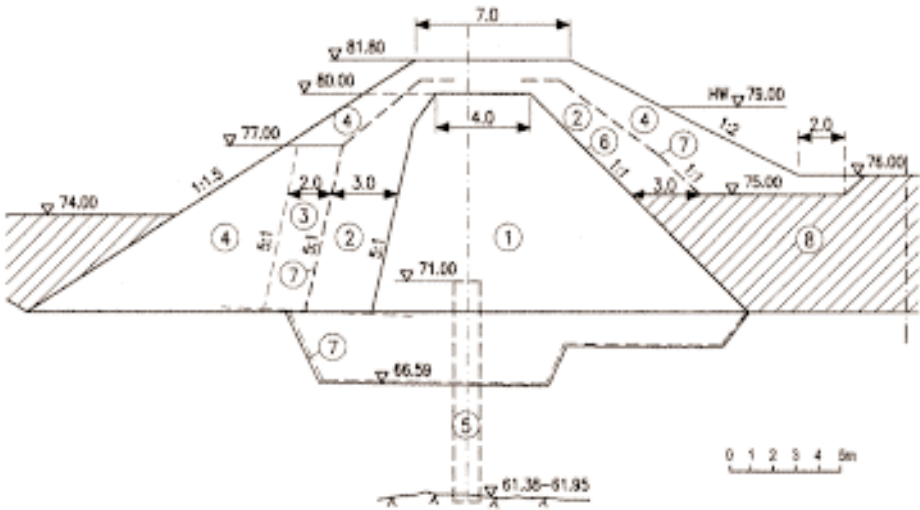
Fig. 4.3.3

Uljua Dam. Reconstructed cross section

The seepage was cut-off by grouting the erosion channel, by constructing a diaphragm wall and by increasing the length of the seepage path. The length of the grouted zone is 585 m and 358 grout holes were grouted using a total of 950 tonnes of cement, more than 5 tonnes of polyurethane, and about 8 tonnes of resin grout. The grout holes were drilled 10 m into rock generally and 15 m in the problem area. Three curtains were drilled. The first two from the crest and the third from ground level after the damaged portion of the dam had been removed. The average spacing of the holes drilled from the crest was 800 mm and in the third curtain 1400 mm. The

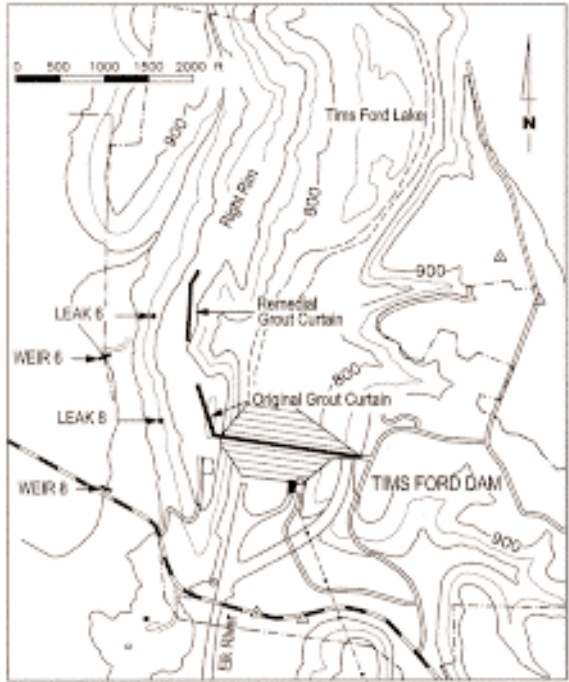
Fig. 4.3.6

The right rim comprises a sequence of limestone formations covered by a red cherty clay resulting from the in-situ weathering of the rock. The limestone beds contain many solution cavities along their bedding planes and vertical joints. The lowest formation is of shale lenses and clay seams. During design, TVA decided to delay treatment of the reservoir rims pending evidence of seepage, see Fig. 4.3.6. Leakage was collected and monitored and found to be responsive to fluctuations in reservoir level. Following the first filling, the TVA planned an orderly programme of work to reduce the flow from all observed leaks.

Grouting was conducted successfully on the left abutment using cement with calcium chloride accelerator and asphalt. Flow from other leaks was also reduced. Leakage increased steadily over the years from Leak 6, which had not been grouted due to the long seepage path, reaching 250 l/s at maximum pool level in 1995. Later that year the rate of flow almost doubled, followed by a large slide on the hillside around the leak. It was reasoned that the annual reservoir fluctuations had resulted in cycles of wetting and drying of the clays and other degenerated material in the features of the limestones. This had made them more susceptible to erosion under the hydraulic gradient at high reservoir levels, thus creating flow paths with larger apertures, and rapidly increasing the overall rock mass transmissivity.

In an exploratory drilling and permeability testing programme at Leak 6, seventeen exploratory holes were percussion drilled, permeability tested in stages, and dye tested to establish flow paths and estimate velocities. Three standpipe piezometers were installed to help gauge the effectiveness of the later grouting. Several dye test connection times of only minutes were encountered to the leak.

Tims Ford Reservoir Rim. Plan of dam and reservoir

A multirow remedial grout curtain was designed. The primary holes of this curtain are shown on Fig. 4.3.7. The holes were inclined at 30 degrees to the vertical to encourage intersection of sub-vertical features and were oriented in opposite directions in the two outside rows. Primary holes in each row were foreseen at 12 m centres, with split spacing to reduce interhole spacings to 3 m. The central, tightening, row was vertical. The grouting was to be executed to seal a 15 m vertical zone and locally deeper if dictated by the stage permeability tests conducted prior to the grouting of each stage.

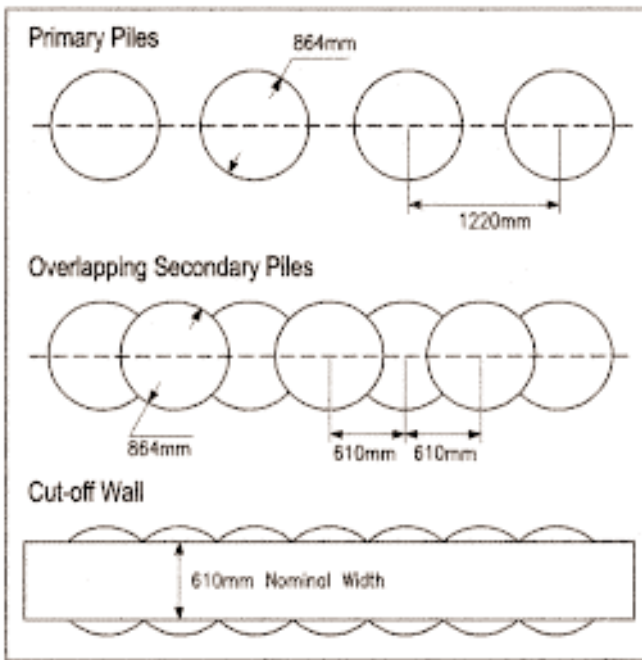
Fig. 4.3.8

**Beaver Dike 1**, USA, is one of the auxiliary embankments closing the **Beaver Dam** reservoir (Bruce & Stefani, 1996). During design a graben beneath the dike was identified as a potential source of difficulty. The graben consists of the permeable and highly weathered Mississippian karstic limestone with clay filling known as the Boone Formation. The original design approach to sealing the foundation comprised a grout curtain. Seepage was observed as soon as the reservoir was filled. Ten years later remedial grouting to a greater depth was carried

Beaver Dike 1. Scheme for construction of the wall

out with difficulty against flowing water. Degradation continued with increased seepage. A positive concrete cut-off was proposed using a slurry trench with rock milling technology. Beds of strong relatively fresh rock prevented use of the rock mill and large diameter secant concrete piles were adopted.

The wall was constructed from a work platform built into the upstream face of the dike. The wall is 464 m long and from 24 m to 56 m deep to accommodate the geological conditions. The total wall area is 19 300 m<sup>2</sup>. The scheme for construction is shown on the Fig. 4.3.8. In Stage 1 a series of primary piles was drilled and grouted with a tremie. In Stage 2 the intermediate secondary piles were drilled and concreted to complete the cut-off. Careful drilling was required to ensure continuity of the wall and special monitoring was used to control the vertical alignment of the holes by ensuring that the piles did not deviate more than 64 mm at a depth of 56.4 m.

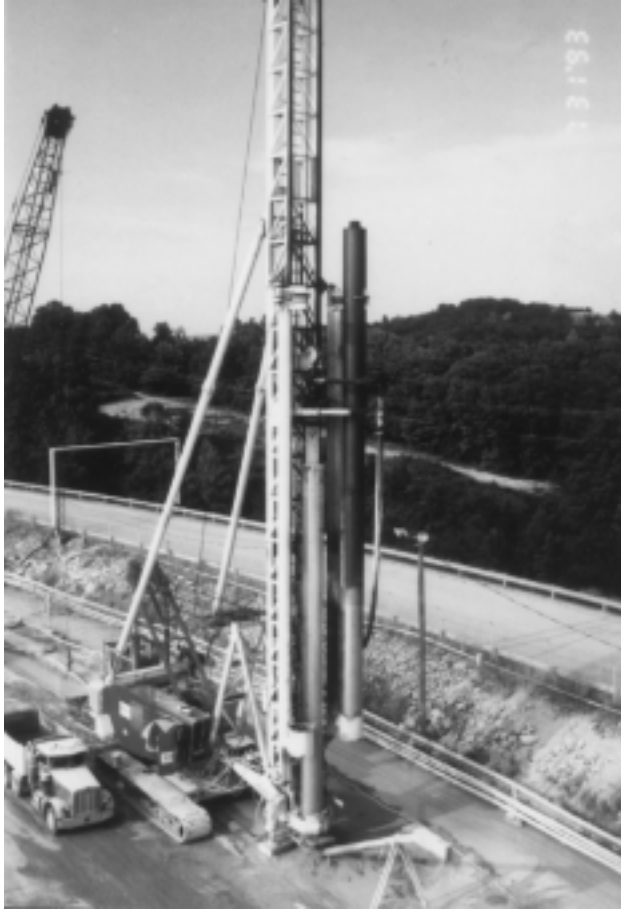
Fig. 4.3.9

Beaver Dike 1. Drill rigs on crawler cranes

Two drill rigs with 30 m masts mounted on crawler cranes were used to drill the holes as shown on Fig. 4.3.9. The 9 m drill rods had an external diameter of 813 mm and an inner air passage of 302 mm. Each rig could drill 21 m in a single pass using down-the-hole hammers with 864 mm diameter bits. The rotational speed varied between 2 rpm and 10 rpm and depended on ground conditions. The 10 bar compressed air supply to each hammer was from a bank of nine, static electric-powered compressors arranged in two groups of four with one spare. The penetration rates varied from 4.3 m/hr for primary holes to 5.4 m/hr for the secondaries. Some pre-treatment of the ground was done by pressure grouting. Elsewhere in unstable weathered rock the holes were stabilised by grouting or down staging. The seepage through the foundation decreased to 0.3 l/s from over 80 l/s before the rehabilitation works.

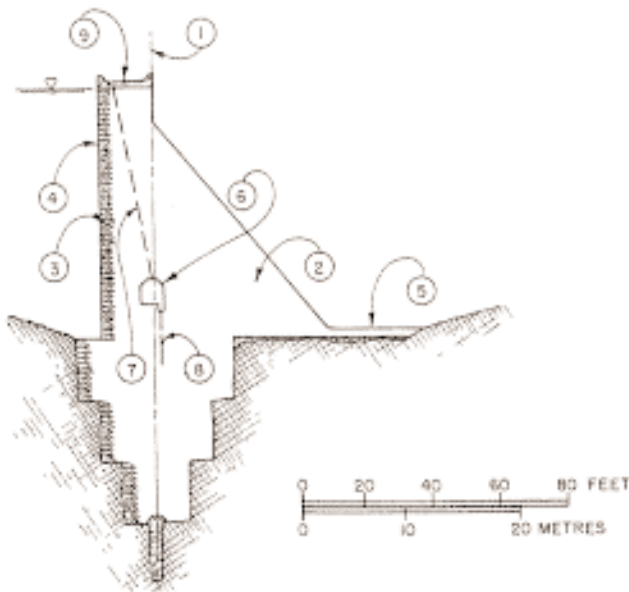
Fig. 4.3.10

Quail Creek Dike. RCC dam section

The failed **Quail Creek Dike** (Catanach et al, 1991), an embankment dam on a foundation of thin-bedded limestone, dolomite and gypsum, was replaced with an RCC foundation cut-off wall and dam as shown on Fig. 4.3.10. The depth of cut-off was based primarily on engineering judgement and the construction on availability of construction equipment and lowest cost (see Fig. 4.3.11). Important in the choice of dam type was that an embankment dam would require filters that would be expensive and was less certain than an RCC dam. In addition, a grouting gallery would be needed in either dam type and the RCC dam construction would constitute a continuation of the cut-off.

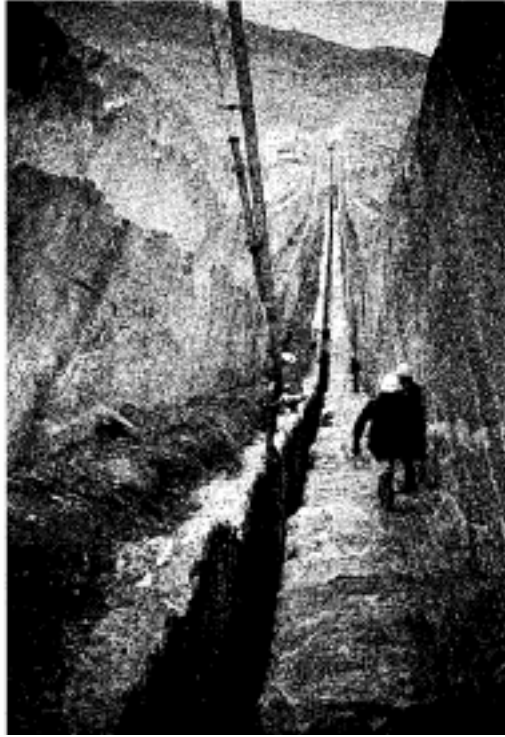
Fig. 4.3.11

Quail Creek Dike. Foundation excavation

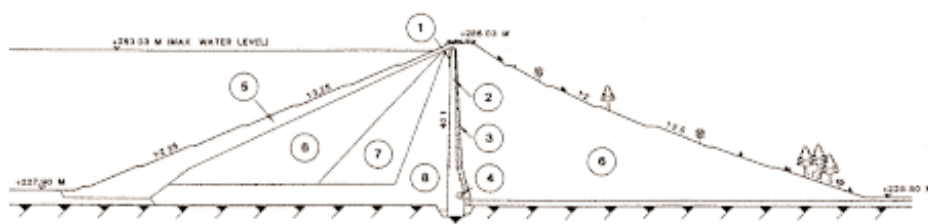
Fig. 4.4.3

**Sorpe Dam**, an earthfill embankment with a vertical concrete core wall was built between 1926 and 1935. At 69 m high it was the highest embankment dam in Germany. The relatively thin core extends from the rock foundation to the crest of the dam. Upstream of the core wall the embankment is made of several zones with material ranging from silty clay close to the wall to coarse stones at the upstream face of the dam. The downstream shoulder consists of pervious rockfill and coarse alluvium. The dam has a double drainage system. Vertical porous concrete pipes are located at a regular spacing in the concrete core wall, while a 1.5 m to 2.5 m thick drain layer just downstream of the concrete wall provides a second line of drainage. In 1951 a substantial increase in leakage was noticed in the inspection gallery at the base of the core wall. The seepage water was muddy and it was feared that the silty clay was eroding, perhaps initiated by cracks in the concrete wall. The water level in the reservoir was lowered and cement grout was injected upstream of the core wall. These measures were not sufficient to bring erosion to an end. The upstream face of the dam had settled locally up to 1.4 m.

Sorpe Dam. Cross section

The selected solution was to seal the core by installing a jet grouted cut-off upstream of the concrete wall and extending some 10 m below the dam crest as shown on Fig. 4.4.3. The procedure was to cut cylindrical columns in the silty clay using a 400 bar water jet and by injecting in a second phase a cement suspension consisting of one part of water to one part of cement and inert fines (rock flour). The columns were initially installed at 240 mm spacing. This was reduced by a second series of columns and the final spacing was 600 mm.

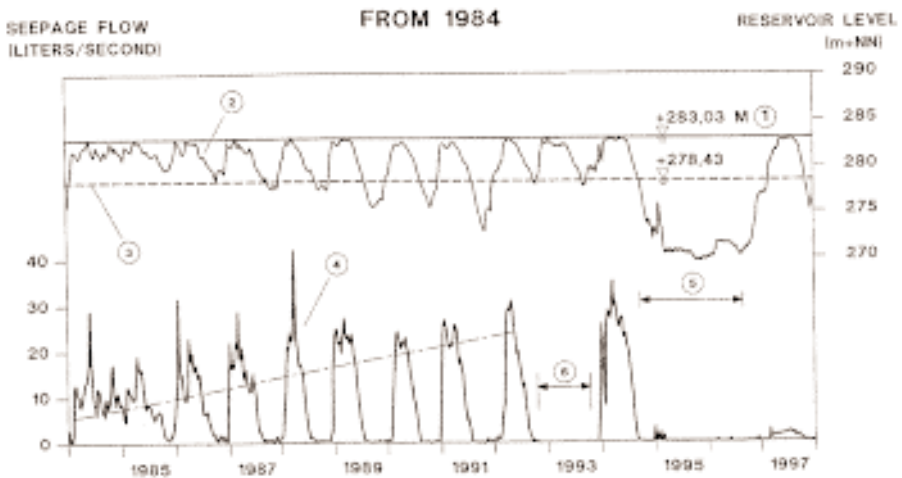
Sorpe Dam. Seepage in the inspection gallery

The rehabilitation work was carried out in 1996-97. The continuous jet grouting wall is 600 m long with a developed area of 6000 m<sup>2</sup>. Inclined checkholes indicated that the jetted columns intersected each other and that they were closely bound to the concrete wall. As shown in Fig. 4.4.4 seepage at high water levels in the reservoir has been almost completely eliminated and the treatment can be considered as successful (Heitefuss et al, 1998).

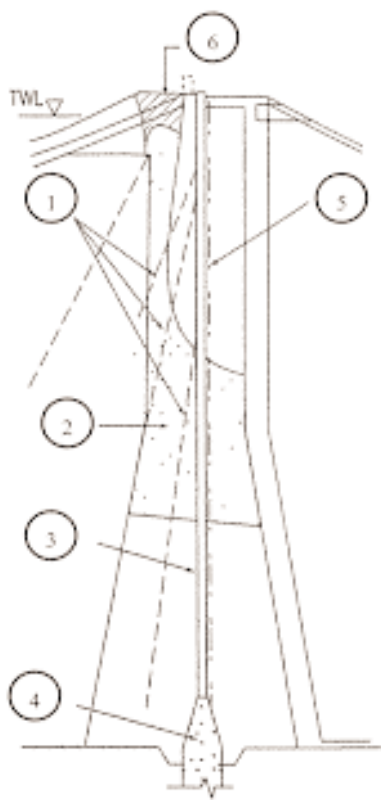
Fig. 4.4.5

Balderhead Dam. Internal erosion and treatment by plastic concrete diaphragm wall

The permeability of the concrete was in the range  $1 \times 10^{-8}$  m/s to  $5 \times 10^{-10}$  m/s. As well as serving as an additional water barrier, the diaphragm wall was intended to prevent migration of eroded material through the core. The trench was constructed within a tolerance of 0.25 % of vertical. The overall area of the diaphragm wall was 8240 m<sup>2</sup>.

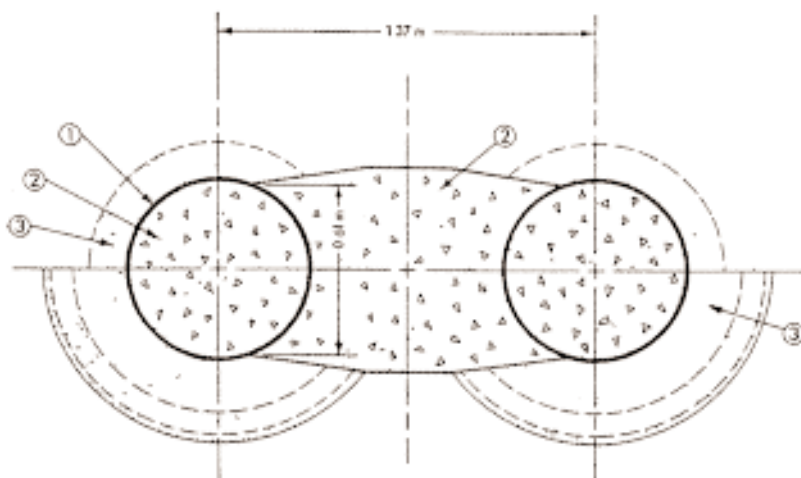
Fig. 4.4.8

Wolf Creek Dam. Plan of primary and secondary wall elements

A separate wall 180 m in length and extending to a maximum depth of 30 m was installed around the switchyard located at the downstream toe of the embankment section to provide protection against tailwater fluctuations. The basic scheme was to construct 660 mm diameter steel cased primary elements at 1.37 m centers and to connect them with bi-concave shaped secondary concrete elements constructed so as to provide a continuous wall with a minimum width of 610 mm. The scheme is shown in Fig. 4.4.8.

Work on primary elements started with excavating a 1.30 m diameter hole to a depth of about 21 m with a clamshell bucket. This work was performed in the dry above the saturation line in the embankment. The hole was then filled with a thin bentonite slurry and 1.20 m diameter temporary steel casing set in the hole. Excavation continued inside the casing as it was sunk to a depth of about 43 m. At

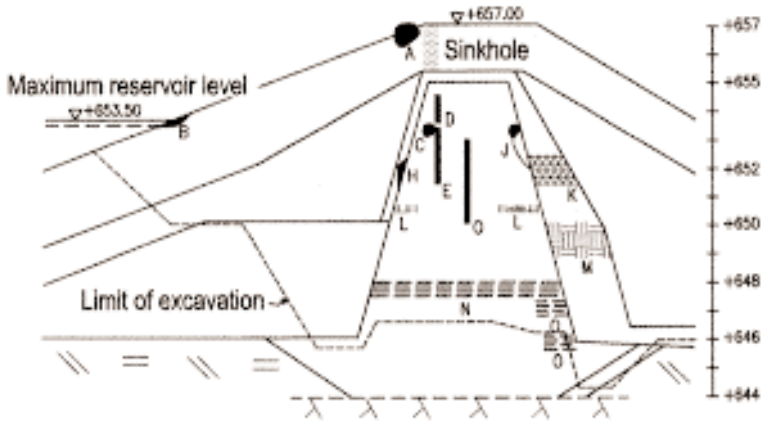
Fig. 4.4.9

A relevant example is **Grundsjön**, which consists of three earthfill dams, of which the highest is 44 m. The structure was completed in 1972 and is located on the Ljusnan River in Sweden. The damage occurred in a 13 m high section. The core of moraine is central, vertical and is surrounded by filter and earthfill. The core is founded on rock and the shoulders on moraine. In 1990 a sinkhole, 400 mm by 500 mm and 1.6 m deep formed in the upstream part of the crest above the zone of the upstream filter. Exploratory drilling through the dam and measurements showed that the core was damaged and it was decided to reconstruct part of the dam (Eurenius et al, 1991). The damaged core is shown on Fig. 4.4.9.

Grundsjön Dam. Cross section of damaged core

Grouting of the core was considered, but, since it was possible to take advantage of a period of low reservoir level, economics favoured reconstruction. The core was excavated out and replaced over a length of 5 m on each side of the sinkhole. During the reconstruction an erosion path of 0.5 m<sup>2</sup> through the core was discovered. No fines were found in the erosion path, suggesting that the sinkhole was a consequence of internal erosion. The erosion probably started in the downstream face of the core, progressed upstream towards the upstream filter and finally reached the crest of the dam. A drainage system has now been installed downstream of the dam. The instrumentation and monitoring programs have been extended.

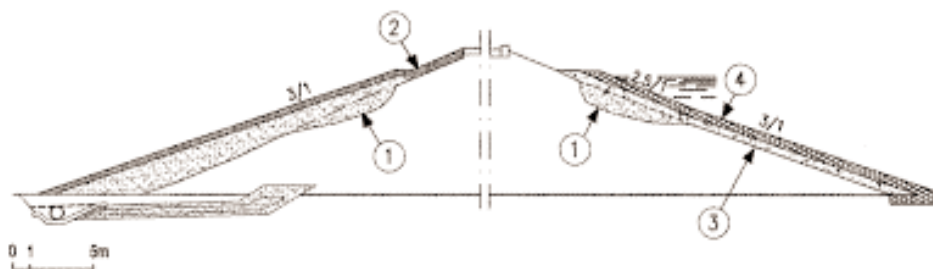
Fig. 4.4.10

Giffaumont Dam. Cross section of the rehabilitated embankment

Corrective measures are shown on Fig. 4.4.10. They consist of :

- installing a minimum thickness of 2 m of stabilising fill on the downstream slope. This was a granular non-cohesive and free draining material and was placed at a constant slope of 1V :3H.
- placing a 1 m thick rockfill layer directly on the upstream slope .

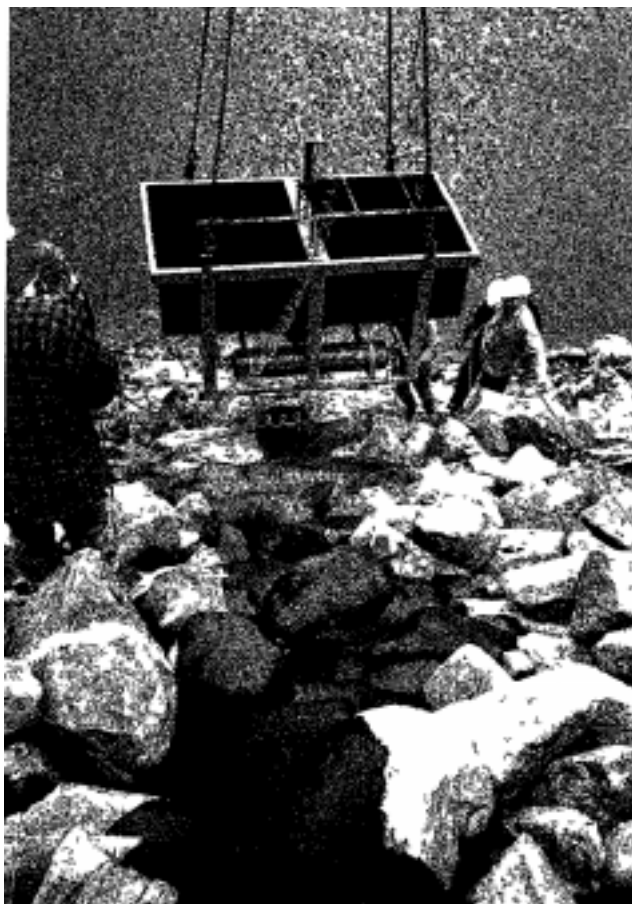
Fig. 4.4.13

Megget Dam. Placing bituminous grout

The vertical strips were grouted in three passes, and the horizontal ones in two. Penetration of the full 1.2 m rip-rap thickness was always achieved. The average grout application rates were 680 kg/m<sup>2</sup> for the vertical strips, 340 kg/m<sup>2</sup> for the horizontal strips and 50 kg/m<sup>2</sup> for the spot grouting. Grout performance tests were performed in addition to standard material production tests. They included small inclined plate tests, large box stability tests, adherence test and in-situ grout penetration, void filling and spread tests.

A major band of thick silt deposits was exposed on the upstream face as the reservoir was drawdown. This would prevent satisfactory grout penetration and had to be removed before grouting could proceed. This was achieved by jetwashing using a steel manifold with six 25 mm nozzles positioned over the dam face by crane, and fed by a submersible pump sited within the reservoir.

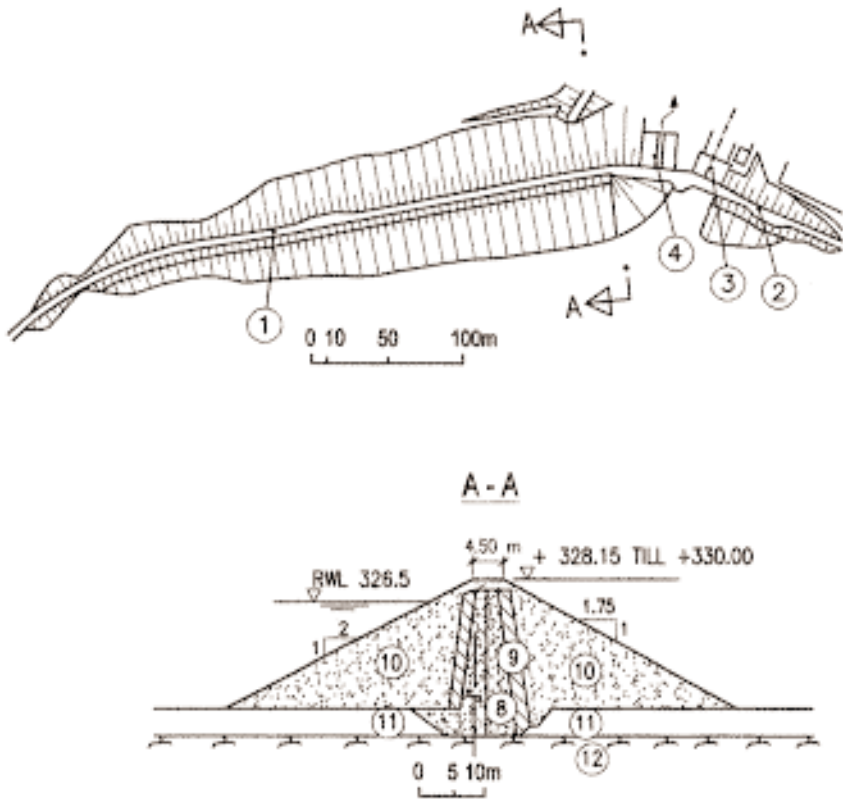
Fig. 4.4.14

In 1998 a safety evaluation of the **Stenkullafors Dam** was carried out, which found no sign of further internal erosion. Furthermore, the seepage through the dam was stable. Today, there are no plans for additional rehabilitation of the weaknesses in the core discussed above. However, this may be reconsidered if the seepage measured in the weirs downstream of the dam increases or fails to remain stable. (Nilsson et al, 1991).

Stenkullafors Dam

It was concluded that leakage could possibly occur in the future and that further erosion of core material could follow. In order to give a satisfactory factor of safety against slides in the downstream slope, and to increase the erosion resistance in case of excessive leakage, a stabilising rockfill berm was placed along the downstream toe in 1990. Additionally, measuring weirs of the Thompson type giving continuous readings, were constructed downstream of the left and right side of the dam.

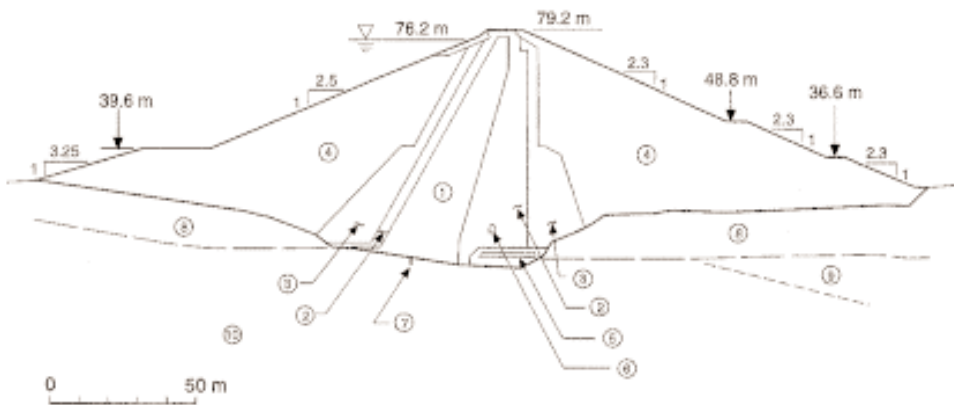
Fault. In 1987 the dam was damaged by a magnitude 6.3 earthquake on the nearby Edgcumbe Fault. A subsequent reappraisal of the Waiohau Fault in relation to the safety of the dam and reservoir concluded that the fault was active and that in the event of future fault movement within the dam foundation, the existing dam would breach rapidly. The dam was strengthened to enable safe reservoir operation in the event of movement of fault traces within the dam foundation. The seismic design of the original dam was in accordance with the practice at that time and allowed for a 0.15 g lateral loading. The dam zones had a minimum thickness of 2.4 m in recognition of the proximity of the Waiohau Fault, as shown below in Fig. 4.5.1 (Gillon et al, 1998).

Matahina Dam. Original dam prior to upgrading

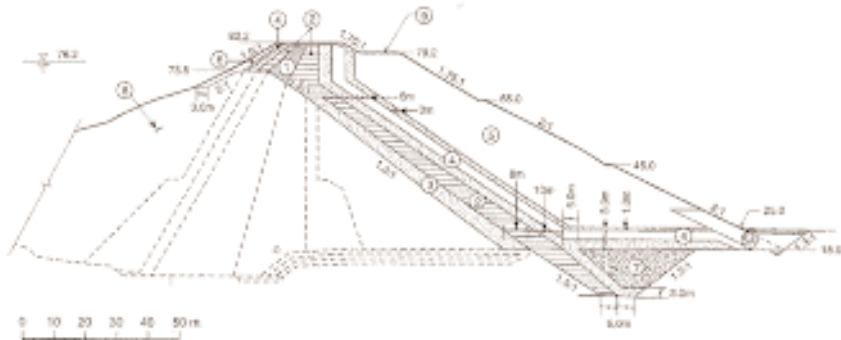
Matahina Dam. Rehabilitated dam

The buttress design included features to control post-earthquake leakage through the dam and prevent internal erosion of the core and inner transition from leading to piping of the dam or collapse of the dam crest. As shown in Fig. 4.5.2 the

The excavation of the existing downstream shell and the location of the buttress were laid out to minimise the size of the buttress required for stability, the amount of buttress overlap required at the left abutment, and the volume of core material that can migrate into the rockfill shell. To prevent piping of materials through the alluvium beneath the buttress, a wide cut-off was excavated through the alluvium as seen in Fig. 4.5.2.

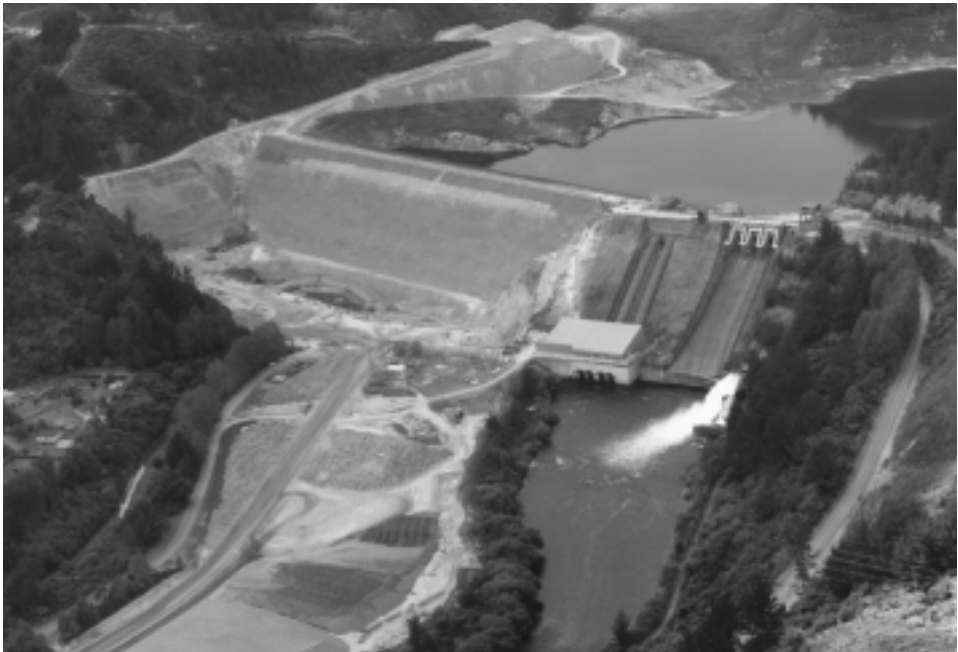
Fig. 4.5.3

Matahina Dam. Work in progress

Rehabilitation of Matahina Dam commenced in June 1997 (Fig. 4.5.3) and consisted of partial excavation of the downstream shoulder of the dam and its replacement by a buttress. The spillway gates have also been strengthened. Reconstruction was completed in late 1998.

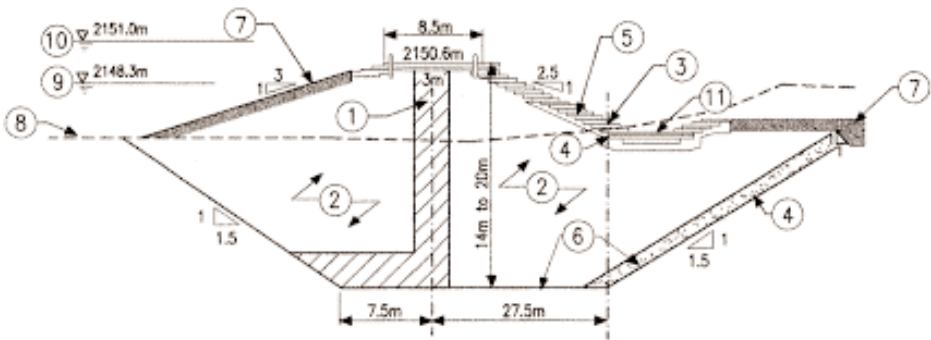
Fig. 4.5.4

Dulce Dam. Typical embankment section

The original dam was breached, while downstream precautions were taken to control the released water. The embankment material was completely removed and stockpiled. The foundation was excavated to a depth of up to 20 m in alluvium to remove the material prone to liquefaction. The excavated material was stockpiled. The foundation was backfilled with a selected impervious material forming a vertical water barrier, random fill supporting the barrier and a downstream filter, drainage blanket. The new construction is shown in Fig. 4.5.4.

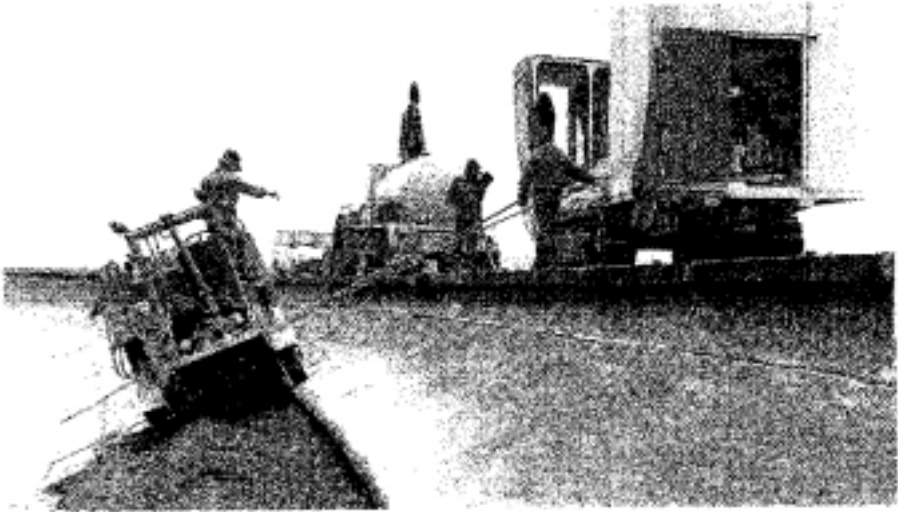
layer. Fig. 4.6.1 shows milling equipment being used to remove part of the impervious layer. Total removal is usually performed by caterpillar excavators.

Milling equipment for a partial removal of sealing layers

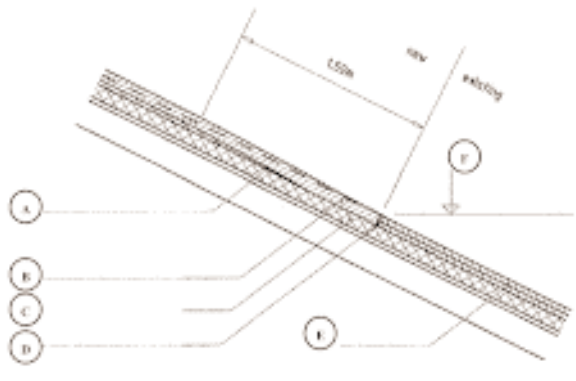
Transition joint from existing to new dense layer

If the rehabilitation is limited to the impervious layer, the existing dense layer is partly milled off to provide a sound asphalt surface for the new lining. Where there are two superposed dense layers, it is important that the top layer is milled off completely and the second layer partly so, in order to avoid the existence of a bondless interface between these old layers. The milled area has to be cleaned and prepared with a bonding agent before the new dense layer is placed. Often the renewal of the dense layer can be limited to the zone of fluctuating water level. Fig. 4.6.2 shows a standard joint design for the connection of the existing to the new dense layer. After placing of the new layer, the joint is re-heated with an infra red heater and re-compacted with vibro tampers.
