# REHABILITATION OF DAMS AND APPURTENANT WORKS

*State of the art and case histories*

**Bulletin 119**

**2000**

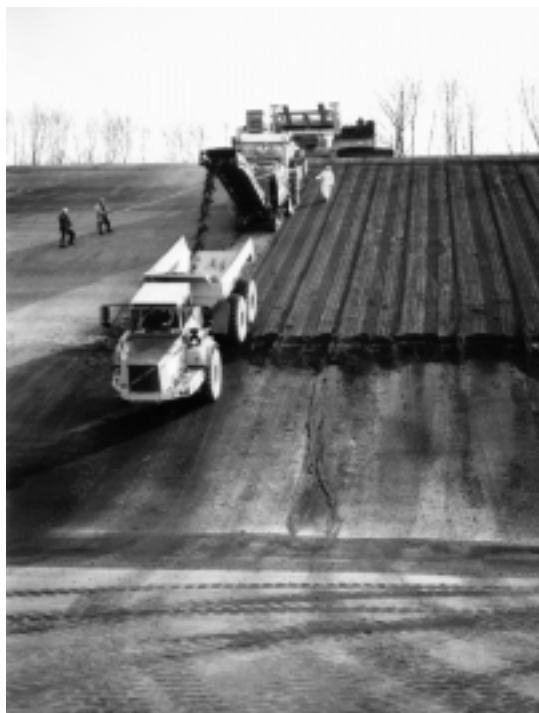
Markersbach Lower Dam. Milling the asphaltic concrete

The top sealing layer at the Lower Dam was removed by milling as shown on Fig. 4.6.3 over an area representing two-thirds of the upstream face. A new single dense bituminous layer 80 mm thick was placed in vertical strips by equipment retained by a mobile winch on the crest of the dam. The layer was compacted by vibratory rollers. A 2 mm thick mastic coating was then applied.

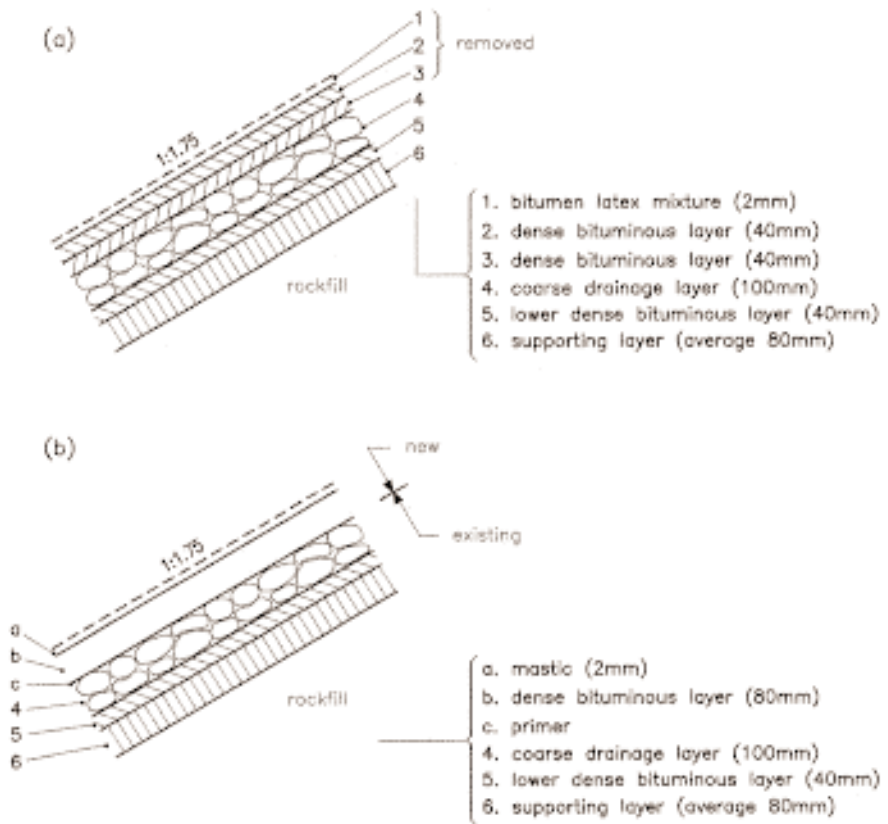
Fig. 4.6.4

Markersbach Lower Dam. Section through the surface layers  
(a) before the repair and (b) after the repair

A section through the surface layers of the lower dam is presented in Fig. 4.6.4. At the upper dam the section is similar, except that the dense layer rests directly on the 80 mm thick supporting layer, without drainage and lower dense bituminous layers. The mineral content of the new dense bituminous layer for both dams consists of natural and crushed sand (up to 2 mm), gravel (2-5 mm, 5-8 mm, 8-11 mm, 11-16 mm) and limestone dust filler. The bitumen has then been added to the dry mix in the ratio 7.4 to 100. The maximum mixing temperature reached 195° C.

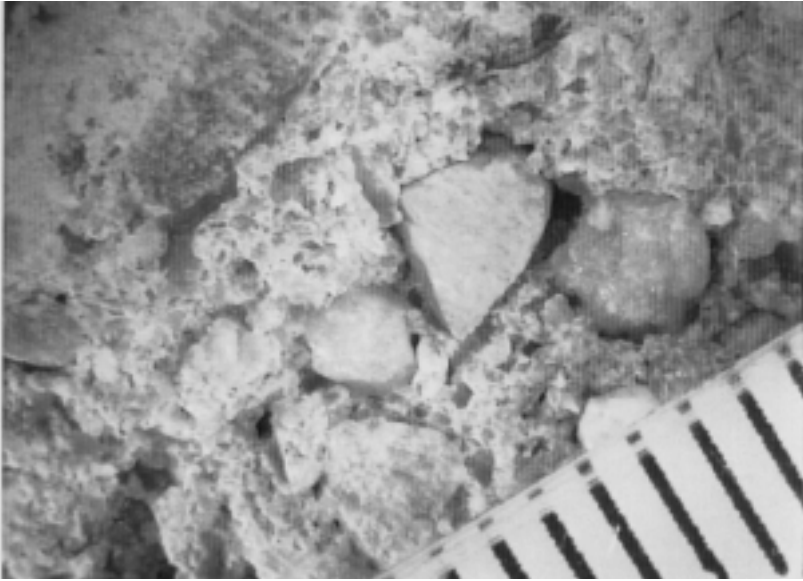
Fig. 5.3.1

Typical cavitation damage

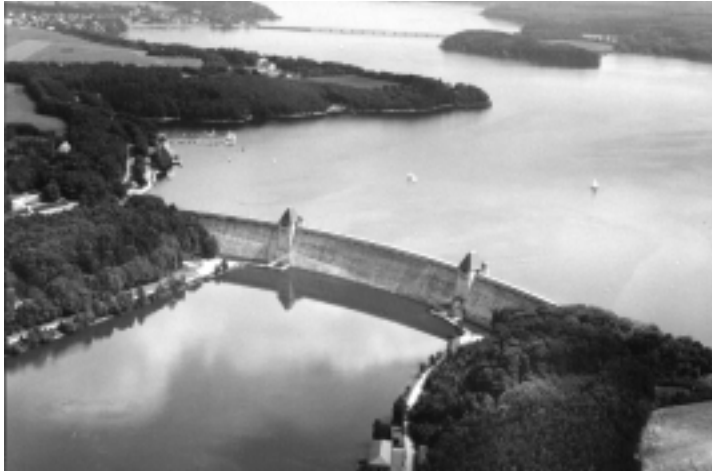
Fig. 5.4.1

Möhne Dam

The reservoir plays an important role in augmenting the flow in the River Ruhr for the supply of water to 5 million people. The outlets were replaced, even though no failure had occurred, to prevent strategic damage to the water supply system should they fail. To avoid taking the reservoir out of service the work was done underwater.

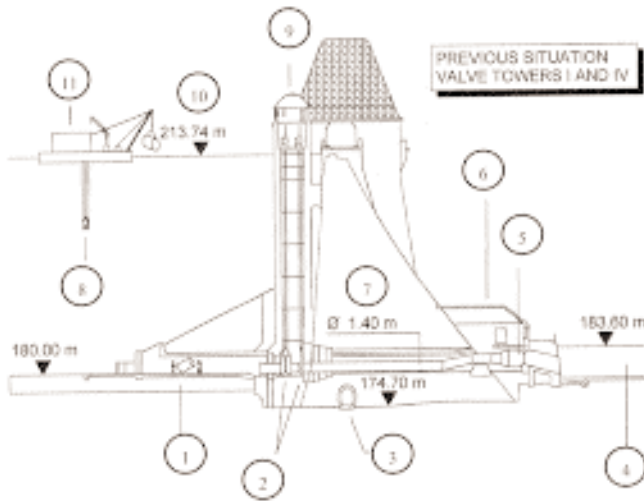
Fig. 5.4.2

The two upstream wedge gate valves in each outlet are controlled through a dedicated valve tower. Water enters the valves at the base of the towers through inlet culverts as shown on Fig. 5.4.2. It passes through 1400 mm diameter pipes within the dam to two further valves. In the outer two outlets these are needle valves, while in the two outlets nearer the centre of the dam sluice gates control the flow into vertical nozzles in the downstream compensation lagoon.

Möhne Dam. Valve tower and bottom outlet

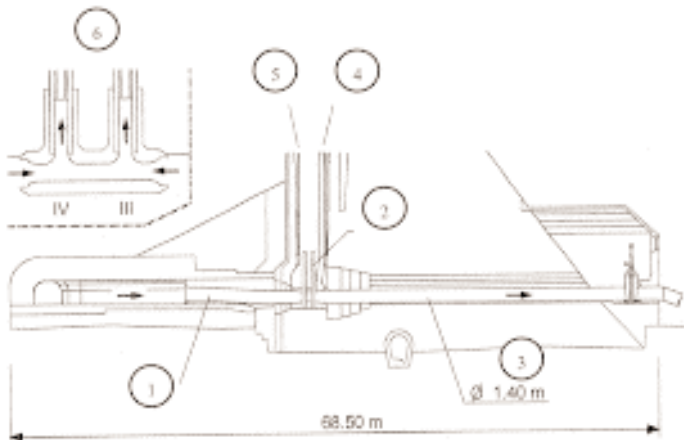
Fig. 5.4.3

Möhne Dam. New valve (bottom outlet III)

Following the wartime damage, two of the outlet culverts under the Intze wedge were strengthened with concrete as shown on Fig. 5.4.3. The design of the culvert liners had to take account of the narrow entrance. Divers manipulated the pipe sections so that the spigots engaged and the joint was tightened against the o-ring using a winch operated from the surface. Final adjustment was made by screws in plates welded to the pipes.

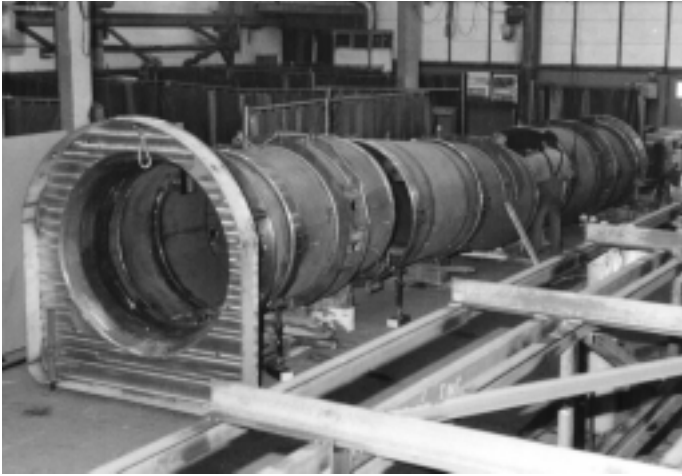
Möhne Dam. Test installation

In the first stage of the work all four culverts were lined and backfilled with concrete. Two of the bottom outlets had to remain serviceable at all times. Fig. 5.4.4 shows the factory installation of a pipe. Fig. 5.4.5 shows an end piece of pipe with buoyancy attached to simplify the manipulation of the pipes underwater. Fig. 5.4.6 shows the concrete work and Fig. 5.4.7 shows one of the emergency gates.

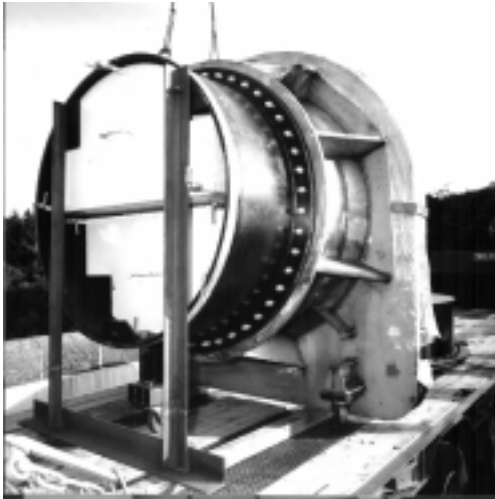
Fig. 5.4.5

Möhne Dam. End piece with flotation

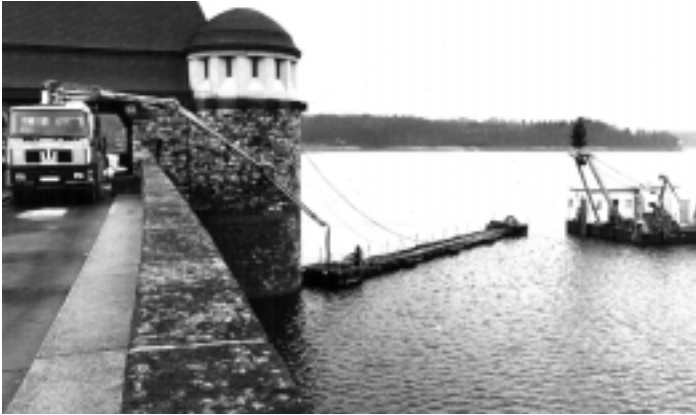
Fig. 5.4.6

Möhne Dam. Backfilling of pipes

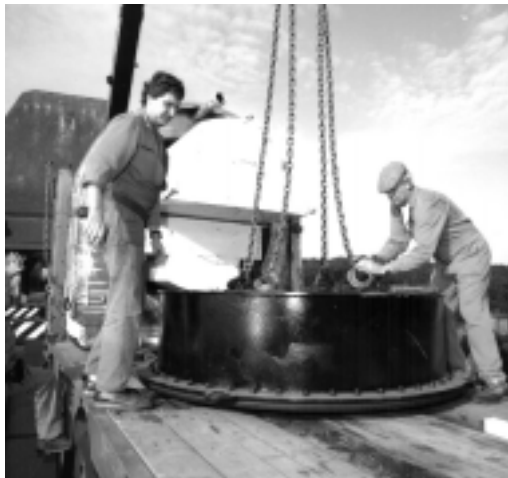
Fig. 5.4.7

Möhne Dam. Emergency gate

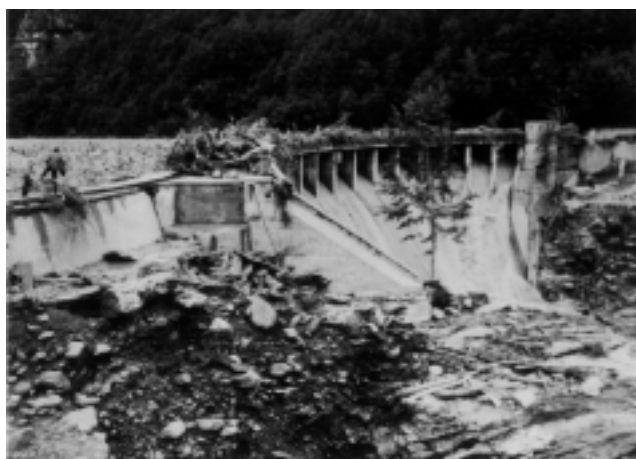
Fig. 5.5.1

An example is **Palagnedra Dam** in Switzerland. This is a 72 m high arch-gravity dam 120 m long built in 1950 to 1952. It forms a fjord-like reservoir over 2 km long. The spillway was situated at the crown of the dam, and comprised 13 openings each 5 m by 3 m. The intermediate piers serve as supports for the bridge of a main road. The design capacity of the spillway of 450 m<sup>3</sup>/s was based on flow measurements from 1927-1935, which showed a peak value of 325 m<sup>3</sup>/s. This was found inadequate during the construction of the dam and during the following years when floods were measured that exceeded the design flood. For instance in 1975 the flow was 700 m<sup>3</sup>/s. On the 7 August 1978 enormous damage was caused in the surrounding area by an exceptional flood. The inflow to the reservoir was 900 m<sup>3</sup>/s. The water level in the reservoir exceeded the permitted value by about 2 m, reaching the roadway of the bridge passing over the dam. A large quantity of floating timber was carried into the reservoir and there to the dam where the tree trunks got stuck in the spillway inlets, and formed a barrier. This is shown on Fig. 5.5.1. As a result the water level rose to 3 m above the road bridge. Because of the sudden breaching of one or more natural dams of driftwood which had formed in the river bed upstream of the reservoir a peak flood wave at the entrance to the reservoir of over 3000 m<sup>3</sup>/s and an overflow of 1800 m<sup>3</sup>/s to 2000 m<sup>3</sup>/s were estimated.

Palagnedra Dam. Crest with up to 3 m cover of wood

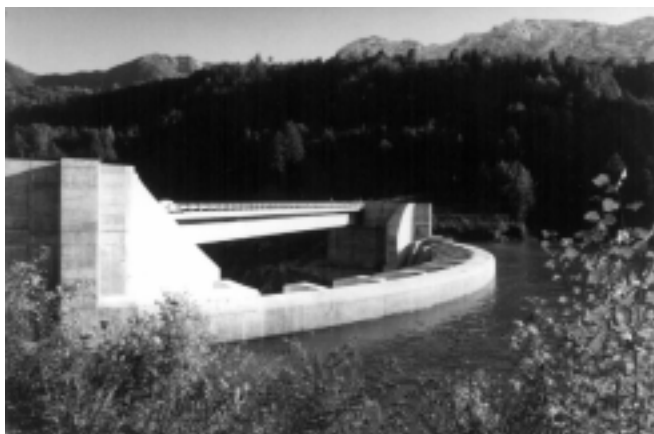
Fig. 5.5.2

Palagnedra Dam. New crest with nappe interrupter

After this event the discharge capacity of the spillway was reassessed. Analysis of the 37 years of records showed the 100 year flood to be 1050 m<sup>3</sup>/s and the 1000 year flood to be 1800 m<sup>3</sup>/s. Because of the possibility of a flood wave following the collapse of a temporary dam upstream of floating timber, the design flood was set at 2200 m<sup>3</sup>/s. The two wing walls of the spillway were raised by 4 m and the bridge over the dam was replaced with a new bridge with 60 m clear span 25 m downstream. The maximum permitted reservoir level was raised by 3.25 m (Zurfluh, 1985). The new design is shown on Fig. 5.5.2.

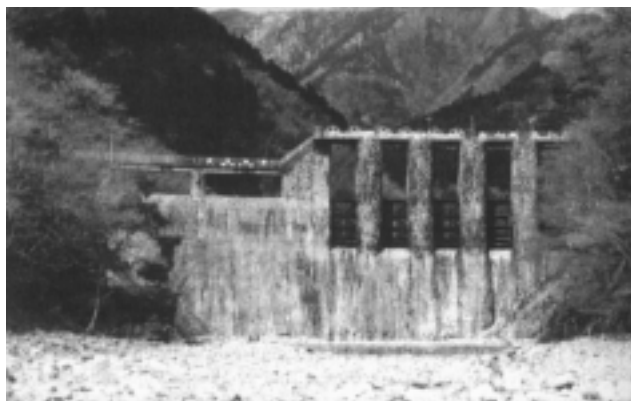
Fig. 5.5.3

Ohmatzawa Dam. Downstream view, before renovation

Not only because of the abrasion damage, but also because of the need to provide additional security against the effect of earthquake it was decided to add concrete to the downstream face. Extensive testing and thermal analysis was done to determine the distribution of shear stress of the joint between the new concrete and the existing dam body, and how this relates to the expected strength. The original stone-pitched facing, removal of which would greatly extend the repair work period, was retained as far as possible to minimise the disruption in power generation operation due to renovation construction. Pumped concrete was used and the mix

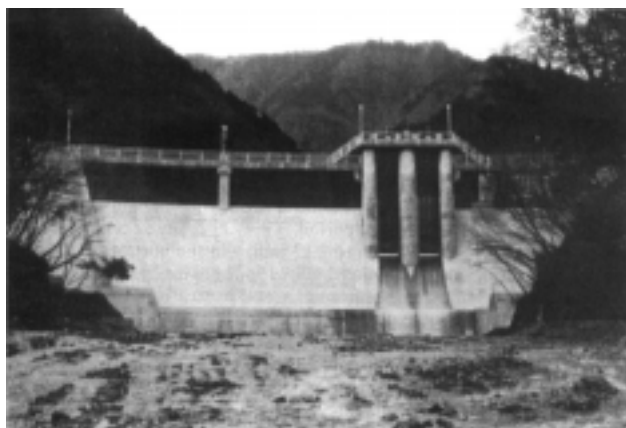
Fig. 5.5.4

Ohmatzawa Dam. View of rehabilitated dam

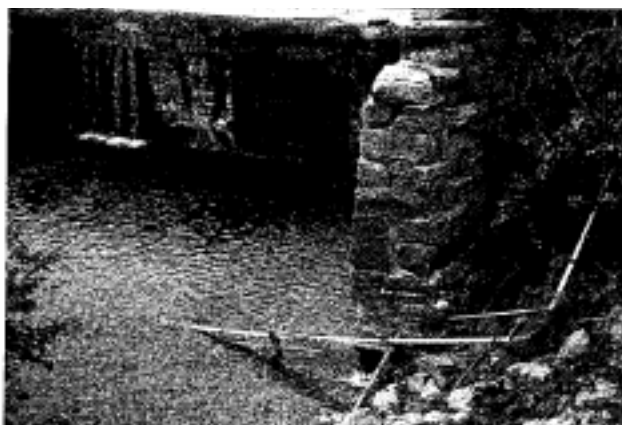
Fig. 5.5.5

diverted away from the dam by cofferdam work, a significant tailwater pool at the dam toe still existed and the damaged area was under as much as 6 m of water. It was necessary therefore to dewater the stilling basin to carry out a comprehensive assessment of the extent of damage and the need for repair of the concrete surface. The voids were formed by the erosive force of the Potomac River continuously flowing over the dam crest and impacting along the downstream dam toe. The geological setting of the foundation bedrock had also an important bearing on the void formation. The loose and weathered rock underlying the dam was progressively undercut and eroded away. The voids destroyed the structural support for the dam, and if left uncorrected could have precipitated a sudden, localised collapse of the dam.

Potomac River Dam. Deterioration and concreting

The repair work was performed underwater to avoid the expense and time required to construct a cofferdam followed by dewatering. Furthermore, dewatering could possibly have increased the potential for collapse by causing further disturbance to the dam. The repairs consisted of filling the voids with concrete pumped from the dam abutment staging area through a slick line that was placed underwater along the toe of the dam. Sketches showing repair of a typical void are shown on Fig. 5.5.5. The backfill concrete was anchored into the bedrock and also grouted at the dam base interface. The engineers responsible concluded that pumped concrete placement offered more versatility than other methods for underwater repairs.

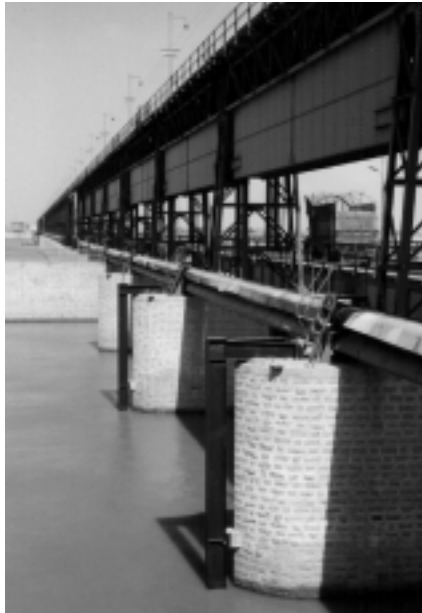
Fig. 5.6.1

Kotri Barrage

The last option was chosen because none of the others would continue the life of the barrage with sufficient security. An immediate problem for the engineers was that the barrage had been constructed without the means to isolate each sluiceway gate. There was no provision in the original design for stoplog gates. Fig. 5.6.1, shows a view of the upstream face of the dam. Not only were there no stoplogs available, there were no slots provided in the masonry either. It was necessary to devise a method of isolating and dewatering each sluiceway. There were several specific problems to be overcome.

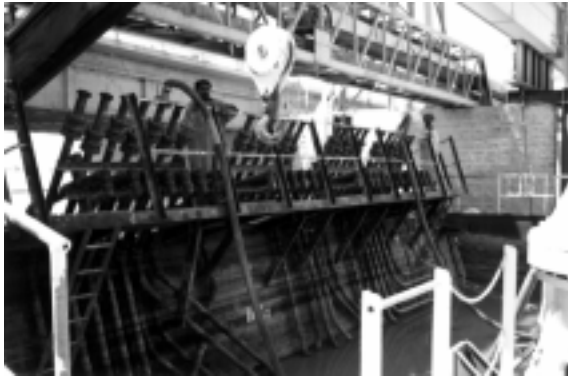
Fig. 5.6.2

Kotri Barrage : Bulkhead gate

The solution adopted was to design and construct a self-contained buoyant bulkhead gate, shown on Fig. 5.6.2. The bulkhead gate is floated into the space between the piers on either side of the gate. This is controlled using a pontoon and a tug. The pontoon is fitted with side spacers to centralise the bulkhead. The bulkhead is positioned to engage side arms on to load transfer fenders previously positioned on each pier. Once in position the ballast of the bulkhead gate is adjusted so that the gate moves from its horizontal attitude to float vertically. The ballast is adjusted further until the bulkhead sinks on to the sill of the gate opening. Side seals are then extended using hydraulic rams and adjusted against the masonry of the pier faces. Finally the space between the bulkhead gate and the gate to be replaced is pumped dry.
