TAILINGS DAMS RISK OF DANGEROUS OCCURRENCES

Lessons learnt from practical experiences

Bulletin 121

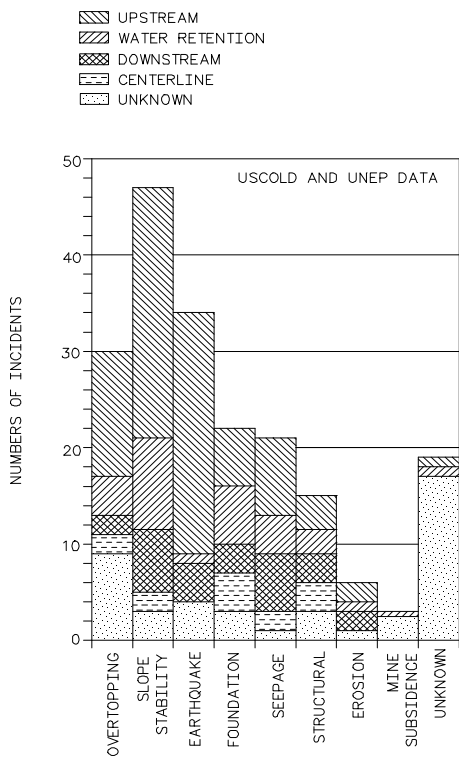
Figure 9. Tailings dam incident cause comparison with dam type.

The incident survey results show that there is no overriding cause or mechanism for all tailings dam incidents, but it is intended that readers may find examples close to cases under their control, and benefit from the experiences recorded here. As shown by Fig.9, incidents are due to a number of factors including overtopping, static and seismic instability, seepage and internal erosion, external erosion, structural and foundation conditions. In addition, no type of tailings dam or operational condition is particularly immune from incidents. Although the majority of tailings dam incidents are associated with active tailings impoundments, a range of types of incidents have been recorded at inactive impoundments.

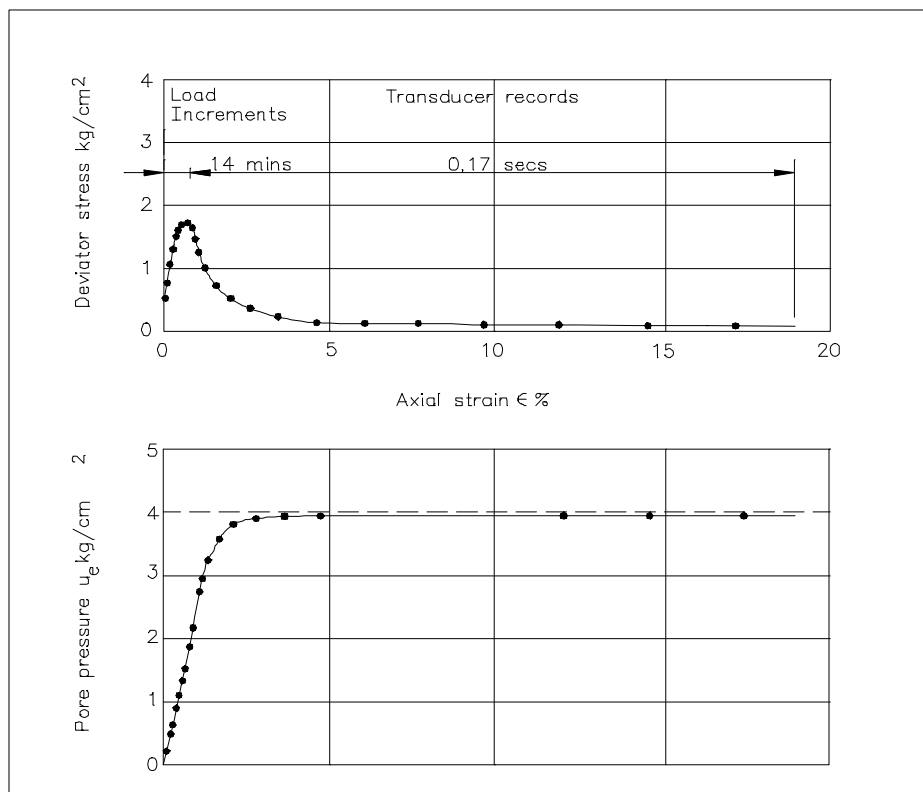
Figure 17. Stress-strain curve for stress controlled consolidated undrained test on saturated loose sand.

Very loose, normally consolidated saturated material as are tailings in an impoundment, exhibit a peak strength higher than the residual strength at greater strains, when tested in apparatus using strain control. This effect is shown more vividly in stress controlled tests, i.e. tests in which the shearing force is applied by weights: an example given by Castro (1969) is shown by Fig.17. The tests were made on a fine uniform sand with a D_{10} size of 0.1 mm at a relative density of 29% using a confining pressure of 400 kN/m². Load was applied in small increments and peak deviator stress was reached in 14 minutes at a strain of 1%, during which time the pore pressure increased to half the confining pressure. But once the peak strength had been reached the strain increased to 19% in 0.17 seconds. The pore pressure climbed to almost the value of the confining pressure and as a consequence the strength fell to almost nothing. This is the mechanism of a flow slide.
