DAM SURVEILLANCE

LESSONS LEARNT FROM CASE HISTORIES

COMMITTEE ON DAM SURVEILLANCE

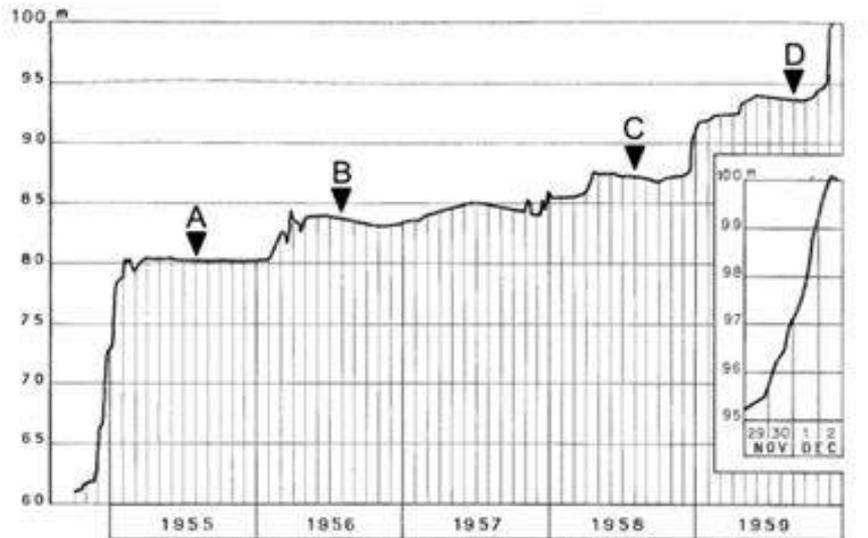
Results from the last geodetic measurement taken (see point D on Figure 4, July 1959, RWL 94.10 i.e. 8 m below the Max Flood Design Level) were not yet in the engineer's hands. (Afterwards, he could not say what would have been his comments on excessive movements in the lower sections of approximately 10 mm).

Figure 4. Reservoir level during years 1954-1959 (the box magnifies the four last days). Triangles = dates of geodetic measurements A (late reference) to D.

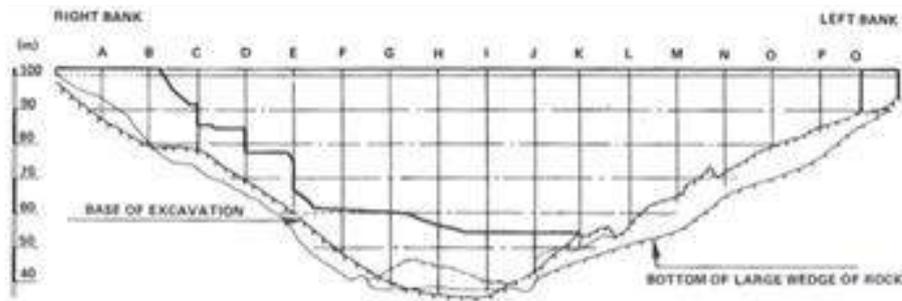
The dam failed the same evening around 21:11 after a sudden failure of the left bank. A large wedge of rock dislodged, below the left half of the arch dam, leaving an excavation in a dihedral form as shown in Figure 5. Only the bases of the right bank and central concrete blocks were still there, as shown in Figure 6. All other parts of the arch washed away; some blocks of concrete were swept away for more than 1.5 km.

Figure 6. Downstream developed elevation after the failure

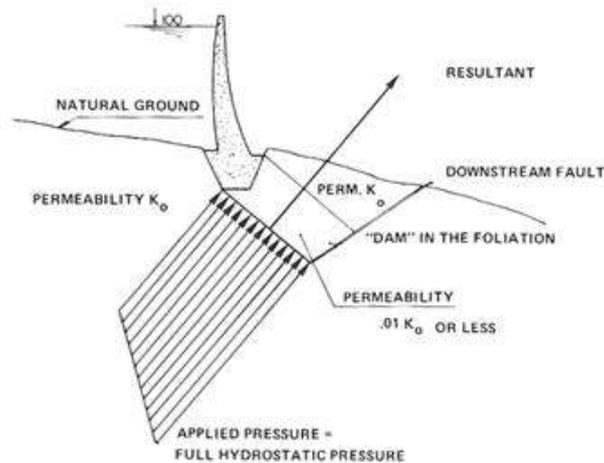
The upstream face of the wedge comprised of several shear planes parallel to the foliation of the gneiss, dipping towards the river. During the design and construction stages the downstream fault was not known. It was between 15 and 40 m below the lowest excavations (Figure 7), and it surfaced unnoticed in the overburden, more than 20 m downstream of the dam.

Figure 7. Full hydrostatic water pressure in the left flank foundation of the dam

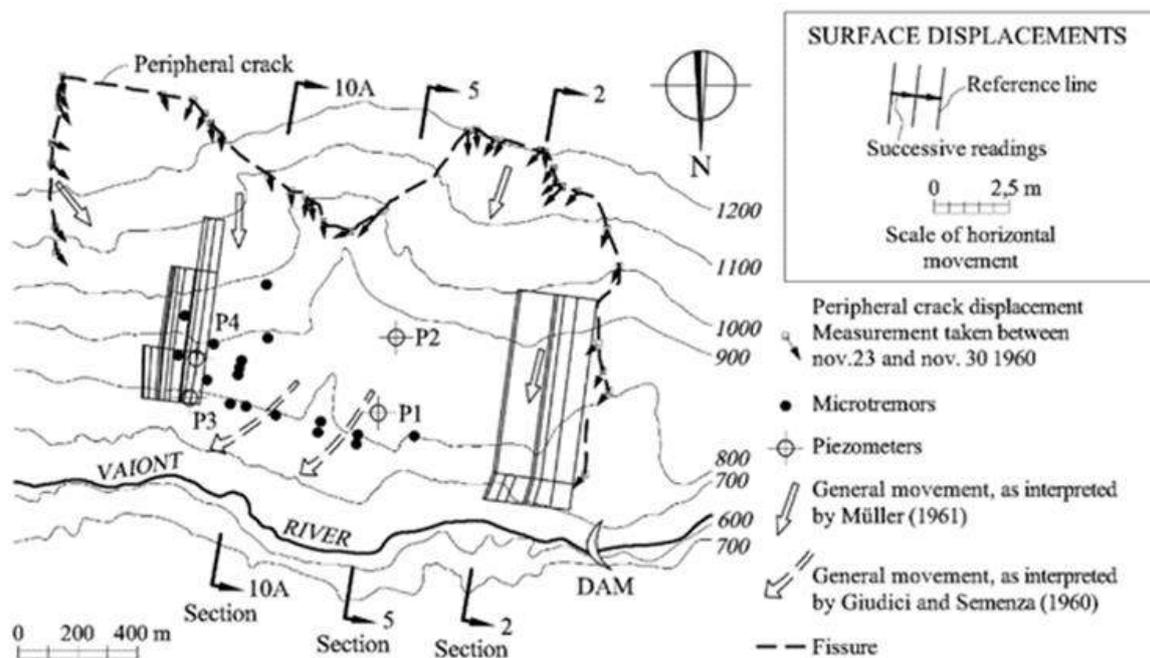
As a result, no action was taken to stabilize the slopes, but a monitoring program was set up. In the following three years, the downward motion of the slide was monitored by means of surface markers. Some of the data provided by them are plotted in Figure 10. In addition, water pressures in perforated pipes, located in four boreholes (location shown in Figure 10), were monitored, starting in July 1961.

Figure 10. Map of the Vajont sliding area. Note the position (and comparative size!) of the arch dam on the lower right-hand corner of the figure (Alonso et al.: 2010)

Data on horizontal displacements, plotted as a function of position and time in several profiles following the south-north direction in Figure 10, suggest that the slide was essentially moving as a rigid body. The direction of the slide is also indicated in the figure by several arrows. Some of them (small arrows along the peripheral crack) indicate that the moving mass was actually detaching from the stable rock, implying no friction resistance along the eastern and western boundaries of the slide.

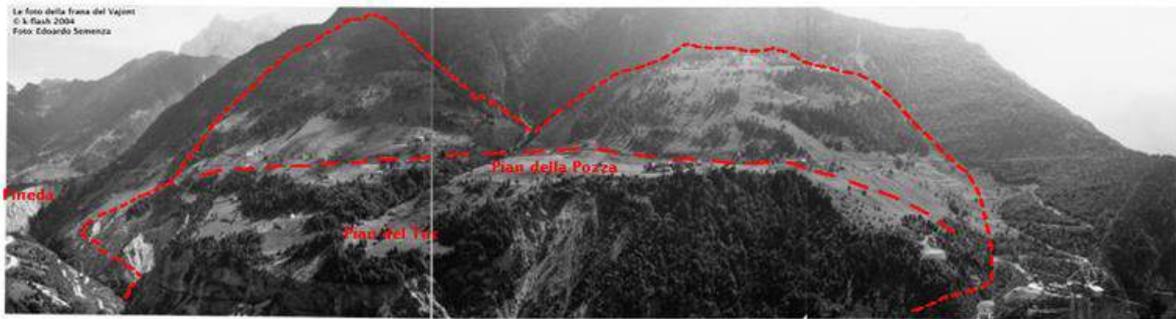
Figure 13. Photograph of Monte Toc taken by E. Semenza on 1 September 1959 with the construction crane for the dam to the right. The lower line corresponds to the existing paleo-landslide and the upper line to the 1963 landslide limit

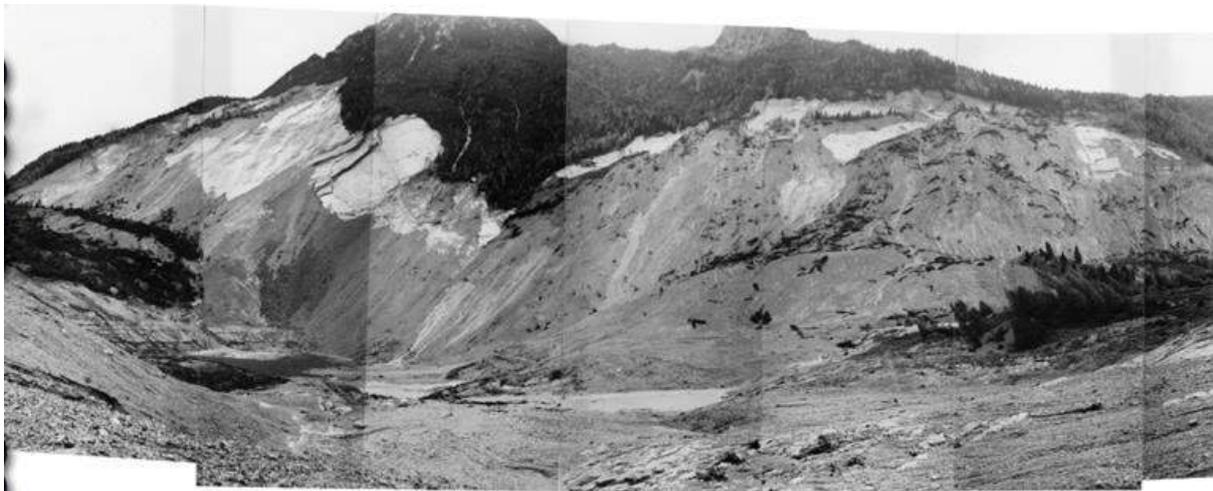
At 10:38 pm on October 9, 1963, the landslide collapsed. The entire mass of approximately 270 million m³ of earth and rock slid 500 m north at up to 30 m sec⁻¹ (110 km per hour). The huge velocity reached by the landslide magnified the tragic consequences. When the mass fell into the lake it had a level of 235 m and contained about 115 million m³ of water. The landslide pushed a wave up the opposite bank 260 m above the original reservoir level and destroyed the lower part of the village of Casso and then over-topped the dam by up to 245m. An estimated 30 million m³ of water fell on five

Figure 14. Identical view taken by Daniele Rossi at the end of October 1963 just after the disaster

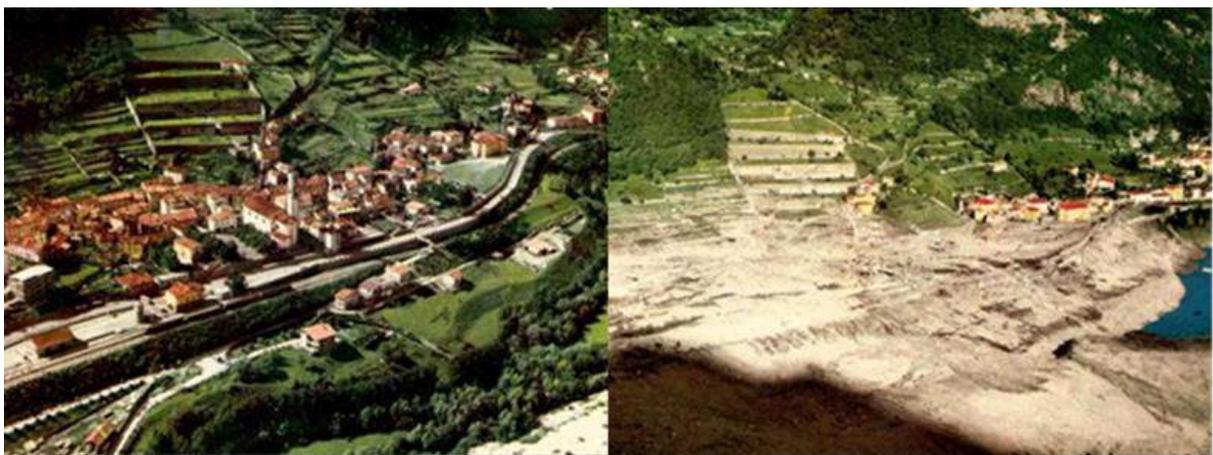
villages decimating them. About 2 000 lives were lost. Despite this the dam was left structurally intact, only a metre of masonry was washed away at the top.

Figure 15. View of the municipality of Longarone before (left) and after (right) the event

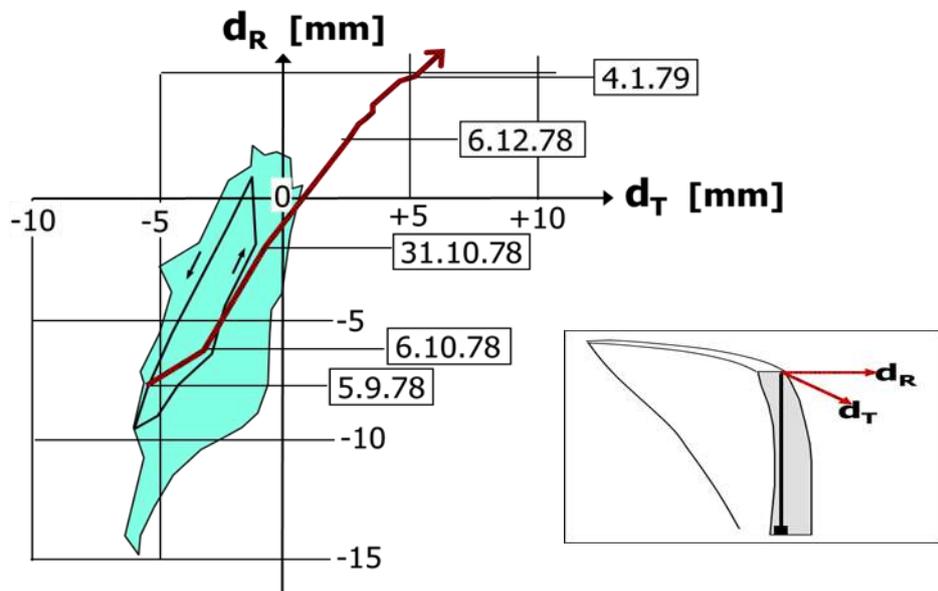
At the beginning of December 1978, the monthly measurement of pendulums indicated that the deformations obviously differed from the former elastic behaviour of the structure. Easily and rapidly detected, the dam crown started to move toward the upstream direction although the reservoir was nearly full (Figure 3). In January 1979, movement reached more than 5 mm in both radial and tangential directions. End of March 1979, movement was more than 20 mm toward upstream and 15 mm toward the abutment.

Figure 3. Radial movement at the crest, central pendulum, before and during the event [mm]
 Green area: envelope for the period 1958 – 1976
 Blue line: Oct. 77 to Sep. 78
 Red line: since October 1978

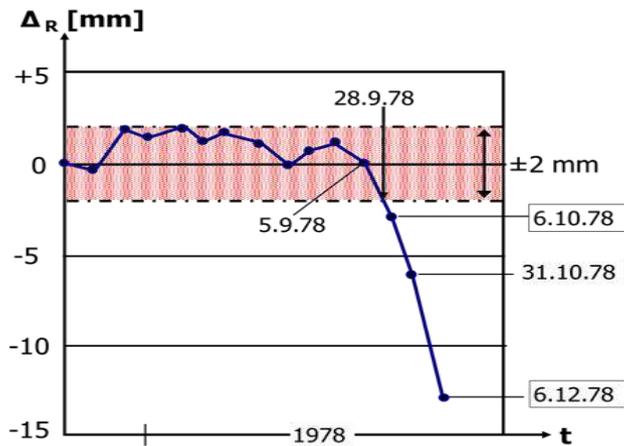
Later on, the analysis permitted to identify the beginning of the abnormal behaviour in the last days of September 1978 (Figure 4). The reservoir was rapidly drowned down to its minimum water level and the frequency of monitoring measurements was increased.

Figure 4. Radial movement at dam crest central section: variation between measurements and deterministic model (in red, considered acceptable variation: +/- 1 mm)

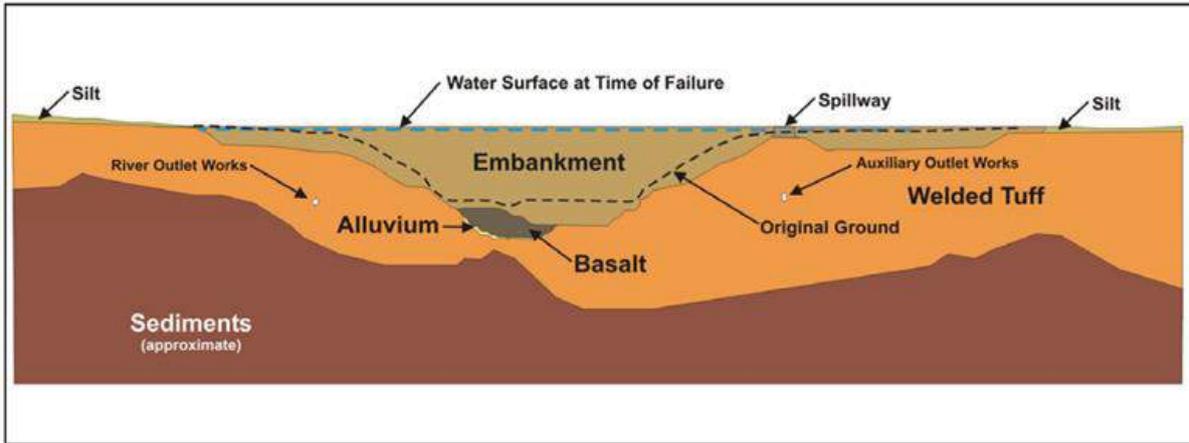
Basalt is present in the bottom of the Teton River Canyon and is a remnant of a lava flow that filled the canyon to about El. 1526 m (see geologic section, Figure 18). In the dam foundation, the basalt is restricted to the left side of the river channel section, where it has a maximum thickness of about 38 m. It is separated from the underlying welded tuff by a deposit of alluvial material consisting of silt, sand, and gravel from 1.2 m to 6.7 m thick. The basalt is dense to moderately vesicular and contains closely spaced, randomly oriented joints and other fractures. In spite of its fractured nature, it is an adequate foundation rock for the dam. Water pressure tests showed the basalt to be tight and the thin alluvial fill between the basalt and the welded tuff to be permeable.

Figure 18. Profile of the Teton embankment and foundation looking downstream

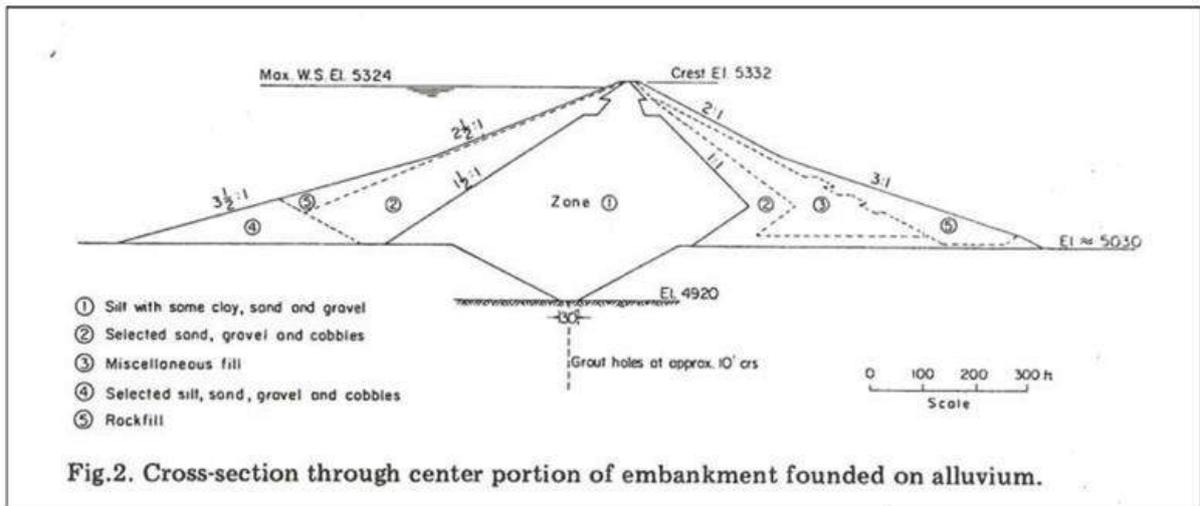
The design for Teton Dam followed standard practices with an impervious core and progressively coarser materials used as the zoning progressed downstream. In the maximum section, a relatively shallow-sloped cut-off leads to a narrow 9 m wide contact with a competent foundation. The intent of the design was to rely on the grout curtain and the cut-off to create an impermeable barrier to protect the main core of the dam. As shown in Figure 19, there are no additional defensive measures provided in either the main embankment or the abutment sections.

Figure 19. Teton Dam maximum section

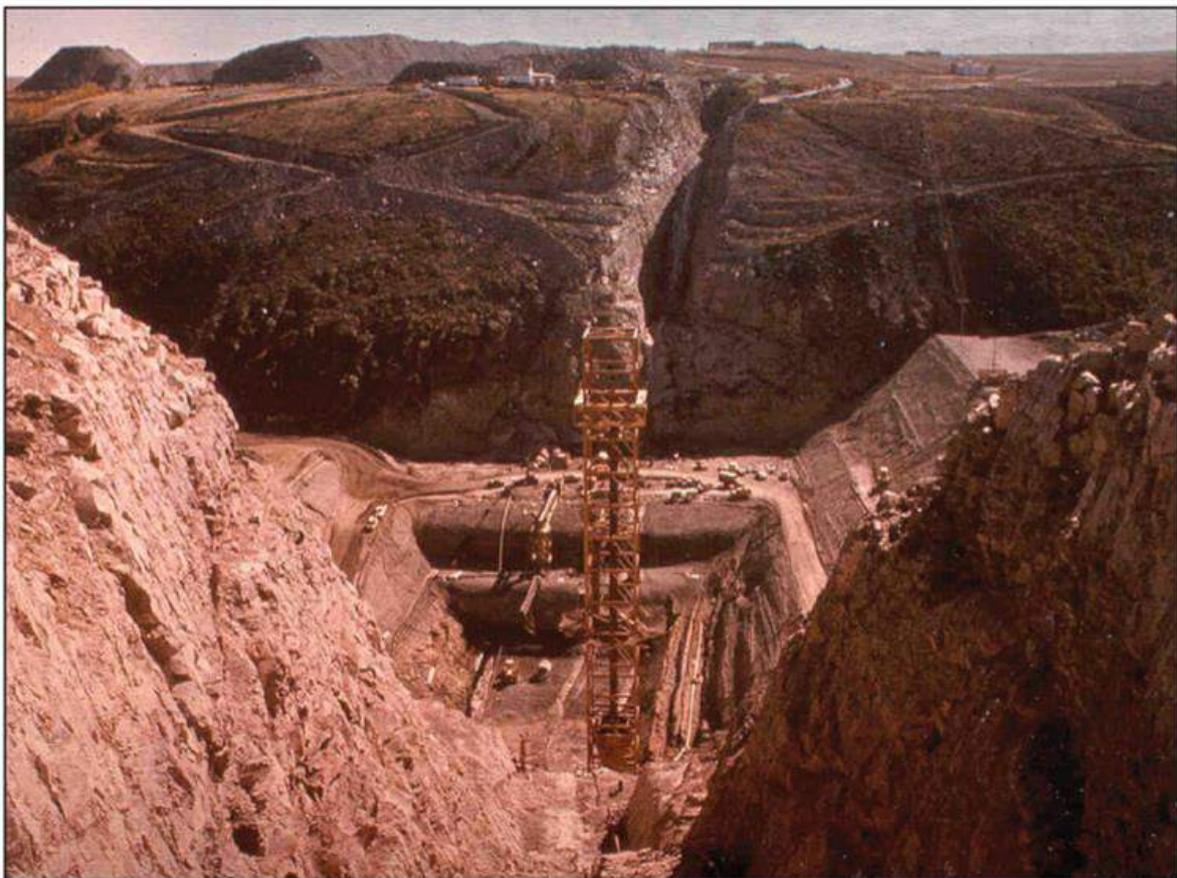
On each abutment, the side wall of the cut-off trench steepens to 0.5H:1V. However, owing to the steepness of the abutment looking parallel to the axis, the actual sidewalls approach vertical on both abutments, which can easily be seen in Figure 20.

Figure 20. A view looking towards the left abutment from the right abutment

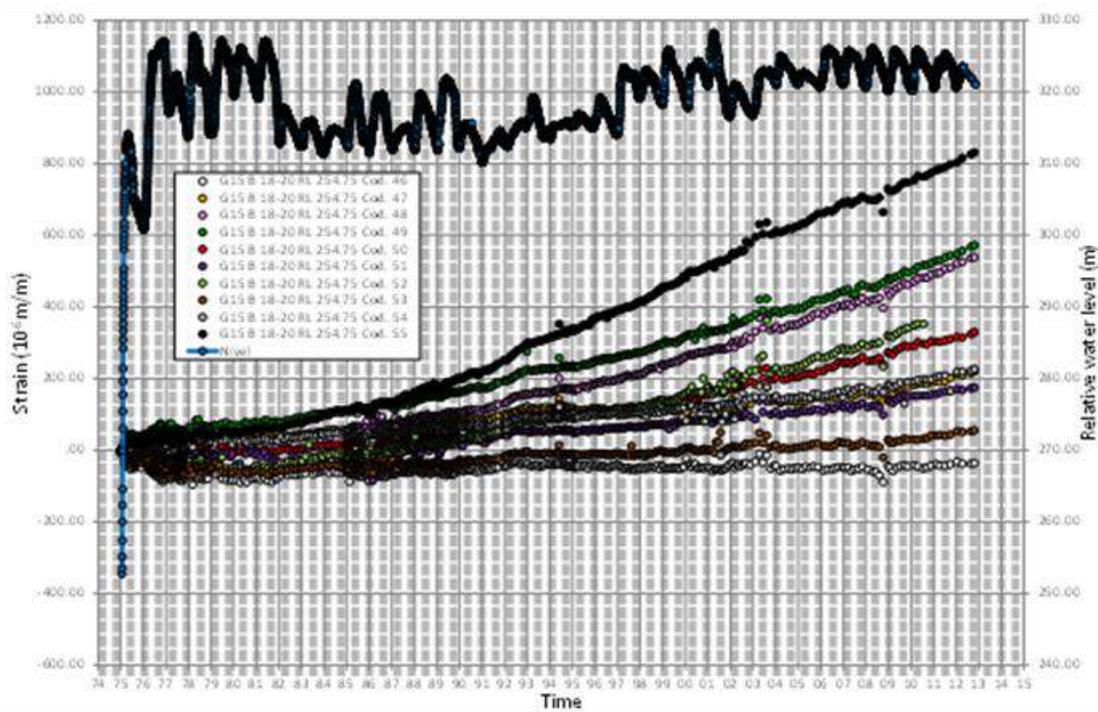
Figure 28. Carlson strain gauges: Strain: RL 254.75 m: Block 18-20: Centre: SACODA results

- The rod extensometer strain rates correlate extremely well with the vertical strain rate results of the originally installed Carlson strain gauges;
- The annual strain rates observed by the convergence meters (between 35-40 and 60 micro strain) are similar to the estimated strain rates of the gate trunnions (around 40 micro strain); and

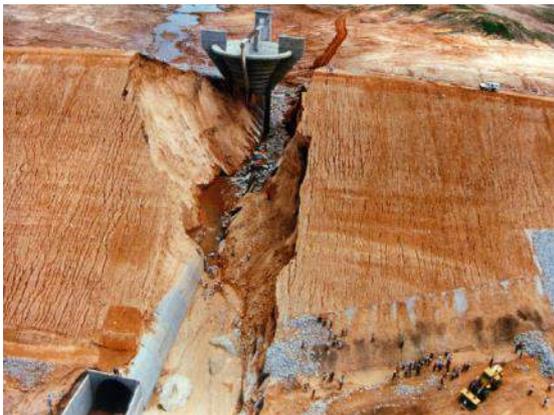
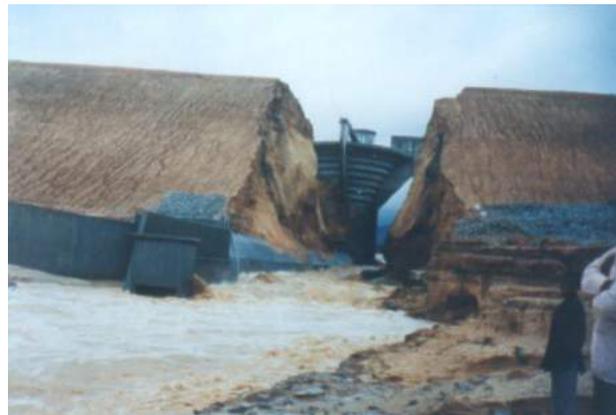
- Early morning of 25 January the dam was breached with no lives lost and fortunately no significant damage to other infrastructure.
- Dam Safety Surveillance teams of DWS visited the dam on 2 and 4 February to investigate the failure. It was suspected that it is a piping failure along the conduit and/or conduit failure leading to the piping failure;

- A week later a taxi driver gave a photo (that he had taken when he passed by early on the morning of the failure) to the site supervising staff. A photo that narrowed the forensic engineers’ task;

Figure 34. Zoeknog Dam on 2 February 1993 on the left (photo courtesy of Willie Croucamp) and the photo that narrowed the investigation on the right (photo courtesy of an unknown taxi driver)

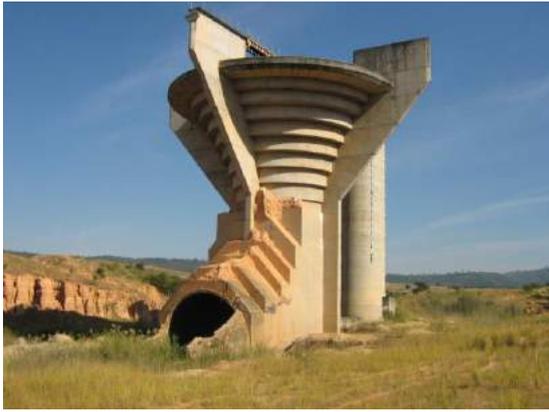
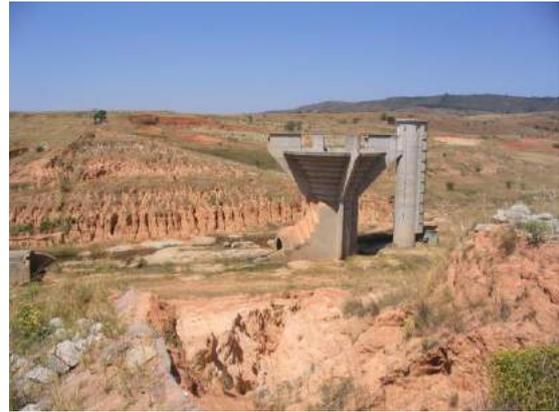
The embankment material comprised of leached granite from the basin area. Dispersive tests done prior to and during construction tested non-dispersive. Apparently tests were always done on the upper leached layers and not on the deeper lying material. The deeper layers of the borrowed material was, however, highly dispersive. ASHTO specifications for optimum moisture content (OMC) were used and not Proctor values. The dam was therefore constructed with highly dispersive material compacted at dry of optimum moisture content (a fatal combination).

Figure 35. Abandoned Zoeknag Dam -note the clear signs of dispersive soils

The main lesson learned is to act on warnings of diligent instrumentation personnel. In the case of Zoeknog Dam it would not have mattered. The obvious solution would have been to drain and breach the dam, remove all the earthfill and start again from foundation level.

Ensure that the blanket drain is constructed on founding level and not on “assumed foundation levels” indicated on design drawings (the actual levels were up to 5 metres lower in this case).

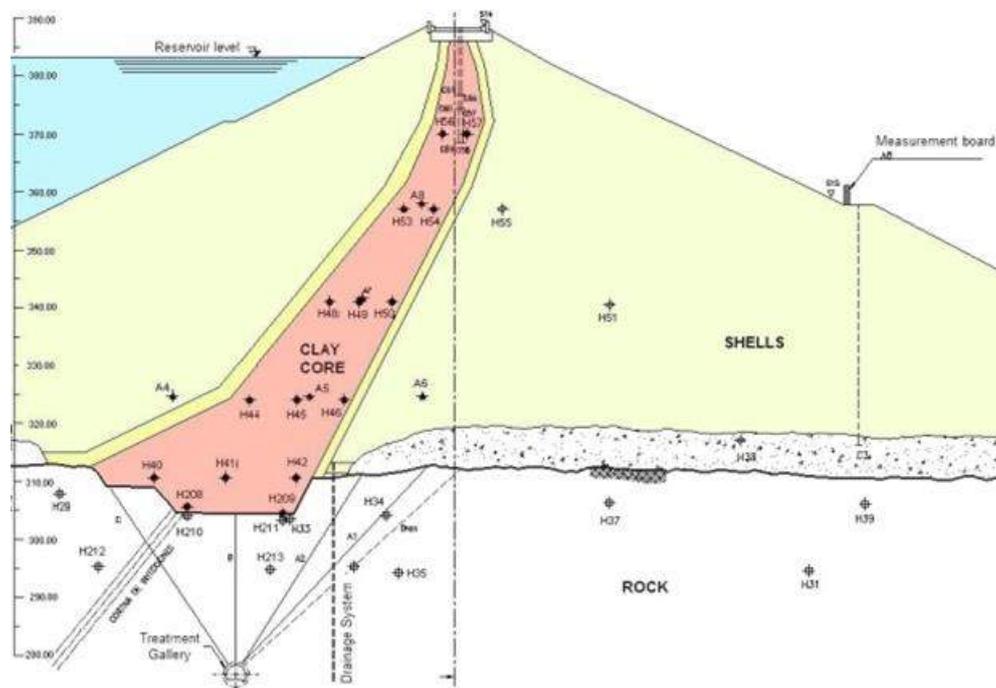
Figure 41. Cross section of dam

A continuous increase of piezometric levels in the rock-core contact on right abutment was observed, leading to the design of the following remedial works: a grouting program considered necessary at both the right and left banks as well as for the entire foundation in order to reduce the potential internal erosion of the clay core into open foundation joints.

Thus, the objective of the remedial works was to reduce the seepage through the open foundation joints, caused either by gypsum dissolution or as a result of the original grouting curtain not being completely effective.

Proper instrumentation is not just essential for monitoring during the foundation remedial work but also for the future long-term behaviour of the remedial work. The design of the remedial works included an important group of piezometers to check the short as well as long term efficiency of the new grouting and drainage curtains.

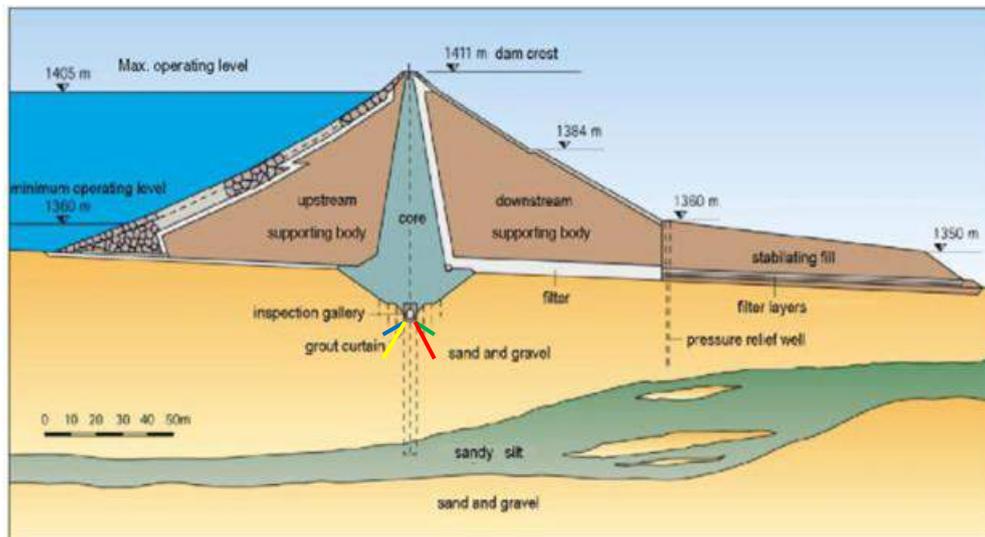
Figure 42. Cross section of the dam

Durlassboden Dam is an embankment dam with a central clay core and is founded on erodible alluvial deposits with a maximum depth of 130 m. Due to economic and technical reasons the grout curtain was not carried out to the full depth of the alluvium, but only down to a silt layer at a depth of about 50 m. Therefore, water can pass through the “window” below the silt layer.

These adverse foundation conditions required an extensive monitoring system that consists of relief wells at the downstream toe, measuring weirs for measuring discharge and turbidity in the area downstream of the dam, piezometers in the area downstream of the embankment and piezometers upstream and downstream of the grout curtain (see coloured lines in Figure 42 above)

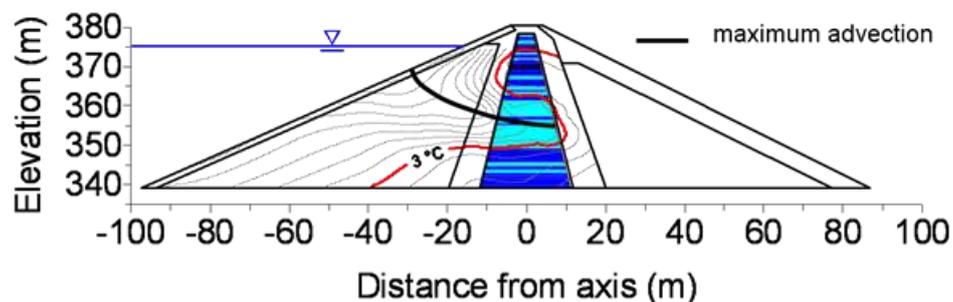
Figure 49. Inferred hydraulic conductivities and line of maximum advection

The representativeness of the inferred hydraulic conductivities was then assessed with temperature monitoring data. The figure below shows the annual temperature amplitudes contour lines superposed with the hydraulic conductivity layering in the core.

The heterogeneities and zones of higher hydraulic conductivity in the dam core were found to be mainly due to variations of fines content and till fabric, which depends on water content and density that occurred during construction. No internal erosion or cracking phenomena are present in the core. No other remedial actions are needed.

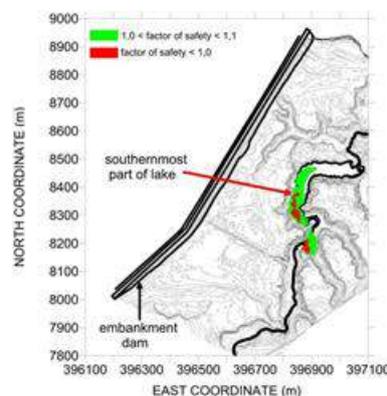
Figure 50. Minimal factors of safety against uplift

Significant seepage was observed downstream from an embankment dam founded on a clay layer underlain by sand located in northern Québec, Canada. This structure is a 15 m high and 1 200 m long embankment founded on marine clay underlain by a fine sand deposit of up to 70 m in thickness.

The risk of internal erosion of the sand layer through the overlying clay is increased where the factor of safety against uplift is lower. The calculation of factors of safety against uplift requires an estimation of clay thickness and pore pressures for the entire area. A global electromagnetic survey was realized to detect the main sources, pathways and exits of seepage from the sand layer. An airborne LIDAR survey was performed to determine land surface elevations. A number of boreholes and cone penetrations tests were realized over the years to assess the foundation stratigraphy and open-tube piezometers were installed. Clay-sand contact elevations and piezometric levels in the sand layer were estimated using geostatistics. A factor of safety against uplift was then computed for the entire downstream area, as shown in Figure 1. The design of stabilizing measures was specifically targeted at the more critical areas where factors of safety was lower. A number of relief wells were installed and their drainage effect caused a decrease of piezometric levels in the sand layer in the lake area. This decrease of pore pressures increased the factor of safety against uplift to acceptable values and thus decreased the likelihood of internal erosion.

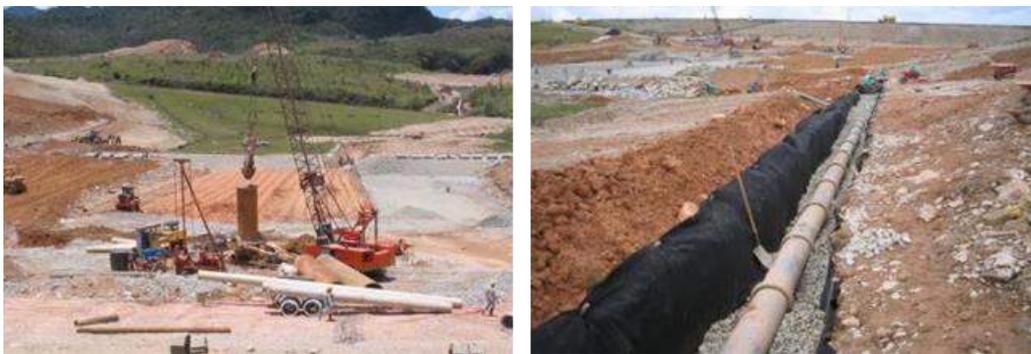
Figure 52. Upgrades at Auxiliary II embankment of Santa Rita Dam done in 2004

During the regular visual inspections carried out at the dam, erosion on the upstream slope and wet areas downstream of the embankment were observed. It was also observed that the body of the dam was saturated and the seepage was flowing through the embankment. In the area downstream of the embankment some wet areas were observed. These anomalies led to an assessment study to determinate the safety of Santa Rita Dam.

The assessment study concluded that a high liquefaction potential in Auxiliary II embankment that could generate mass movements during the occurrence of an exceptional earthquake. The solutions proposed by the assessment were focussed on the reduction of the liquefaction potential of soil, the control of seepage flow through the left abutment and the reduction of the effect of possible increases in the seepage flow through this abutment during an earthquake. The update works were carry out in 2004. The main element of the upgrade to reduce the liquefaction potential, a group of gravel wells were installed to increase the effective stresses in the most susceptible areas. To protect the left abutment, a blanket drain/filter and a reinforcement fill were added on the downstream side, to control fines migration and ensure efficient drainage system. In addition, geotechnical instrumentation (vibrating wire piezometers and seepage weirs) was installed to improve monitoring of the dam and to verify the effectiveness of the upgrades in the long term.

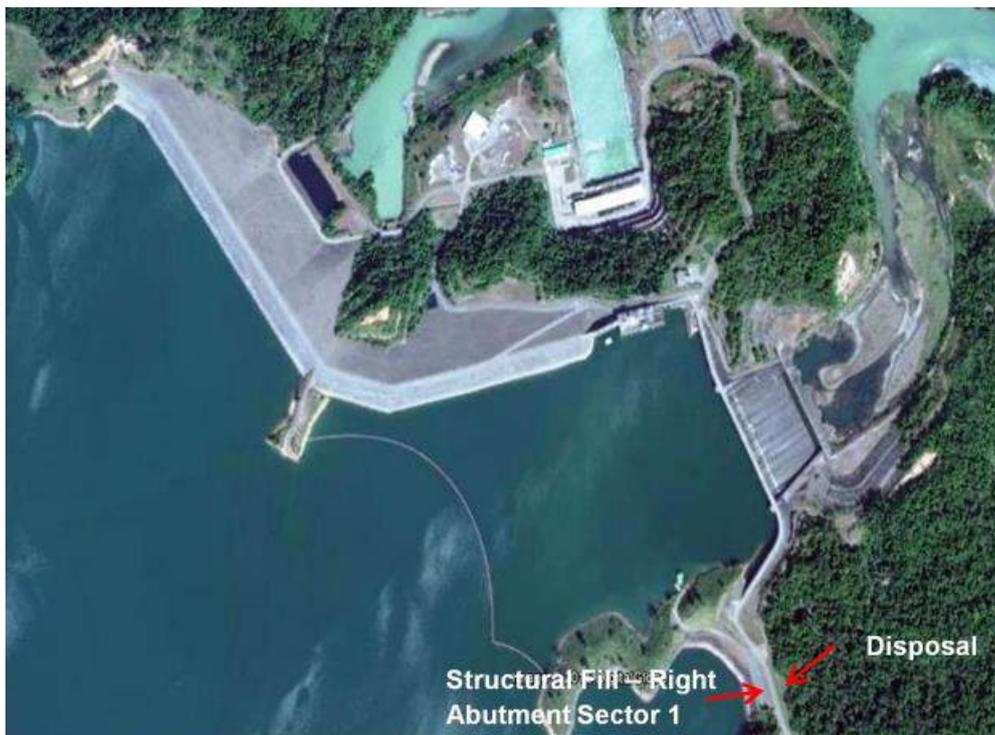
Figure 53. Layout of Urrá Dam

A possible slope failure in a disposal fill identified on the right abutment of the Urrá I Hydroelectric Project because of the saturation of materials in the disposal fill. The structural fill was not compromised at all nor the natural slope's integrity on the abutment at this point.

Thanks to the observations from the visual inspections and the proper interpretation of the monitoring results, the risk of failure was identified and mitigated through the installation of a drainage system.

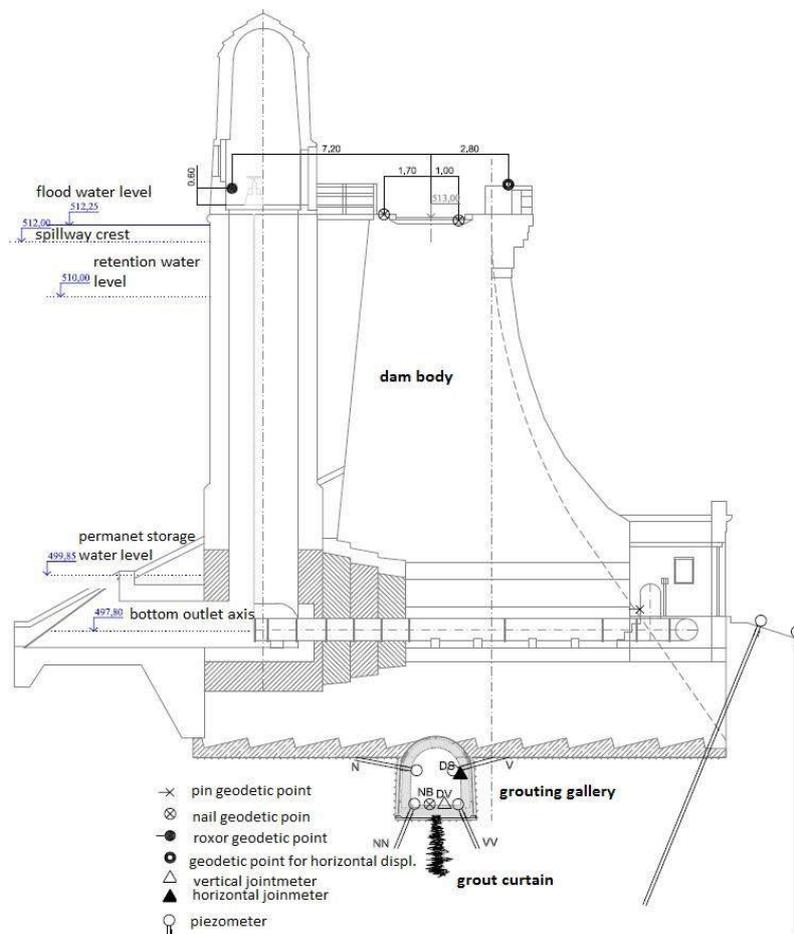
Fig. 1. Cross section of dam

Masonry dam was in operation from 1909. A complications during regular maintenance of the area near the downstream toe in the 80's indicated changes in permeability in the dam foundation zone. There were done several geotechnical surveys to evaluate precisely bedrock, the material in foundation zone and to monitor seepage regime by open piezometers as well. The expert evaluations of the dam stability were made. Operator and dam safety experts carried out large in situ operational tests to verify the influence of hydraulic and temperature loads to the deformation of the dam body.

Different ways of remedial measures were taken into account. Finally, more expensive and more risky one was chosen – excavation of the new grouting gallery in contact with the dam foundation zone and short grouting curtain from the gallery to bedrock.

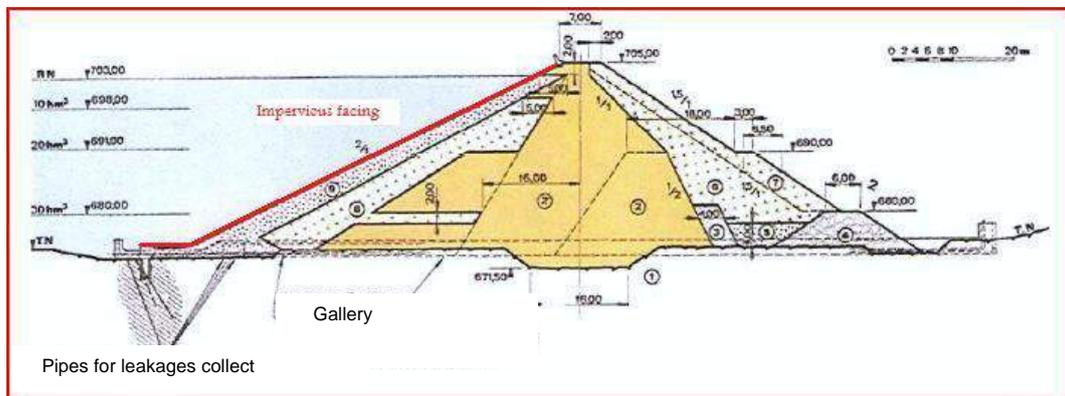
Fig. 1. Highest vertical section.

On 22 Feb. 2000, the engineer in charge of dam monitoring was visiting the site, with the reservoir nearly full (1.2 m below Normal WL). He visually noticed that the channel collecting the total leakage was unusually full of water. Immediate readings of the monitoring instruments were done and revealed a significant increase of the total leakage (32 l/s, approximately twice the usual figure), and local increases of piezometric levels (up to + 4 m), behind the upstream membrane and in the foundation.

Following the detection of this anomaly, the dam operator decided to draw down the reservoir, at a maximum controlled rate of 0.40 m/hour. During the following visual inspection of the upstream membrane, a crack was found on the upstream toe: it was horizontal, 12 m long, and 5 to 10 mm open. Repair works were immediately undertaken using water reactive resin grouting.

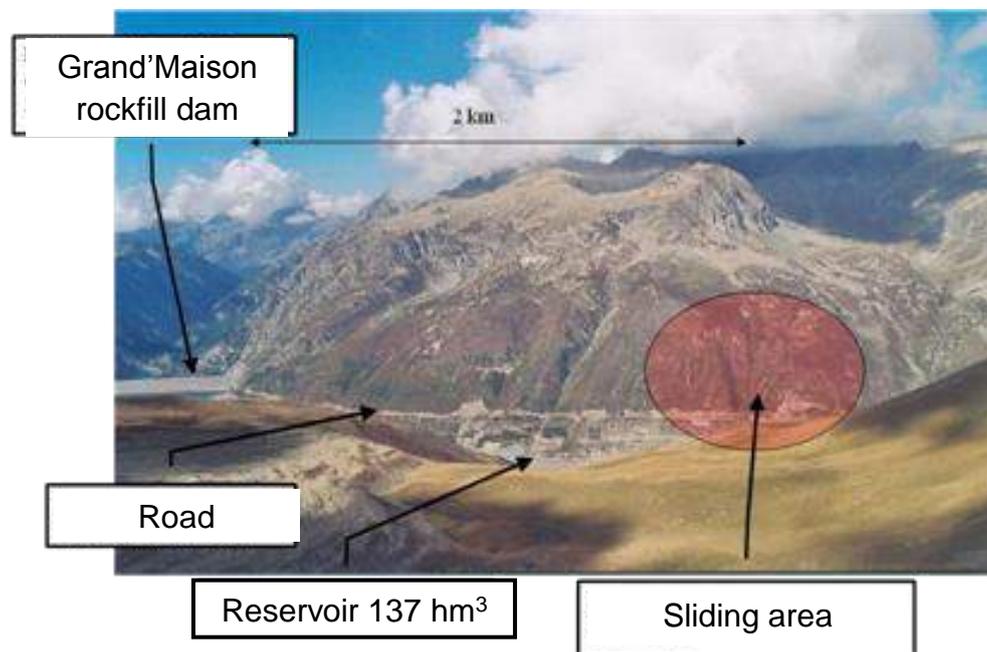
Fig. 1. Location of the unstable slope on the right bank

Grand'Maison dam was built from 1978 to 1985. Since 1981, the stability of the new road along the right bank called for attention, and a levelling monitoring system was installed along 600 m. On May 26th 1986, the reservoir was its final year of impounding, 20 m below the normal water level (Elev. 1695), when cracks appeared in the asphalt of the road. The same day a levelling measurement showed 17 cm road settlement compared to the previous measurement taken in October 1985.

The sliding volume was estimated between 0.5 and 1 million m³, and could have set off a wave stream resulting in the reservoir overtopping the dam crest. The following measures were immediately taken: lowering the reservoir at a rate of 1 m/day, reinforced monitoring, and draining the slope with a 800 m long gallery from which a series of 29 upward drain holes were drilled.

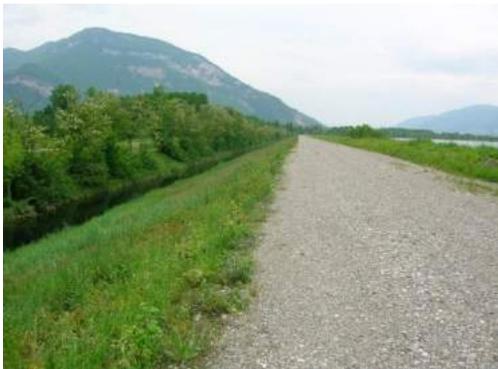
Fig. 1. La Palière dike

A number of leak zones with a very weak and diffuse flow and without any transport of material (clear water) were recorded during visual inspections at mid height on the downstream slope. At the same time, the piezometers showed a good hydraulic drawdown in the downstream shoulder of the dike. Indeed, these repair works were destabilising events which reactivated the primary consolidation, generated lateral deformations of the structure, and led to a decompression of the dyke body.

The structure was impounded in 1982, and in 2005 total consolidation reached 85 cm, which was the maximum settlement foreseen in the design. To maintain the necessary freeboard, a general rising of the dike crest by 50 cm was carried out.

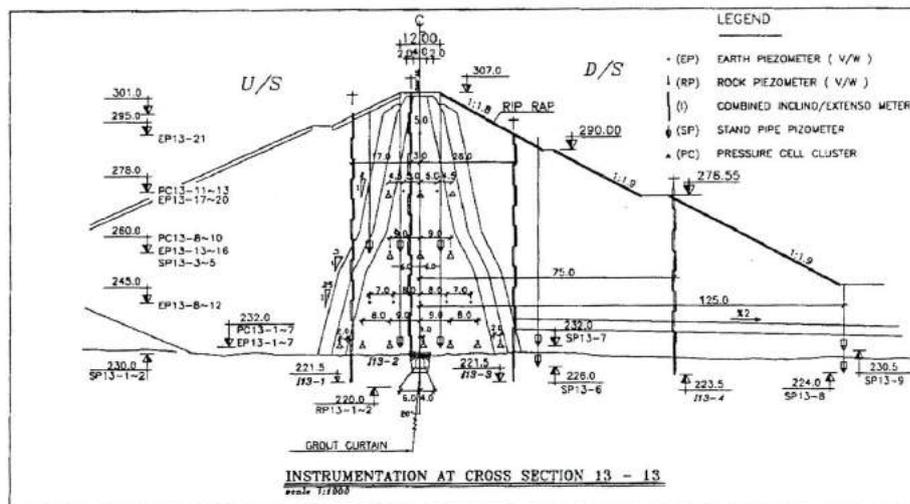
Fig. 1. Instrumentation at the maximum cross section of Alborz dam

Around 60% of standpipes have been distorted due to deformation of the dam body mostly during construction. Since vibrating wire piezometers have shown dependable results of pore water pressure over time in many dams, one solution could be reducing the number of standpipes and relying on vibrating wire piezometers to monitor pore water pressure in dam body, especially where the amounts of deformations are estimated to be relatively high.

Above and beyond this, installation details of the standpipes (such as pipe material, sealing grout, casing, etc.) should be considered and done more thoroughly so that they could resist properly against possible deformations of soils without excessive distortions or failure.

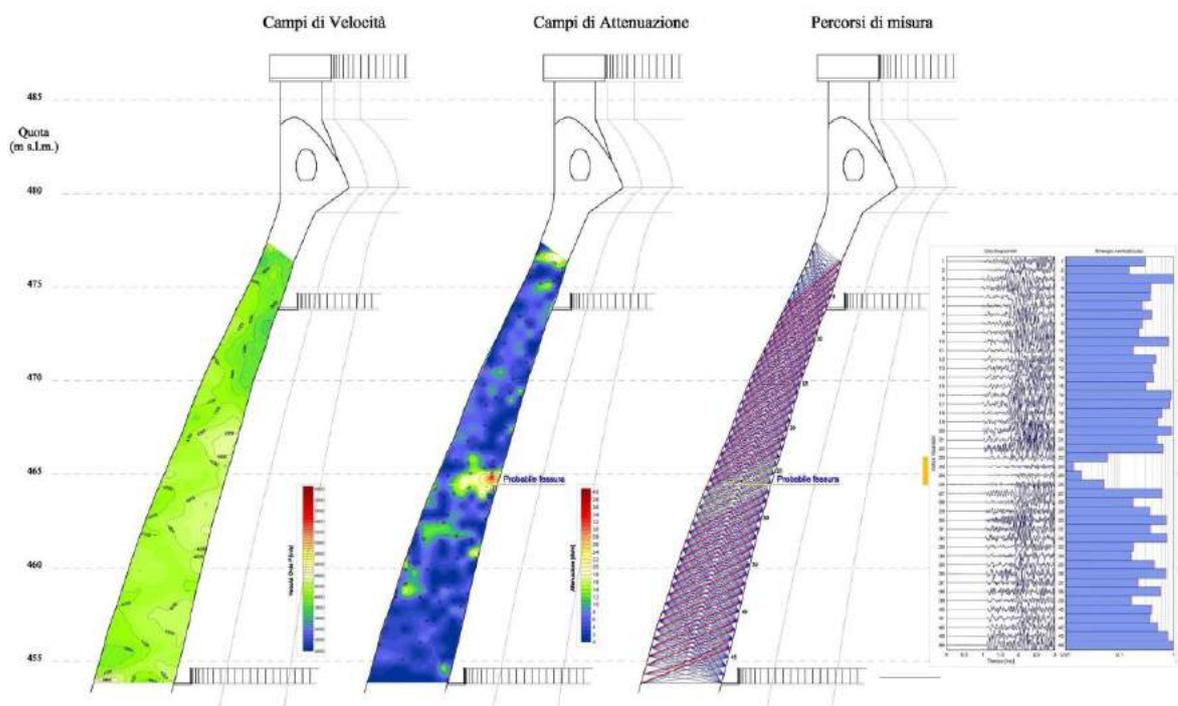
Fig. 1. Ambiesta Dam – Velocity tomography (Left) calculus of MAP (middle) and ray path tracing (Right)

The investigations have used geophysical techniques such as sonic tomography and micro seismic refraction in the dam wall, with the aim of characterizing the concrete of the area affected by the cracks patterns compared to healthy areas, constituting the dam body, and to trace the penetration depth of the cracks visible from outside face. The sonic investigation has been processed using the modulus of Attenuation of P waves coefficient (MAP).

The results of the investigation put in evidence that the cracks appeared planar and sub-horizontal towards upstream-downstream and the cracks are not passing the entire structure. The attenuations of the amplitudes of the individual signal detected have confirmed the presence of the cracks showing a decrease of the energy content of the signals that pass directly through the cracks, but highlighting at the same time as the cracks are not through the entire thickness of the dam.

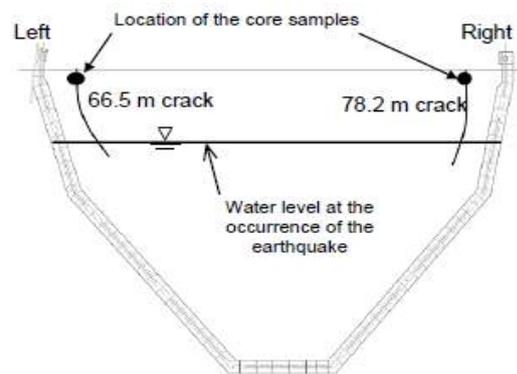
Figure 2 Location of cracks

Immediately after the Great East Japan Earthquake that occurred on March 11, 2011, water leaking from the asphalt facing, which had not been detected previously, rapidly increased to 100 L / min at the Yashio Dam. As a result, the water level quickly lowered and urgent inspections and investigations were carried out. From this, large cracks were confirmed about 20 m from the left and right abutments, as shown in Figure 2. As a result of the analysis, it was inferred that the cause of the cracks was the strain concentration on the asphalt facing at the joint openings of the concrete block at the crest. Reinforcement work on the crack sites was completed quickly in time for the summer season when the electricity demand increases, and the water leakage was reduced back to zero.

- The leakage from the upper impermeable layer is captured in the intermediate drainage layer, guided to the inspection gallery, and the water leakage detection system makes it possible to identify the occurrence of water leakage and the location of the leakage at an early stage.
- The cause of the cracks is presumed to be strain concentration on the asphalt facing at the joint openings of the concrete block at the crest.
- The residual displacement of the dam body is about 4 mm maximum in both the horizontal and vertical directions, and we evaluate that there is no problem with the stability of the dam.

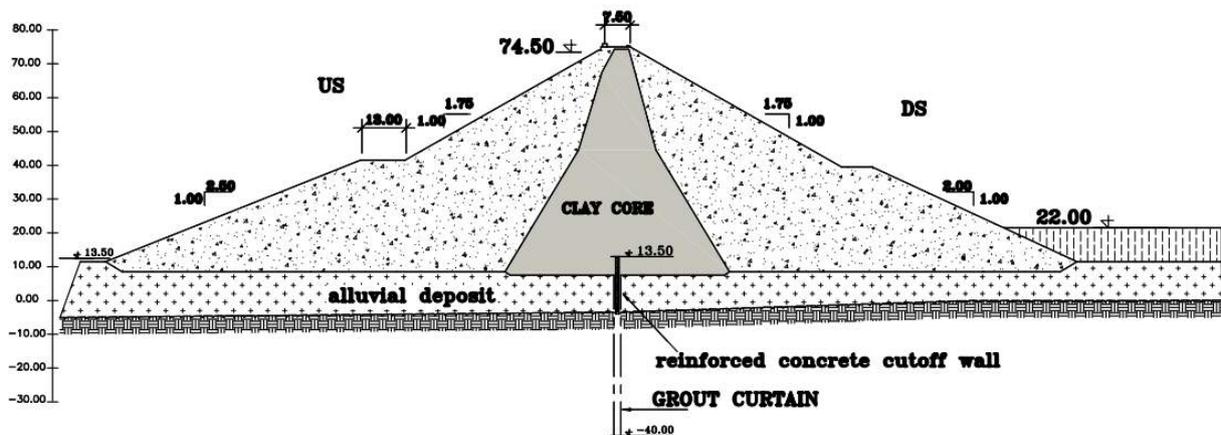
Fig. 1. Cross section of dam

The dam is founded on alluvial deposit where a positive cutoff wall, made of conventional reinforced concrete, has been constructed in the continuity of the clay core. Since the first impoundment of the reservoir occurred in 1979, the pore pressure in the alluvial deposit was gradually increasing downstream of the cutoff wall, while it was decreasing upstream. This was attributed to the continuous deterioration of the cutoff wall as it is brittle and subject to imposed deformations (Fig. 1).

The safety of the dam was jeopardized when the piezometric level reached in 1995, almost the downstream toe of the dam with a reservoir 10m below the normal storage elevation. An extensive drainage system including relief wells and deep drainage trenches allowed for the total control of the seepage along with a decrease of the piezometric level at the toe of the dam. Although the seepage flow is still increasing, because of the persistent damage of the cutoff wall, the safety of the dam is not any more threatened.

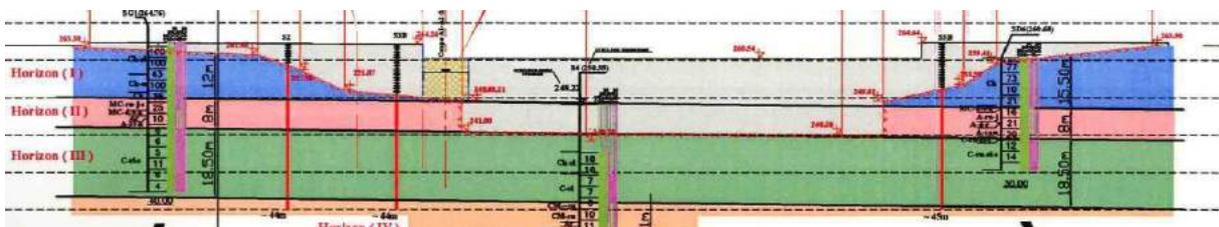
Fig. 1

the dam foundation is made of hard limestone moderately karstified. A porous, erodible and continuous marly limestone layer of almost 10m thickness was identified and removed in the footprint of the dam, only in the reverbed where it was outcropping. The geological section along the dam axis is given in fig. 1.

Geological section along the dam axis. Horizon II (pink) is made of erodible marly-limestone

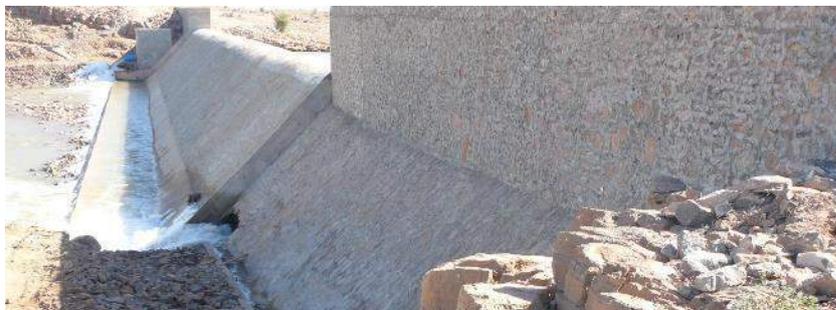
During the first impoundment, humidity signs extended humidity signs appeared, in the left abutment and far downstream where the marly-limestone layer is outcropping, evidence of increasing leakage became visible. Few weeks later, uncontrolled flow exceeding 15 m³/s developed as shown in the following photos. Hopefully, the dam didn't collapse completely.

A large remedial works were conducted to provide the required safety and water tightness to the dam and its foundation. It include an extensive grouting and drainage works along with the masonry repair.

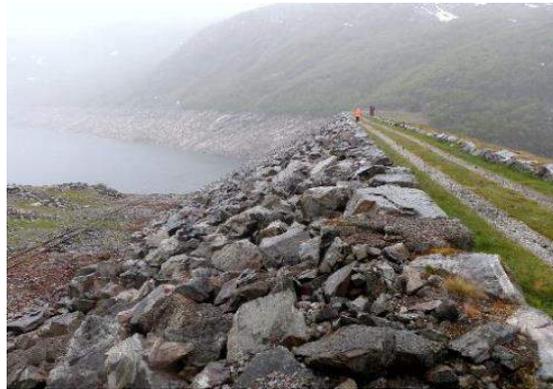
Fig. 2
Photograph of the Viddalsvatn Dam

The Viddalsvatn Dam was constructed in 1970-71. Major concentrated leaks of turbid water leaks occurred in autumn and winter 1972. Leaks emerged abruptly several times at the downstream toe of the dam the first time the reservoir was nearly full.

Also by the second filling of the reservoir, autumn 1973, a concentrated leak was observed and sinking (sinkholes) in the top of the dam were recorded. Before the third filling of the reservoir, the core had been repaired by grouting. In autumn 1980 it was again registered a momentary leakage at 180 l/s.

The leakage and erosion has been caused by selective erosion of the fines out of the moraine core material through the coarse downstream filter. Surface manifestation of piping within the core material took the form of an abrupt increase of seepage discharge laden with sediments, and the appearance of sinkholes. The incidents did not involve dam breach, but created a real sense of urgency for remedial action, and required costly repairs.
