DAM SURVEILLANCE

LESSONS LEARNT FROM CASE HISTORIES

COMMITTEE ON DAM SURVEILLANCE

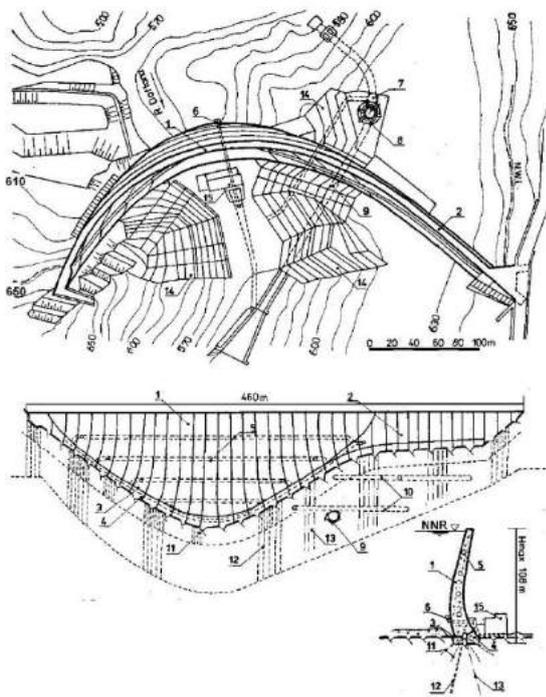
Fig. 1. Lay-out, downstream view and cross section of Paltinu Dam

During first impounding, in June 1974 while the water level reached a maximum of 642.85 m ASL an increase of the level in the drain drillings on the left slope was recorded, and subsequently, the start of water discharging at some drillings, initially with suspensions and foundation rock displacements towards downstream. These developments were located especially on the left slope terrace but present also in the area of the central blocks of the dam:

Due to the extent of the abnormal phenomena and the impossibility to control the level by the existing bottom outlet, the storage had to be completely emptied by exploding the plug of the diversion gallery and substantial rehabilitation works had to be carried out.

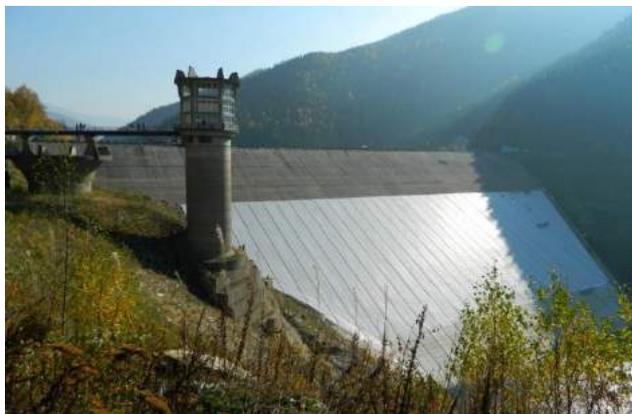
Fig. 2 Upstream vie after applying the geomembrane on the concrete mask

The dam was commissioned in 1985 and the filling has been carried out gradually, having reached maximum levels that increased by about 10 m from one year to another, but as the reservoir level rose over 1080 m, an increase of the infiltrations was recorded, much more than the previously recorded values, at similar levels.

The inspection of the concrete facing, (visual and with georadar) emphasise the when the outstanding faults of the perimetral tiles that are resting on the bedrock.

Deformations measured on the mask explain the degrading mechanism of the perimetral tiles and draw attention upon the fact that they can be very large also at the lower side of the dam which is not visible. Relation between the infiltration flow and the water level in the reservoir draws attention on overlaying of a diffuse infiltration and a multitude of spread local faults and it justifies a radical action.

Repairment works consist in a geo- membrane applied on the concrete face.
