## SAFETY PERFORMANCE OF DAMS IN CHILE HIGHLY SEISMIC ENVIRONMENT

### ABSTRACT

The paper presents a summary of the performance of large dams in Chile (heights  $\geq 15$  m) from the end of XIX century to the present, including moderate high dams for irrigation and water supply built since 1850 up to 1930 and larger dams for the same purposes as well as for energy generation from 1930 to the present days. Being Chile an important mining country there are numerous tailings dams of different types which seismic performance is also discussed. The variety of dam's types for different purposes and different construction materials constitutes an interesting scenery to the analysis of dam behaviour under high seismic loading. Although the number of concrete dams in Chile is rather limited, comments on the seismic behaviour of two arch dam and a few rolled concrete dams of medium height are also presented, as well as the case of the only rockfill dam with asphalt core existing in Chile.

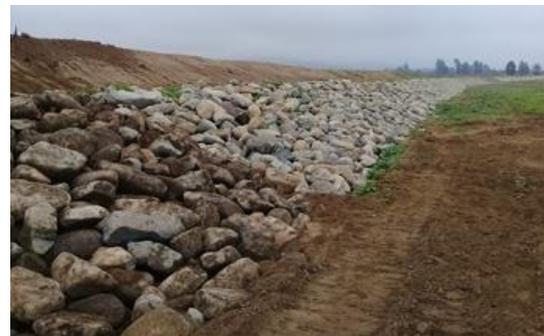
Fig. 11 - U/S slope Catapilco dam [11]

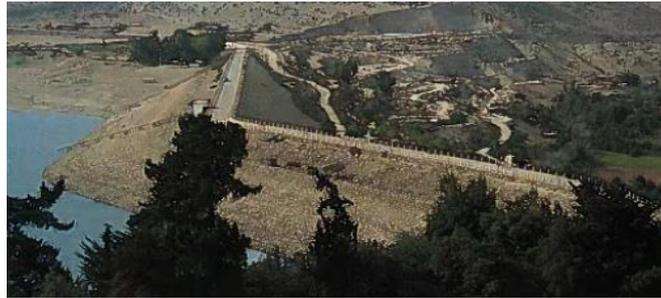
**Fig. 14 - Recoleta dam general view**

contributed to the good seismic performance over its 85 years of operation. This dam has been subjected to the Illapel EQs of 1943 ( $M=8,2$ ) and of 2015 ( $M=8,4$ ) and it was recently inspected after the 2015 EQ, identifying only minor slides of the downstream rip-rap and deformation at the crest [15]. The dam is about 125 km from the epicentre of those EQs. In 2017 a lateral wall, built by the operators over the lateral spillway, allowed the water level in the reservoir to go over the spillway crest, and the additional wall was overtopped, bringing the dam to the risk of a much serious major failure, fortunately not realized. The additional wall was later removed and restored the design conditions.

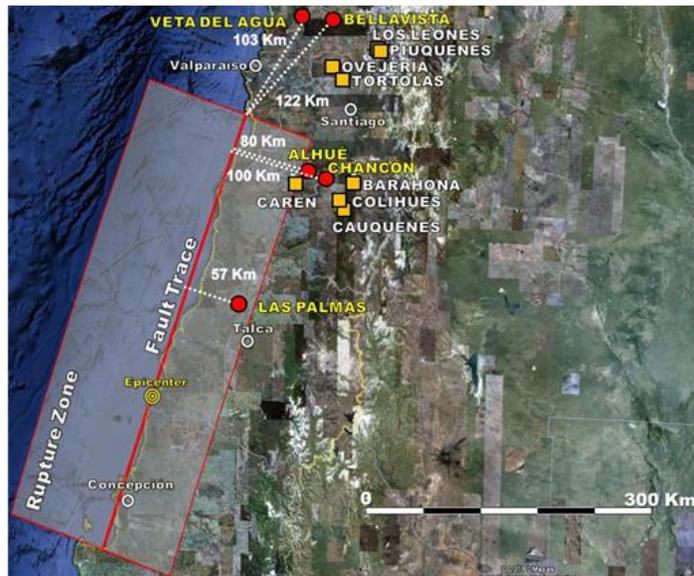
**Fig.15 - Earth dams impacted by Maule EQ 2010. [14]**

dam and the neighbour earth dam are located almost over the fault trace associated to the Maule EQ as it is shown in Fig. 15. Although the earth dam suffered some damage as it was already commented, not damage was found in the RCC dam.

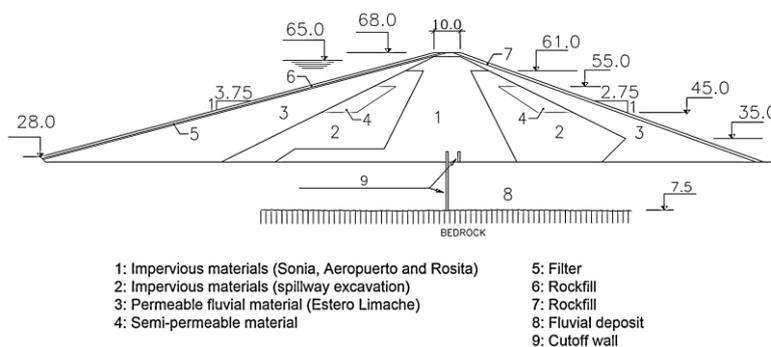
**Fig. 19 - Aromos dam design cross section**

The dam did not suffer any serious damage during the 1985 EQ, although the acceleration level around the dam is estimated in the range of 0.3g to 0.4g. The data showed that the 1985 EQ induced in the embankment vertical settlements smaller than 10 cm, which implied that the foundation ground did not suffer any major liquefaction. Therefore, new studies were carried out, which concluded that the areas of low N-SPT (liquefiable sandy soils) are surrounded by areas with high N-SPT (no-liquefiable soils). It was interpreted that the areas of high N-SPT, that are stiffer, probably took most of the dynamic shear stresses, reducing in this way the disturbances of the loose confined zones [17].

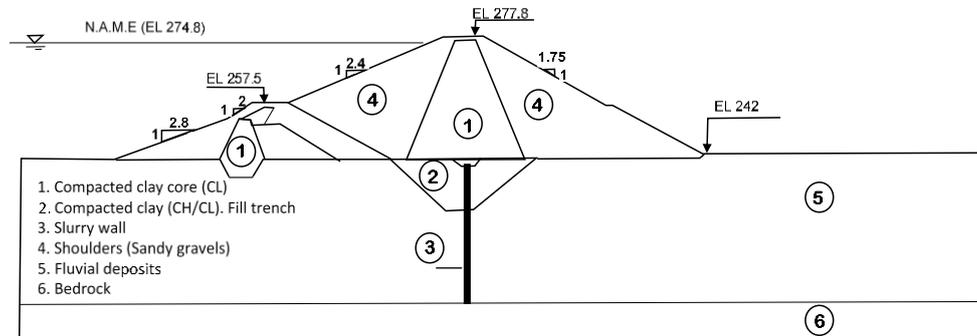
**Fig. 20 - Cross-Section Design of the Convento Viejo Dam [18].**

The Maule EQ 2010 ( $M=8.8$ ) was somewhat greater than the MCE considering in the design (MCE of  $M=8.5$ ). The results of the registers for the Maule EQ of 3 triaxial accelerographs installed in the dam and in an adjacent tunnel are indicated in Table 3. Superficial cracks were detected at the dam crest. It was not possible to identify, during repeated inspections of the earth dam, any seepage flow, or filtrations in the downstream slope of the dam. One of the piezometers located at the crest of the dam presented a sudden rise in water pressure interpreted as a possible crack in the clay core, but no increase in seepage or infiltrations confirmed this hypothesis. The maximum vertical deformations recorded at the crest, after the main earthquake, were lower than 35 cm [18]. A study through a numerical analysis carried after the EQ suggested that the February 27 EQ modified the fundamental period of the wall, analysis that should be confirmed with the registers of new strong EQ [19].

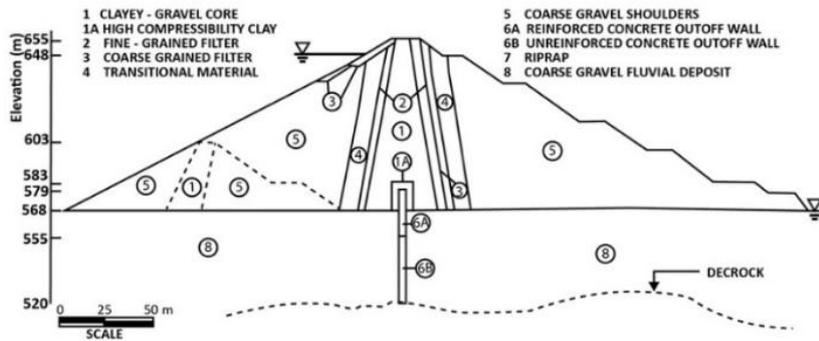
Visual inspection indicated a longitudinal crack along the crest, 10 to 20 mm width and 100 cm long. Also, a transversal crack near the left abutment and another one in the contact with the spillway. None of the cracks were too deep. No variation on Casagrande piezometers were detected as well as no changes in infiltration flows.

Fig. 21 –Typical cross section Melado dam [20]

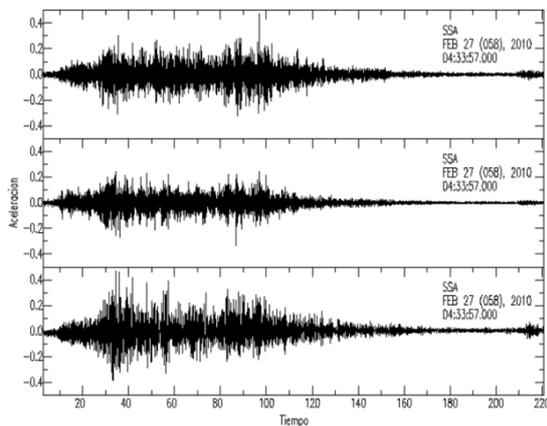
Because of the Maule EQ of 2010 ( $M=8.8$ ) the dam, which is 200 km from epicentre, received a strong impact. The peak ground acceleration at the dam was estimated to be 0,15 g using an attenuation relationship [22]. Actual accelerograph measurements in the crest of the dam indicated maximum accelerations of 0,47g (transversal), 0,33g (longitudinal) and 0,45g (vertical) with estimated amplification with respect the base of the order of 3,6 to 3,8. [23].

Fig. 22 – Registers of accelerographs at the crest of Melado dam. February 27, 2010 [23].

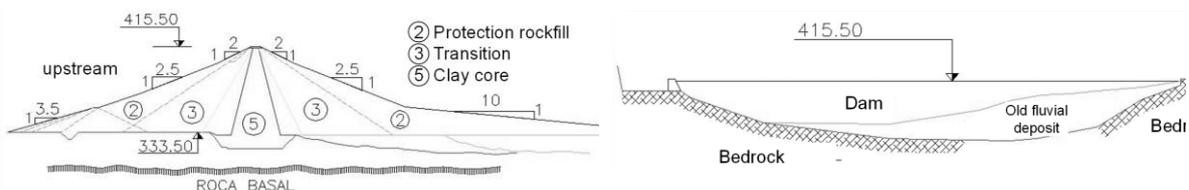
La Paloma Dam is located approximately 25 km to the South-East of Ovalle City, with a reservoir of 740 million m<sup>3</sup> capacity. This dam was constructed between 1959 and 1967, it has a maximum height of 82 m and a length of 1000 m (including a spillway of 100 m of width in the left abutment). Paloma dam is a zoned dam with a clay core and shoulders constituted by borrow materials as observed in the cross-section of Fig. 24. It is founded in an old fluvial gravelly material of variable thickness, however, part of the right abutment is directly supported by the bedrock (see Fig. 24). The irregular foundation ground has been the cause of non-homogeneous settlements; however, Paloma Dam has shown a good seismic behavior, with minor damages after the Punitaqui and Illapel EQs.

Fig. 24 - Cross section and longitudinal section of Paloma Dam

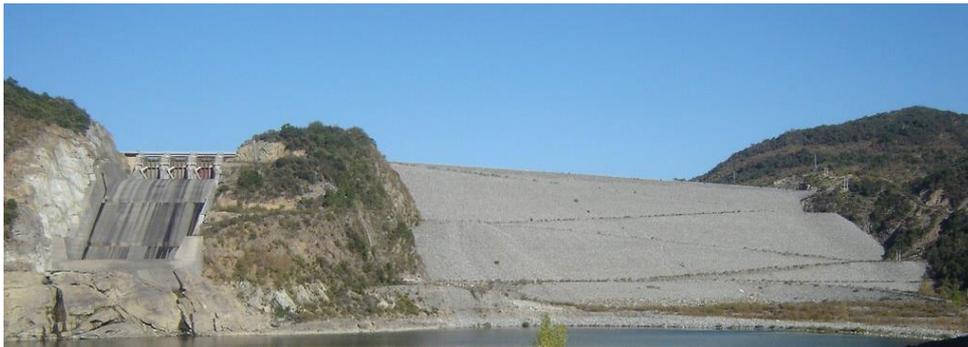
It has been informed [20][24] that this dam, the highest earth dam for water retaining purposes in Chile, suffered only minor damage during the 2010 EQ and relatively low settlements and displacements, of no more than 10 cm. Transverse cracks across the crest next to both abutments had a thickness of 1 cm, and when excavated disappeared at a depth of 3 m.

An electrical conduit next to downstream edge of the crest was displaced a maximum of 2 m horizontally and almost 1 m vertically, but inclinometers along the downstream shoulder did not show deformations after the EQ.

Fig. 25 – Colbún dam general view (<https://mapio.net/pic/p-9289343/>)

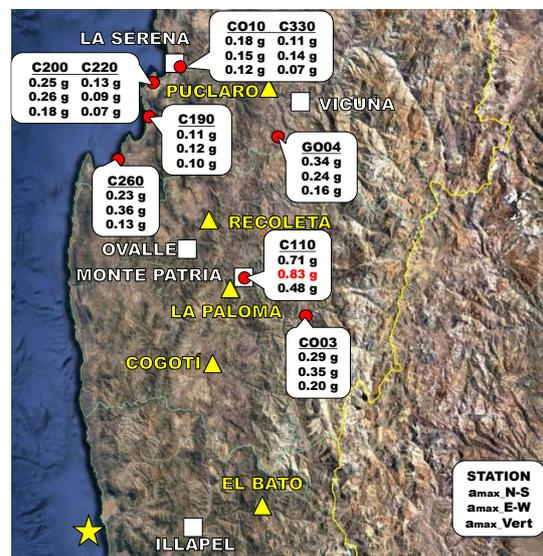
Fig. 26 - Dams impacted by Illapel EQ 2015

Rock fill dams as water retaining structures started relatively late with the construction of two dams designed by MOP and operated by irrigation associations and two dams built by private, all of them built between 1935 and 1946. Only in the 1970's new rockfill dams were built and a new revival appeared later with natural gravel dams with concrete faces following the general concepts of rock fill dams. Location of some of the dams that will be mentioned later is indicated in Fig. 26 together with the accelerations registered in various stations during the Illapel EQ of 2015. Of the 5 dams indicated in the figure only La Paloma (a zoned earth dam (96 m high) suffered some damage in its right abutment [15]. The other 4 dams of the CFRD type did not suffer damage during this EQ.

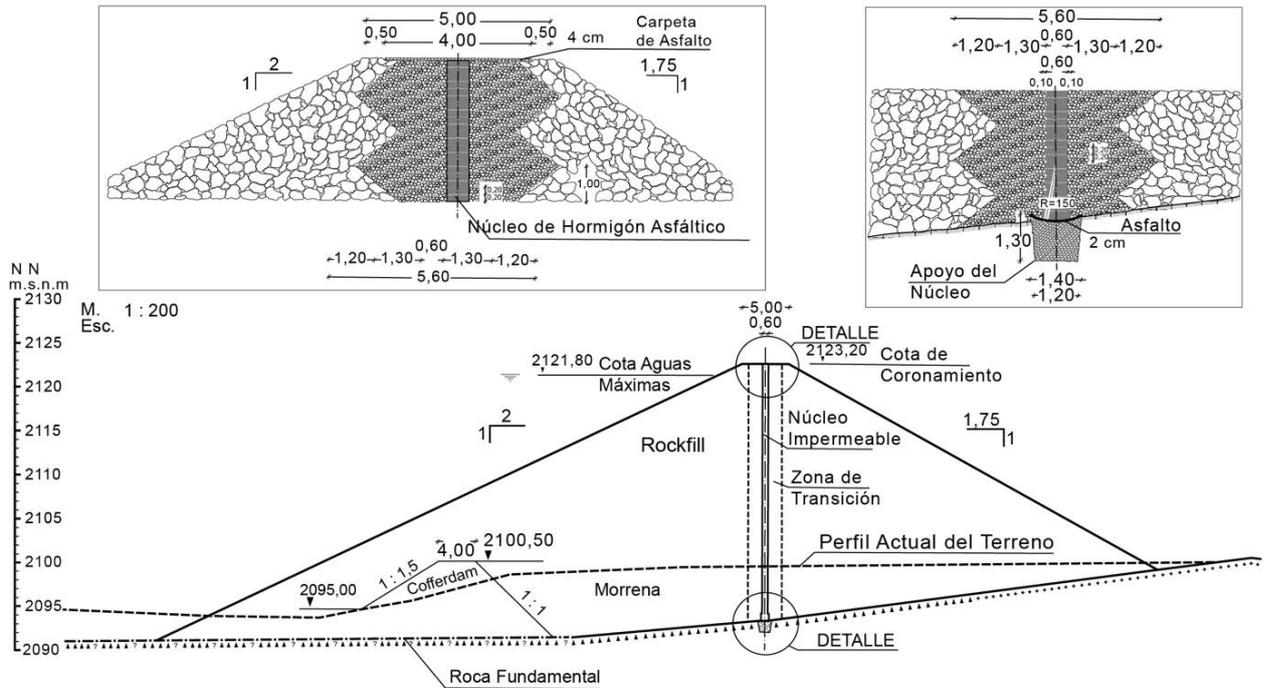
**Fig. 27 - Cross-Section Design of Los Cristales Dam.**

An evolution of the original concept of the rockfill dams with central clay core is represented by Los Cristales dam (31 m high) built in 1977 by MOP including an asphalt core. The cross section of the dam and details of the top and bottom of the asphalt core are shown in Fig. 27. The dam was visited after the Maule EQ of 2010 in view of its relatively short distance to the fault trace and epicenter of the EQ. The asphaltic vertical core has a constant thickness of 60 cm. The post seismic survey carried out on the dam indicated settlements of the shells of only a few millimeters. Even though the seismic response of this dam was satisfactory the core settled about 14 cm (Fig. 27) next to the left abutment of the dam shown in Fig. 26. [14].

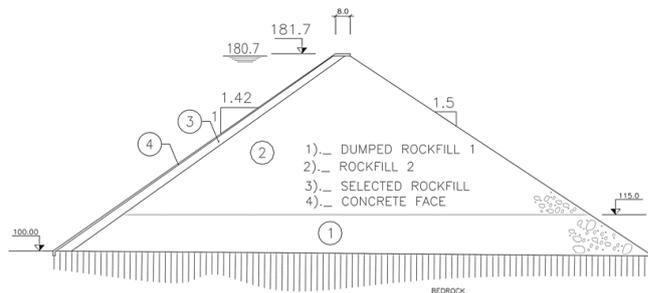
**Fig. 30 - Cross section Cogotí Dam [17]**

spillway excavated in rock and without gate allows a water flow of 5 thousand  $m^3/s$ . The dam is a concrete face rock fill dam (CFRD), completed in 1940, although the main body was finished earlier in 1938. The embankment, 160 m long, with a maximum height of 83 m and a crest width of 8 m and it was built with rock from an adjacent quarry placed in the dam without compaction. The u/s slope is 1.42-1.47:1 (H:V), while the d/s slope is 1.47-1.50:1 (H:V). A cross-section of the embankment is shown in Fig. 30. In the first 15 m, rock blocks with a maximum size of 1.5 m were used, which were just dumped by gravity in the dam site. Afterwards, the same material limited to a maximum size of 1.3 m was placed by mechanical means, which induced a slight compaction generated by the passage of trucks during the construction. The technical specifications requested the application of abundant sluicing with water (water pressure of 60 m) using a quantity of water equivalent to three times the volume of the sluiced layer. However, the available technical records of the construction indicate that most of the time the requested amount of water was not fully satisfied. Due to construction procedure, it is possible to conclude that Cogotí Dam is composed of a rockfill with poor densification.[17]

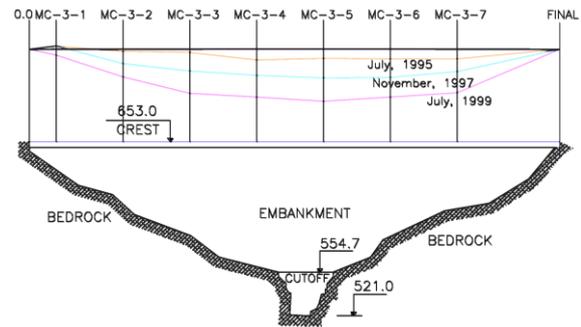
**Fig. 33 - Profile of the valley and settlement distributions [17]**

In Fig. 33 are also presented the measured settlements at the control points located along the crest of the dam. It is observed that the vertical deformation is in some way shifted to the right, confirming the results observed in Cogotí Dam that suggest that the shape of the bedrock has an important effect on the distribution of the vertical settlements, static and seismic.

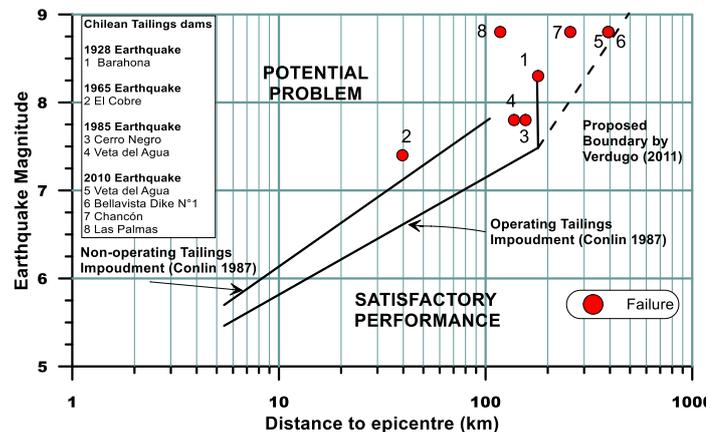
Fig. 37 - Tailings dams failures in 1928, 1965, 1985 and 2010 EQs [33][34]

The date of 28th of March 1965 became a milestone in the practice of design and construction of tailings dam in Chile. Because of the failure of El Cobre tailings dams that caused more than 200 fatalities and significant environmental damage, the construction of tailings dams constructed by the upstream method was legally forbidden (decree N°86 of 1970) [35] and this restriction has been kept until the present time (decree N° 248 of 2007) [36] The failures that occurred after 1965 correspond to dams that were built before 1965 using the upstream method or relatively new dams, as Las Palmas, that had a substandard design and poor operation and abandonment conditions

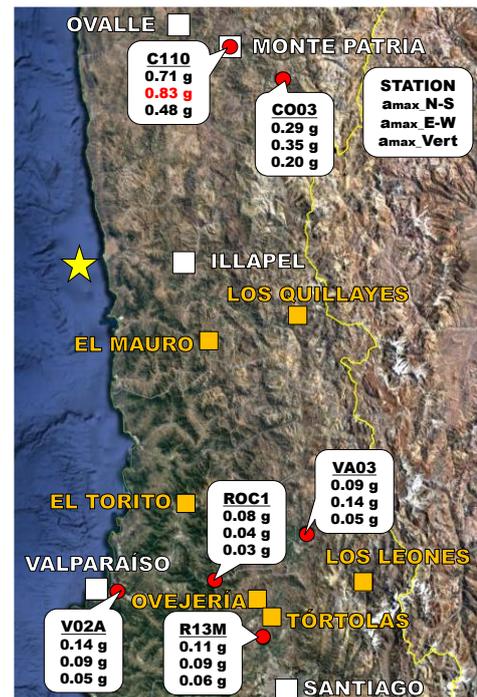
**Fig. 41 – Tailings dams, Illapel EQ**

None of these dams has suffered some significant damage during the relatively recent EQs of Valparaiso 1985 ( $M=8.0$ ), Maule 2010 ( $M=8.8$ ) and Illapel 2015 ( $M=8.4$ ) although most of these dams are at a relatively short distance of the epicentres, as it is shown in Fig. 41 for the particular case of the Illapel EQ of 2015.
