# DESIGN FEATURES OF DAMS TO RESIST SEISMIC GROUND MOTION

*Guidelines and case studies*

**Bulletin 120**

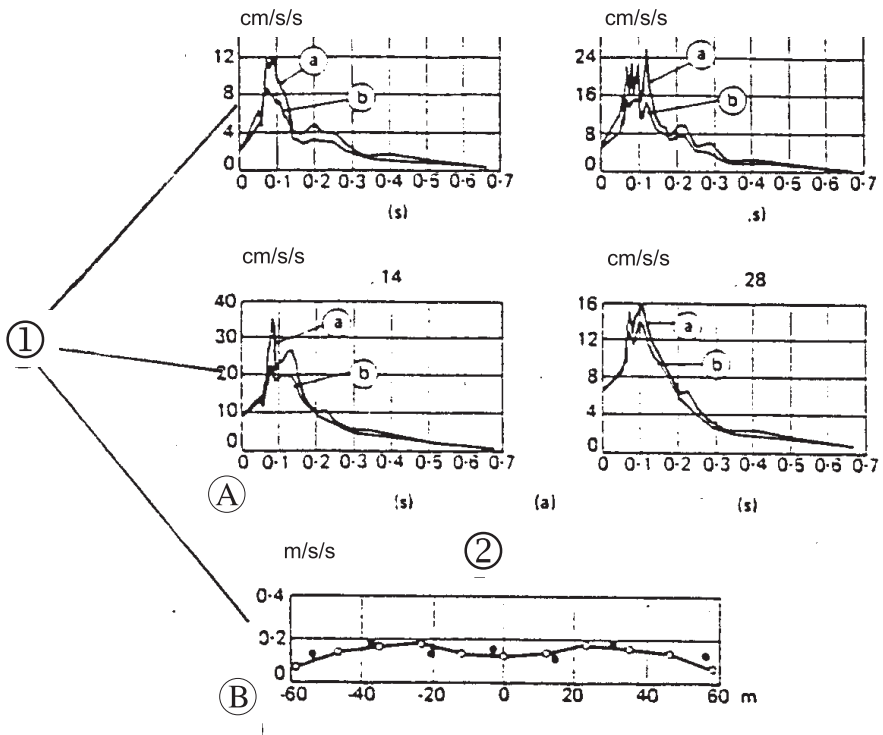
Fig. 1.4  
Ambiesta Dam  
*Barrage Ambiesta*

A) Response Spectra to Aftershocks  
B) Comparison between Computed and Recorded Accelerations

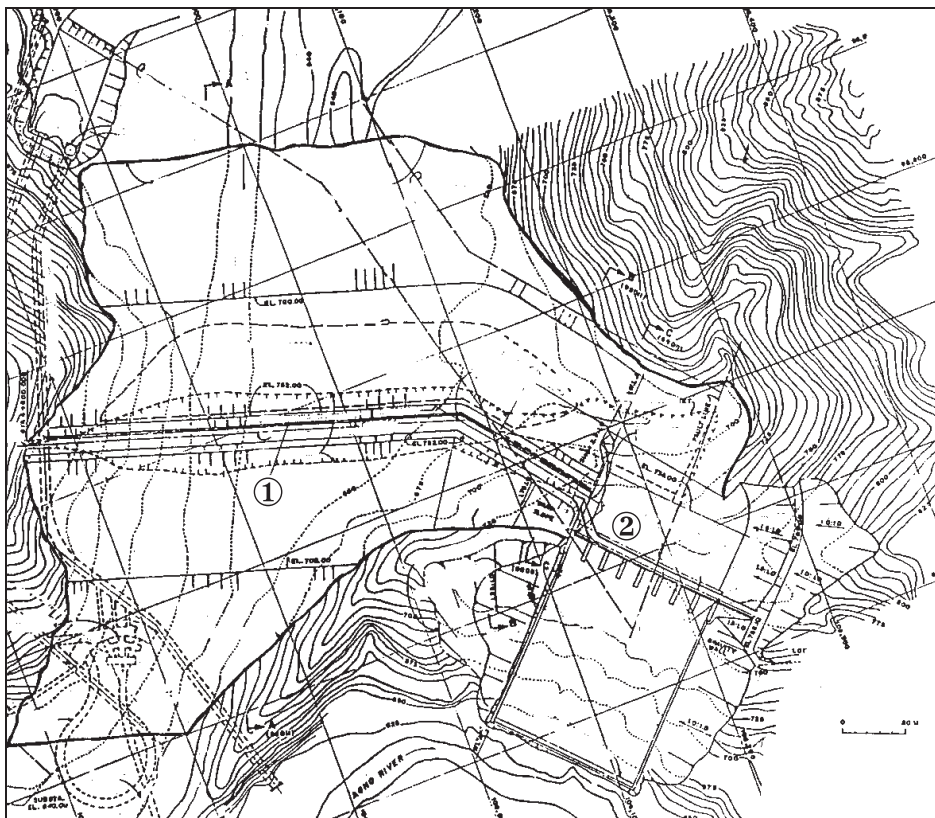
Fig. 2.2

Ambuklao Dam – Dam Site Layout

- 1) Horizontal Axis of Dam
- 2) Spillway

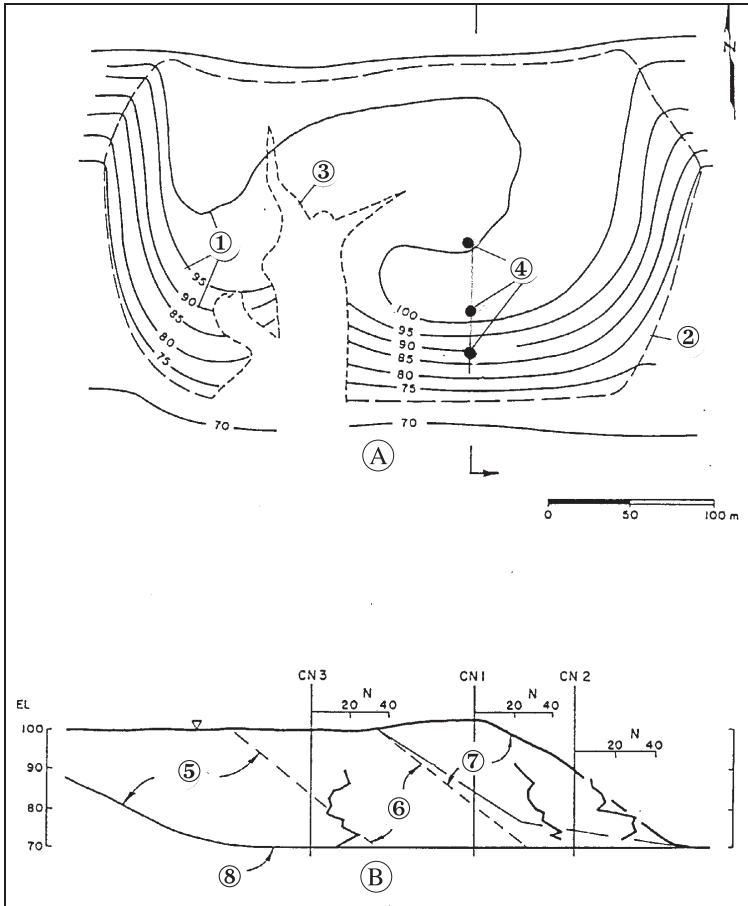
Cerro Negro Tailings Dam – Plan and Section

The Cerro Negro tailings impoundment Number 4 was built outward from a valley side slope. The dam consisted of three sections, a central section roughly parallel to the valley floor, and two transverse sections linking the central section to the valley slope, see Fig. 5.1.

Three borings were drilled in 1987 at the locations shown on Fig. 5.1. (Castro and Troncoso, 1989). Three zones were encountered: an outer zone consisting of the sand fraction; an intermediate zone of stratified sands and slimes; and an interior zone of slime. The boundaries shown on Fig. 5.1 are based on boring logs data and observations of the walls of a large crevasse formed during the failure. This zoning confirmed the information regarding construction, which indicated a procedure intermediate between upstream and centerline construction methods. All three borings encountered a natural foundation material consisting of a dense gravelly sand.

The zone forming the sand fraction of the tailings, see Fig. 5.1, actually ranged from a silty fine sand, with about 20 percent of silt, to a non-plastic sandy silt. The percentage of fines increased with distance from the outer slope, as shown on Fig. 5.2. Standard penetration testing (SPT) corrected blowcounts within the sand zone

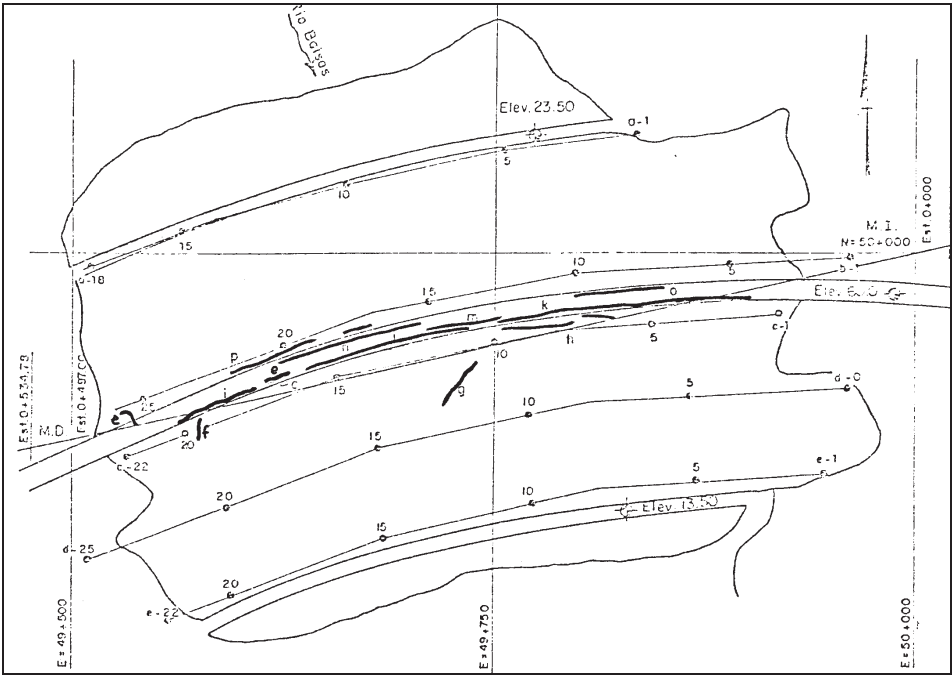
Fig. 8.3  
 La Villita Dam – Crack Location at La Villita Dam  
*Barrage La Villita – Emplacement des fissures sur le barrage La Villita*

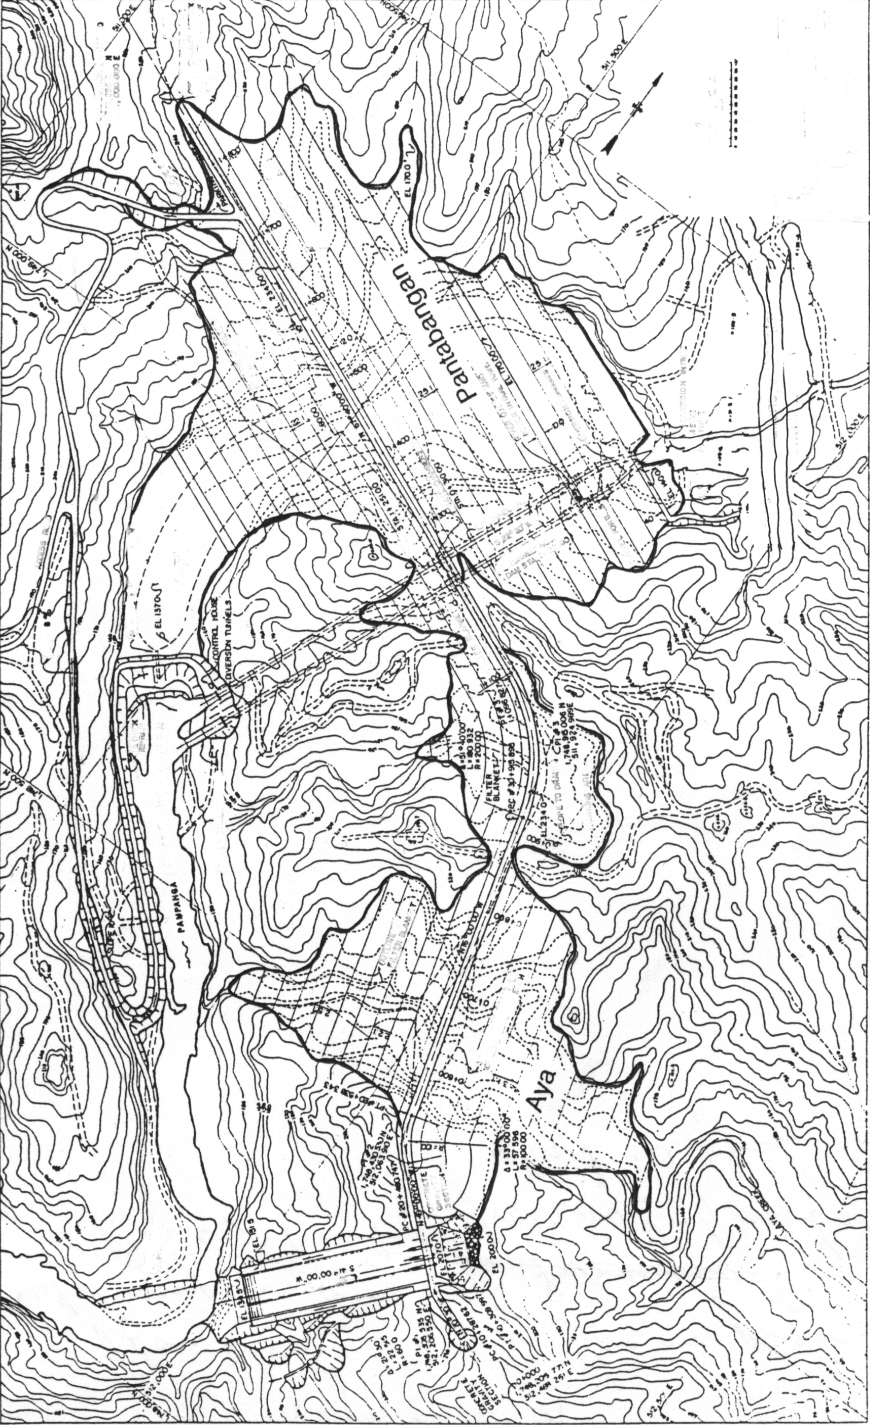
Fig. 13.1  
 Plan View of Pantabangan and Anya Dams  
*Vue en plan des barrages Pantabangan et Anya*
